Technical Service Bulletin

No. B501-07v2
22 April 2005

Subject/Concern/Concern:	Possible Causes of Water Ingress into the Vehicle
---------------------------------	---

XJ Range	VIN-range: G00442 Onwards
----------	---------------------------

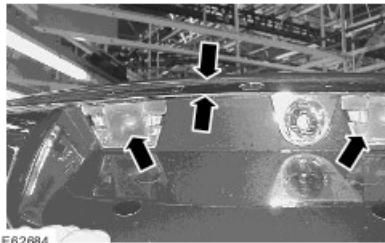
E62684

- 66 . **Issue:** Water ingress into the rear number plate lamps. **NOTENOTE:** Foam attached to finisher may be distorted.

Possible cause: Luggage compartment trim finisher not correctly sealed to the luggage compartment lid.

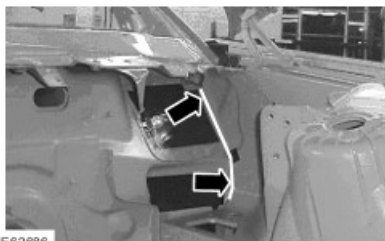
E62686

- 88 . **Issue:** Water ingress into the front footwells. **Possible cause:** Inner front fender to bulkhead seams leaking.

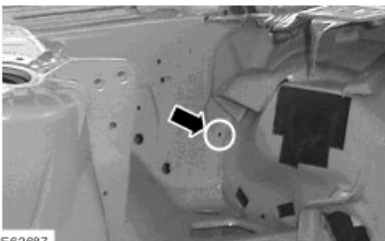
E62687

- 99 . **Issue:** Water ingress into the front passenger footwell. **NOTENOTE:** On driver side this hole is used to mount the plenum drain tube. On passenger side a blanking patch is installed.

Possible cause: Patch over hole can leak water.

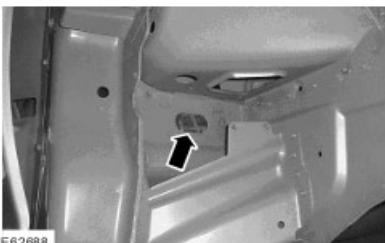
E62688

- 1010 **Issue:** Water ingress into the front footwell. **Possible cause:** Water ingress from harness grommet under front wheel arch.

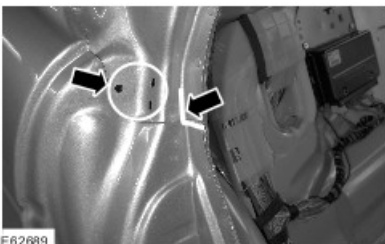
E62689

- 1111 **Issue:** Sill carpet wet at rear. **NOTENOTE:** Remove rubber finisher and apply a suitable wet sealant (to the areas shown) to block the water path.

Possible cause: Water tracks under the rubber finisher along the C-pillar/door shut joint and/or behind the rubber finisher fixings, then down along draft welt.

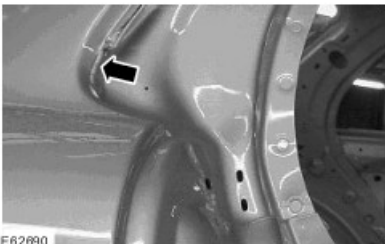
E62690

- 1212 **Issue:** Water ingress into the cabin. **Possible cause:** Water can run from the drain channel, behind the putty, and then down onto the inner wheel arch. From here the water can run forwards into the cabin.

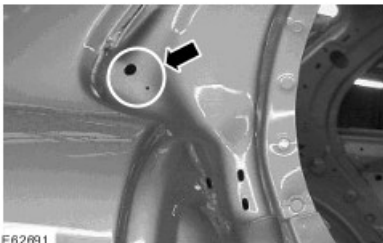
- 1313 **Issue:** Water ingress into the cabin. **NOTENOTE:** Pull away finisher for access, remove two fixings securing the drain channel clip and apply a suitable wet sealant around the fixing holes (areas shown) to block the water path.

Possible cause: Water ingress through the drain channel finisher fixings.

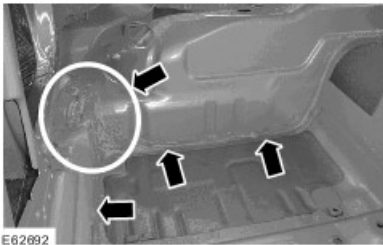
1414 **Issue:** Water ingress into the rear of the cabin. **Possible cause:** Water ingress through the seams by the rear seat.

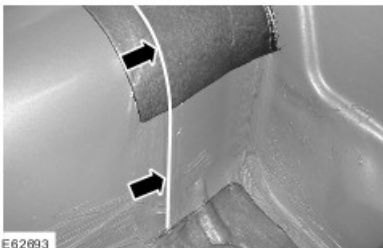
1515 **Issue:** Long Wheel Base Vehicles Only - Water ingress into the left-hand and right-hand rear footwells.
NOTENOTE: Illustration, right-hand shown left-hand similar.

Possible cause: Water ingress through the long wheel base extension seem, left-hand and right-hand side.
