SERVICE ACTION

Service Action
Number: K309

TECHNICAL BULLETIN
LTB00671NAS6
27 JUN 2016

Engine MIL Illuminated With Heated Oxygen Sensor-Related DTCs Stored

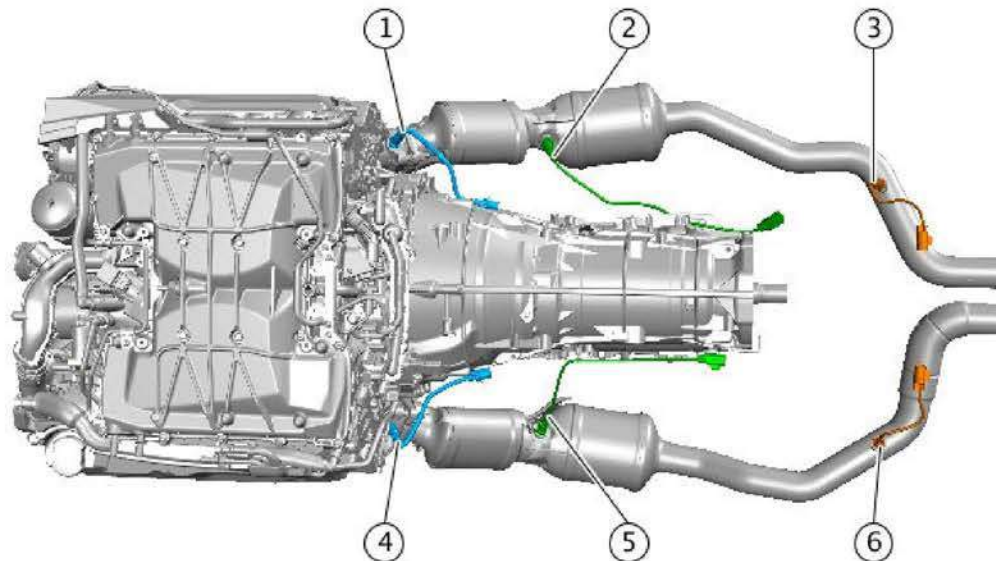
E181489

Heated Oxygen Sensor (HO2S) location and designation.

HO2S	Description	Identification
1	Heated Oxygen Sensor (HO2S) - Pre-catalyst - Bank 1, Sensor 1	B1-S1
2	Heated Oxygen Sensor (HO2S) - Mid-catalyst - Bank 1, Sensor 2	B1-S2
3	Heated Oxygen Sensor (HO2S) - Post-catalyst - Bank 1, Sensor 3	B1-S3
4	Heated Oxygen Sensor (HO2S) - Pre-catalyst - Bank 2, Sensor 1	B2-S1
5	Heated Oxygen Sensor (HO2S) - Mid-catalyst - Bank 2, Sensor 2	B2-S2
6	Heated Oxygen Sensor (HO2S) - Post-catalyst - Bank 2, Sensor 3	B2-S3
