**JTB00518NAS5**  
**TECHNICAL BULLETIN**  
**29 JUN 2017**

303-03 - Engine Cooling

Engine Coolant Expansion Tank Leak

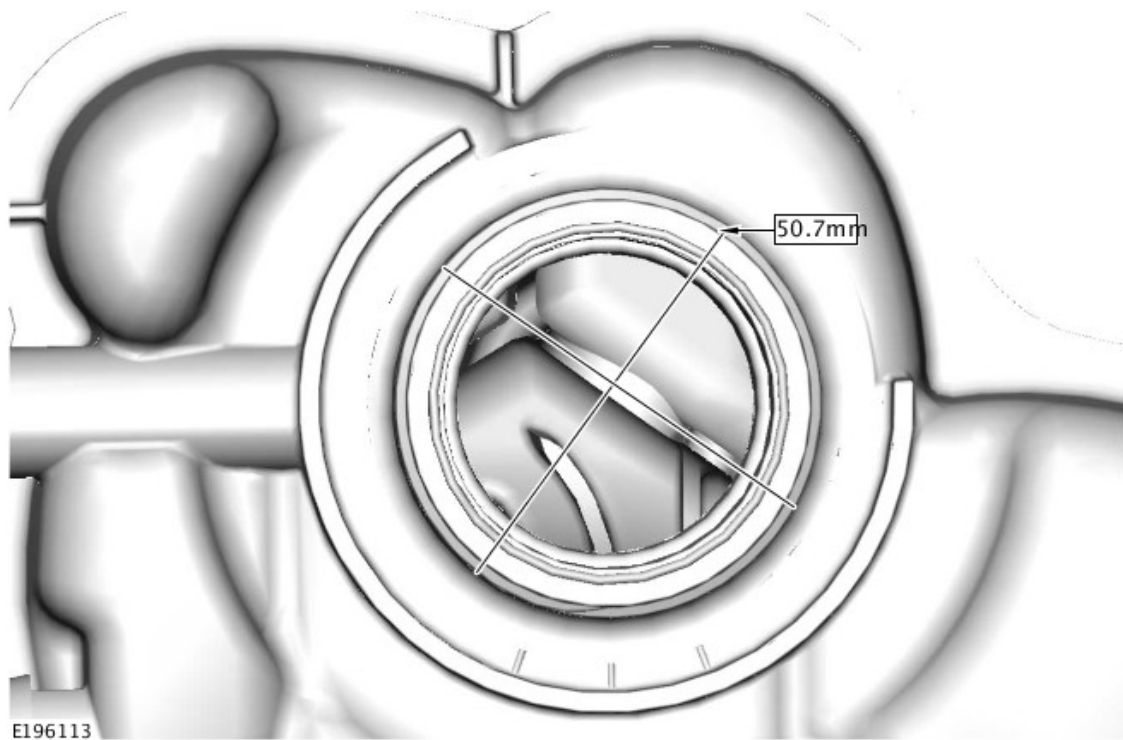
Check the dimensions of the engine coolant expansion tank threaded neck in the two positions shown.

If the dimensions across the centerline neck are less than 50.70mm, go to Step 5.

If the dimensions across the centerline of the neck are 50.70mm or greater, go to Step 4.

<sup>5</sup> Install a new engine coolant expansion tank and a new coolant pressure cap (see TOPIx Workshop Manual section 303-03: Engine Cooling - Engine Coolant Expansion Tank).

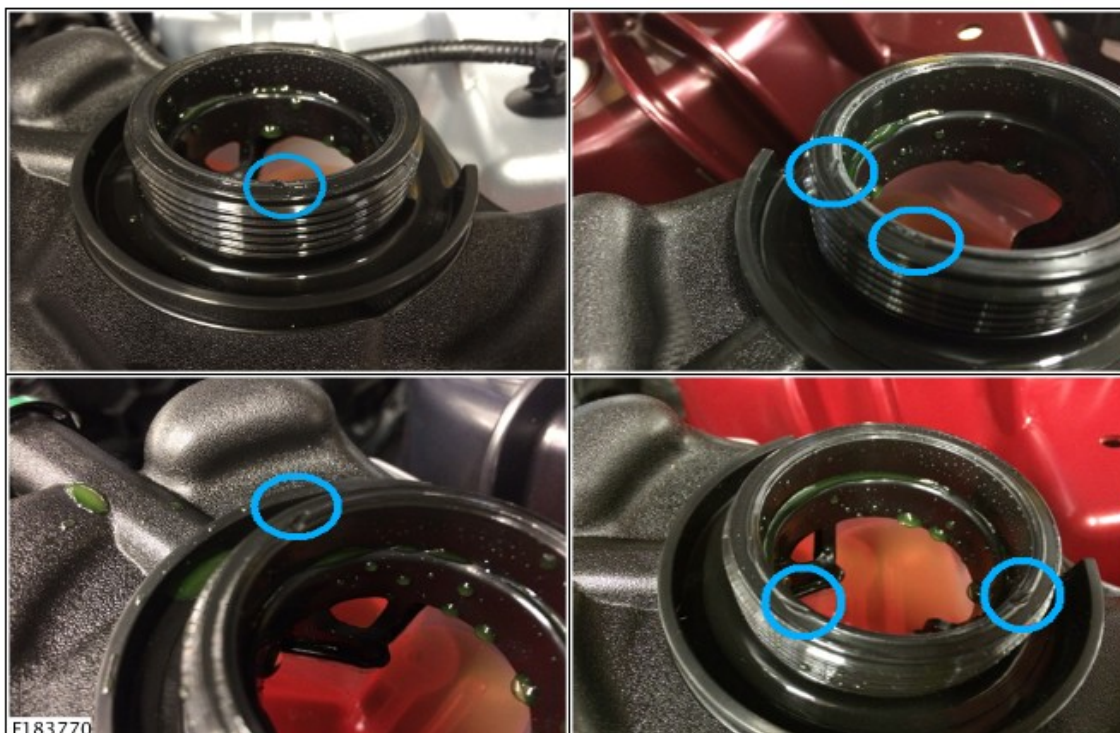
Visually inspect the sealing bead on the engine coolant expansion tank neck to check for damage.

If the sealing bead is damaged, go to Step 5.

Install a new engine coolant expansion tank pressure cap.

Top up the engine coolant to the MAX level mark.
