JTB00472NAS1

TECHNICAL BULLETIN

SUBJECT/CONCERN:

Engine Intermittently Will Not Start

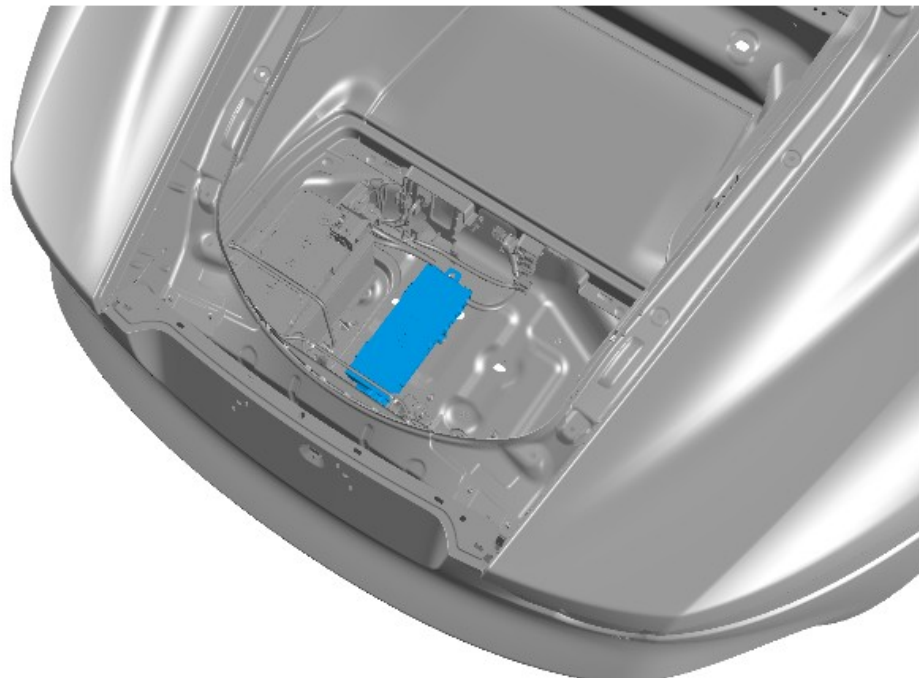
E186896

This may be caused by the Battery Junction Box (BJB) connection not being tightened to correct torque value.

Battery Junction Box (BJB) location.
