TECHNICAL BULLETIN
JTBO0377NAS1
05 JAN 2015

SB-10057687-7322

Fluid Ingress Into Central Junction Box

XF (X250)

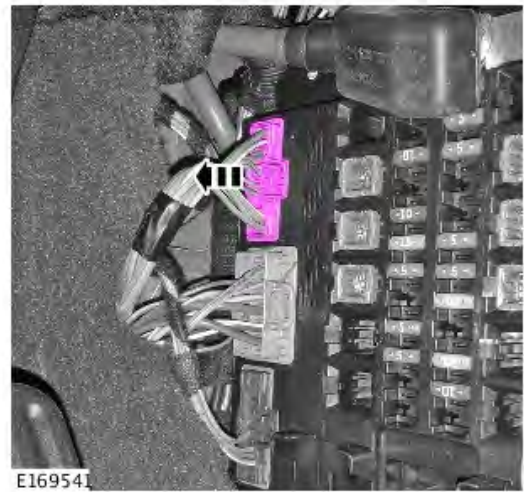
Disconnect the Central Junction Box (CJB) connector (C3BP01E) and inspect the connector for moisture and/or corrosion.

- If there is no corrosion and/or moisture, **NO** further action required.
- If corrosion and/or moisture is found, continue to the next step.
