Tacho Generator repair. Sep 2020

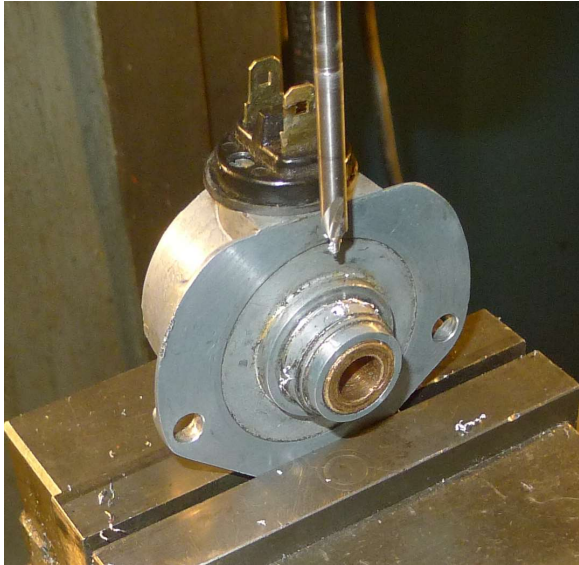
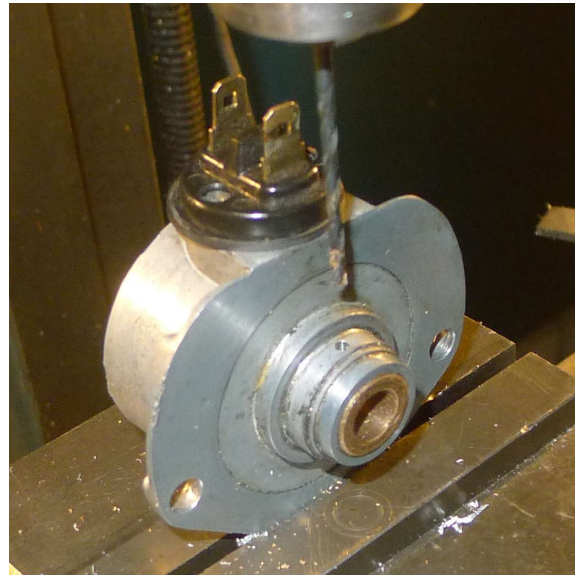
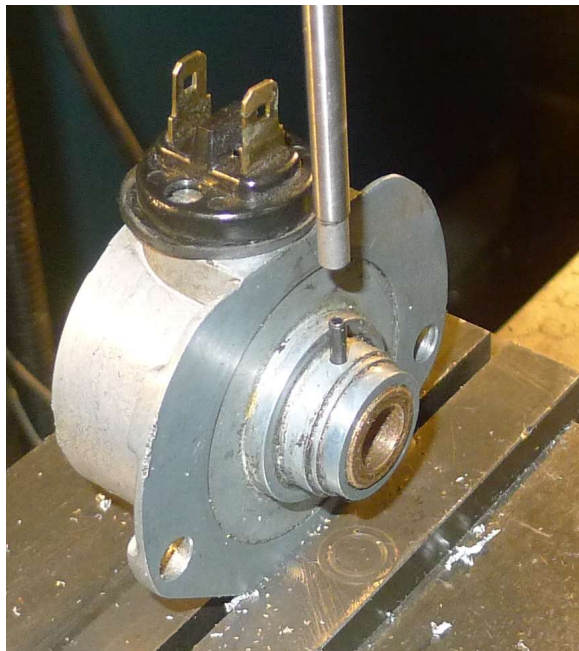
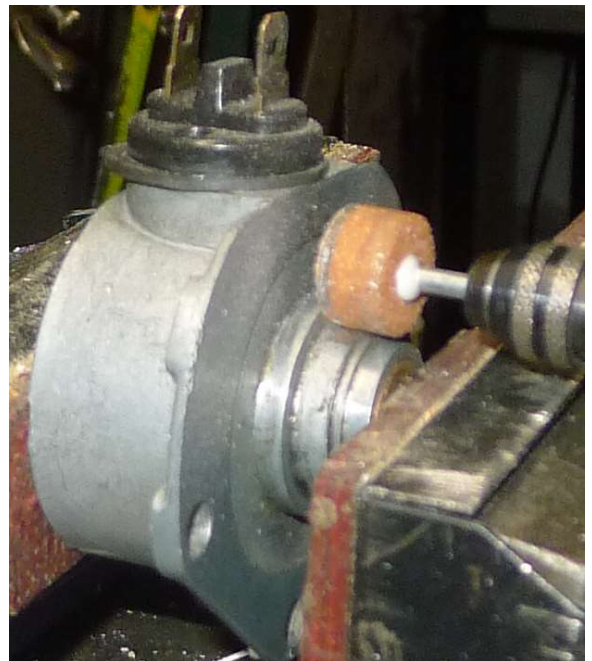
The plain bearing bush tends to migrate into the body of the generator, thus allowing the driving dog to disengage resulting in no reading on the tacho.

This was fixed by pulling the dog outwards until the bush was in its correct axial location and then fixing with a 3/32 spring pin. The pin hole was drilled 0.22" deep so that it would not contact the shaft.
