© D. Jensen 2006	<b>REPLACEMENT OF V8 SECONDARY TIMING CHAIN TENSIONERS</b>	V. 1.0 June 2006
Distribution: <a href="http://www.jag-lovers.com">www.jag-lovers.com</a>

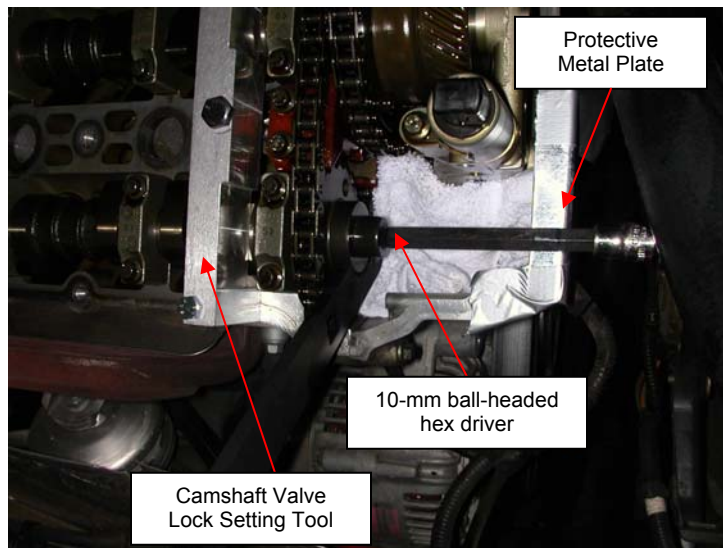
Fig. 6 shows the right side of the engine after installation of Camshaft Valve Setting Lock Tool and 10-mm ball-end hex driver. As per the instructions, I first attached a short piece of metal plate to the timing cover, taped in place, to prevent damage to the timing cover/cam cover mating surface. While not obvious in the photo, the hex driver enters off center a few degrees. Note the rag stuffed into timing chain cover to avoid potential disaster.

Fig. 6 View of right side with camshaft setting tool, 10-mm ball-end hex driver and protective metal plate in place

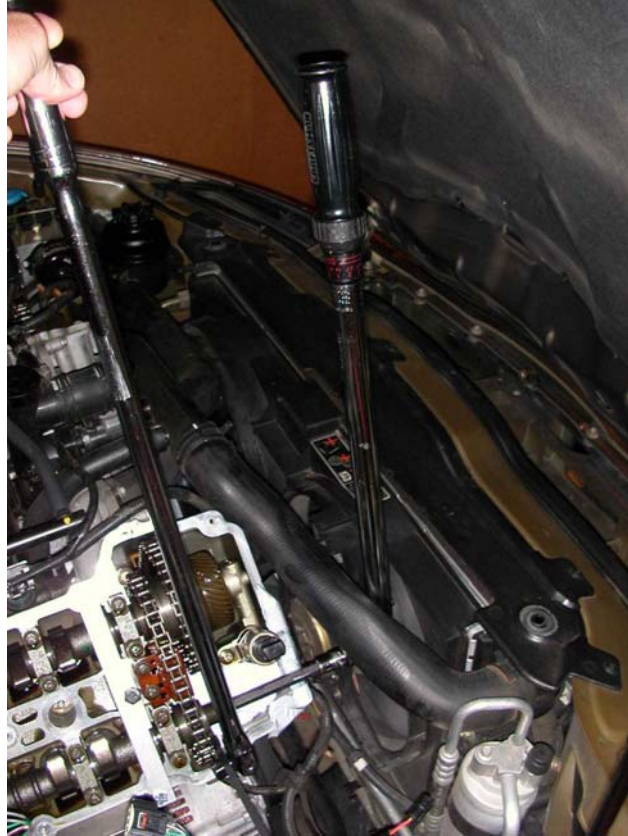
As shown in Fig. 7, I used a ½-in.-drive torque wrench and ½-in. breaker bar, inserted into the square opening in the Timing Chain Tensioning Tool, to loosen the bolt securing the sprocket to the camshaft. This is a long bolt that, surprising to me, is hollow (per a local Jag specialist I deal with). Figure 8 shows the sprocket as it was nearly off of the camshaft.

Fig. 7 Torque wrench, Timing Chain Tensioning Tool and breaker bar in place during removal of sprocket-to-camshaft bolt

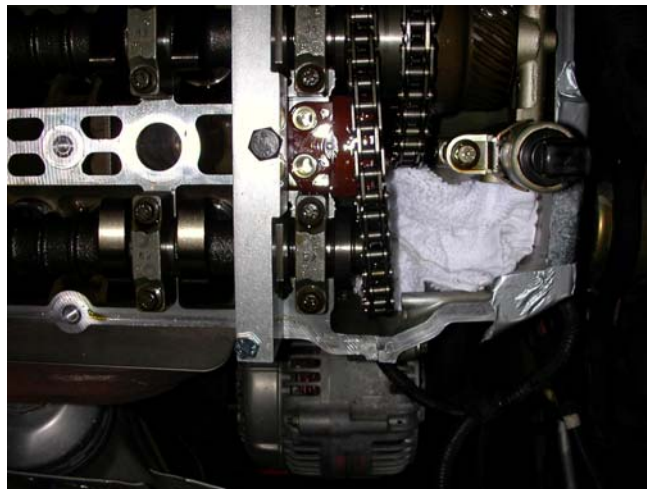
Fig. 8 Sprocket moved forward off of camshaft

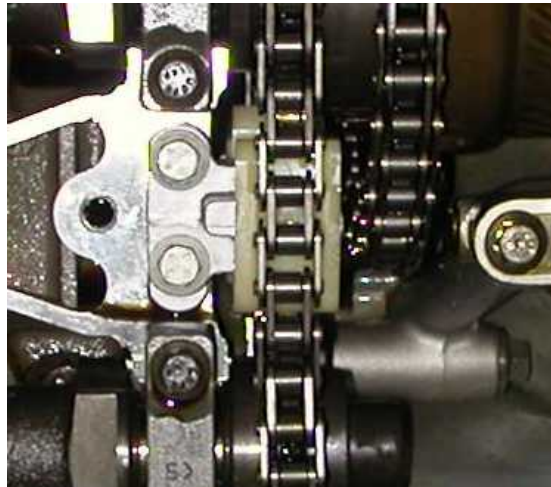
Fig. 9 New tensioner in place

Once the sprocket was off the camshaft, it was a fairly simple matter to remove the tensioner after the two hold-down bolts were removed. Reinstallation was likewise simple. Note that the tensioner bolts only need to be torqued to 10-14 Nm (7.4-10.3 ft-lb). This isn't very much. I used an in.-lb torque wrench to get it right. Even so, one bolt on the right side seemed to continue to yield slightly above 10 Nm. I opted to put a bit of Loctite on it and torque it to 10 Nm only.

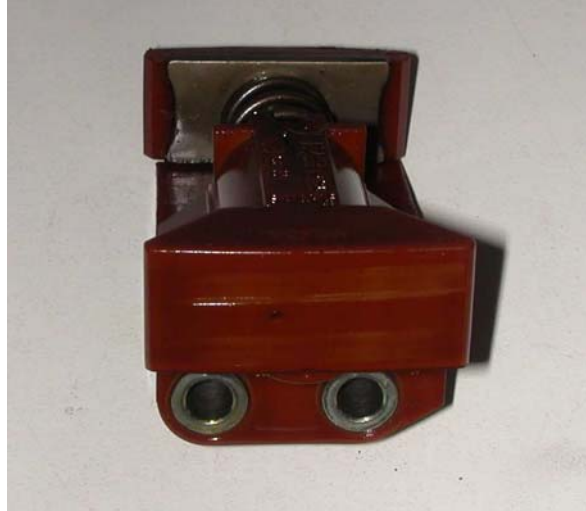
The final question: were my tensioners cracked? A look inside the engine showed it was extremely clean, reflecting the frequent oil changes it has had. It also has not had any overheating issues. The tensioner plastic was reddish-brown, as is characteristic of all used-tensioner pictures I have seen. Surprisingly, there was little wear on the slipper pad, as shown in Fig. 10. I don't know if the left tensioner was cracked or not since it broke during removal as I tapped it lightly with a hammer to loosen it. However, the right one was definitely cracked, as can be seen in Fig. 11. For comparison, I have seen tensioners at my local Jag specialist that were much worse than this on other, higher-mileage V8s.

Fig. 10 Slipper surface showing minimal wear

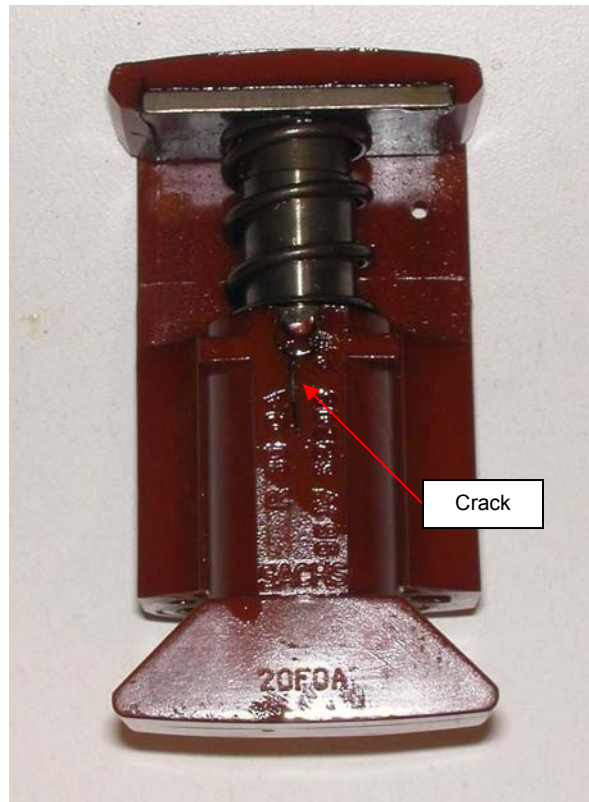
Fig. 11 Right-side tensioner showing crack
