S204-08

MODEL
2000-02 MY S-TYPE

Clunk From Front Stabilizer Bar - Revised Design Bushings - Installation Procedure

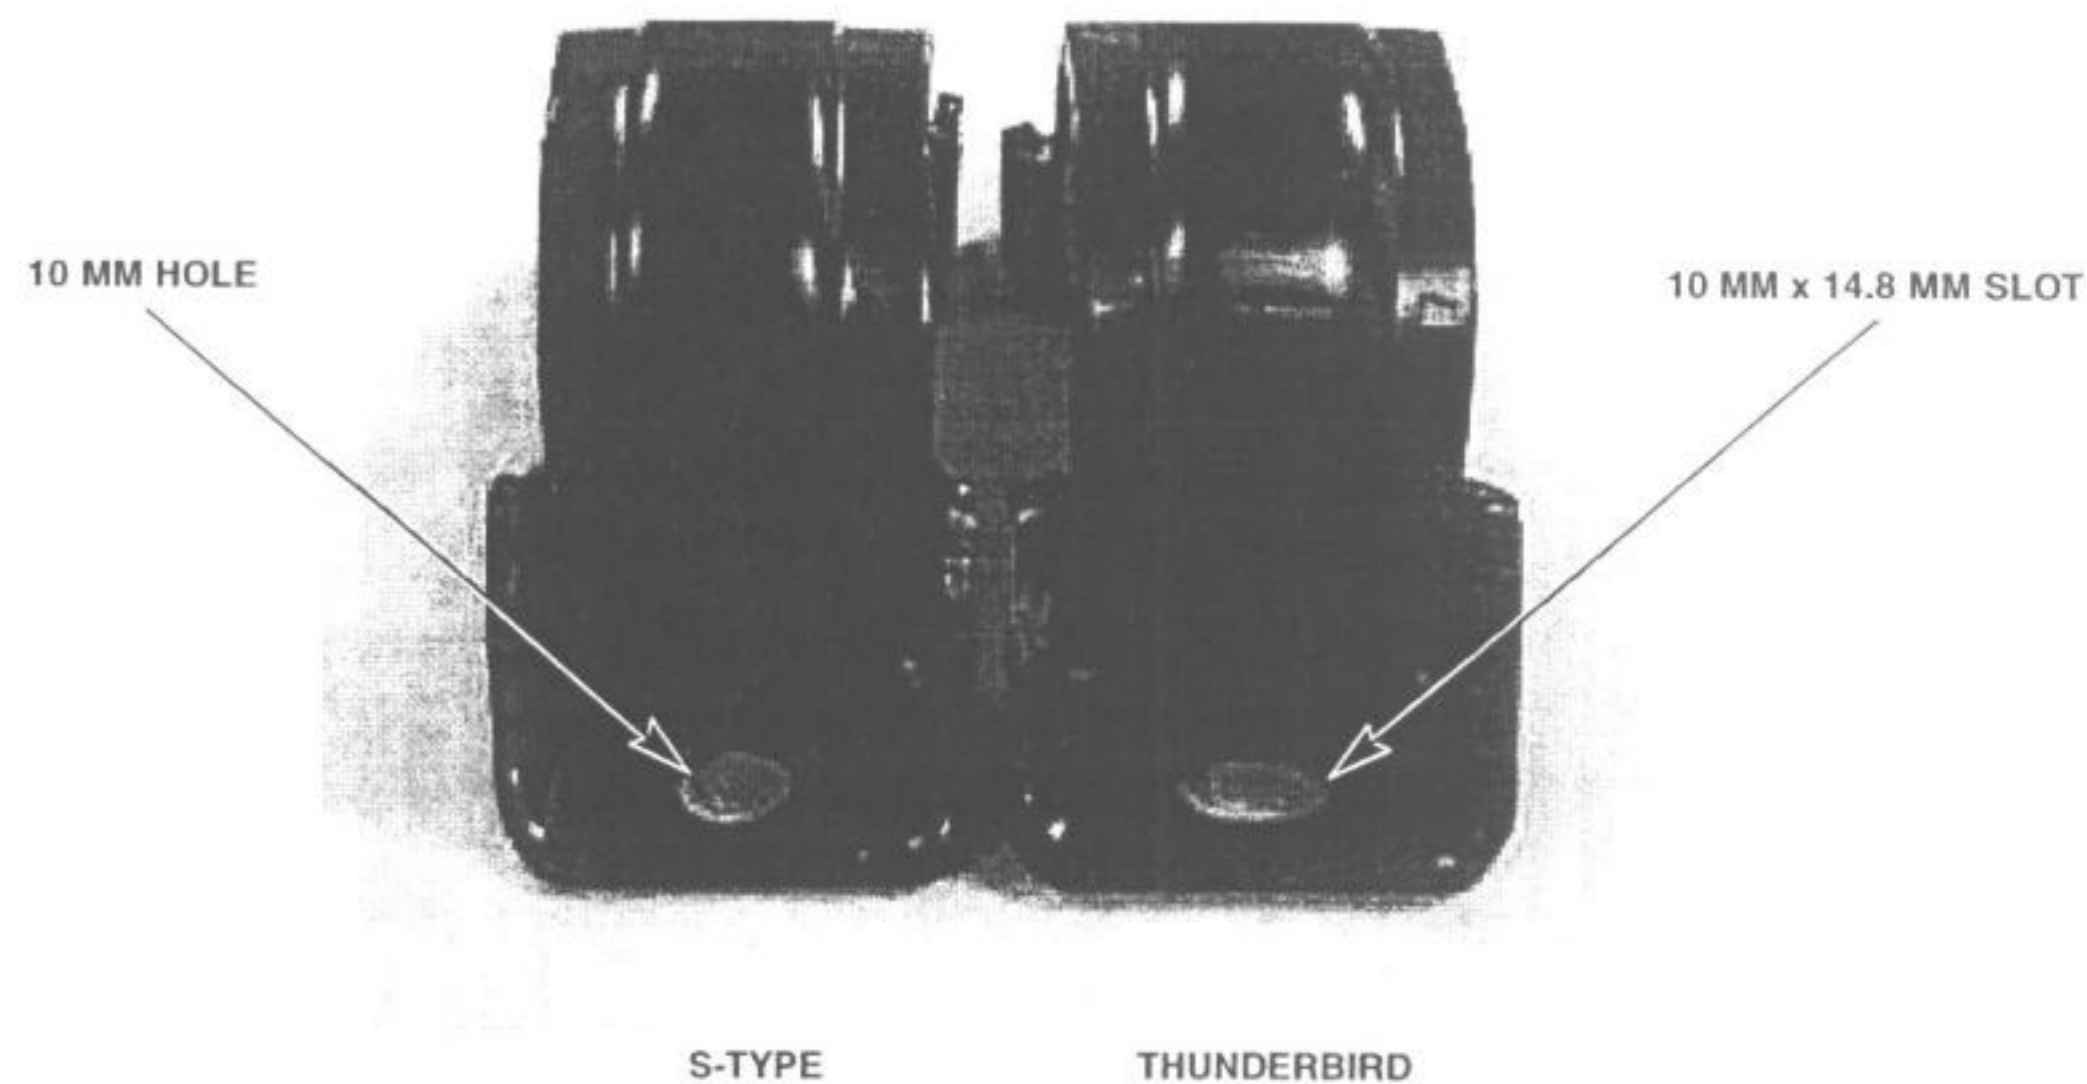
ILLUSTRATION 1

On vehicles up to VIN M39727, inspect the mounting brackets to ensure the vehicle is equipped with the correct specification brackets. Due to a supplier error, Thunderbird mounting brackets may have been installed. The S-TYPE bracket has a 10 mm clearance mounting hole, compared with a 10 x 14.8 mm mounting slot in the Thunderbird bracket (Illustration 1). The Jaguar bracket has an overall hoop height of 55 mm compared with 56 mm for the Thunderbird bracket and the Jaguar material is 1 mm thinner than the Thunderbird bracket. The incorrect bracket will reduce the effective clamping load on the bushing resulting in premature bushing failure. Replace any incorrect brackets with part no. XR8 1834.

BRACKET IDENTIFICATION
