S303-S159

**SERVICE****TECHNICAL BULLETIN**

Engine In Limp Home/Check Engine MIL –  
Water Ingress into Throttle Position Sensor –  
Service Action S159

MODEL 2003-04 MY  
S-TYPE R

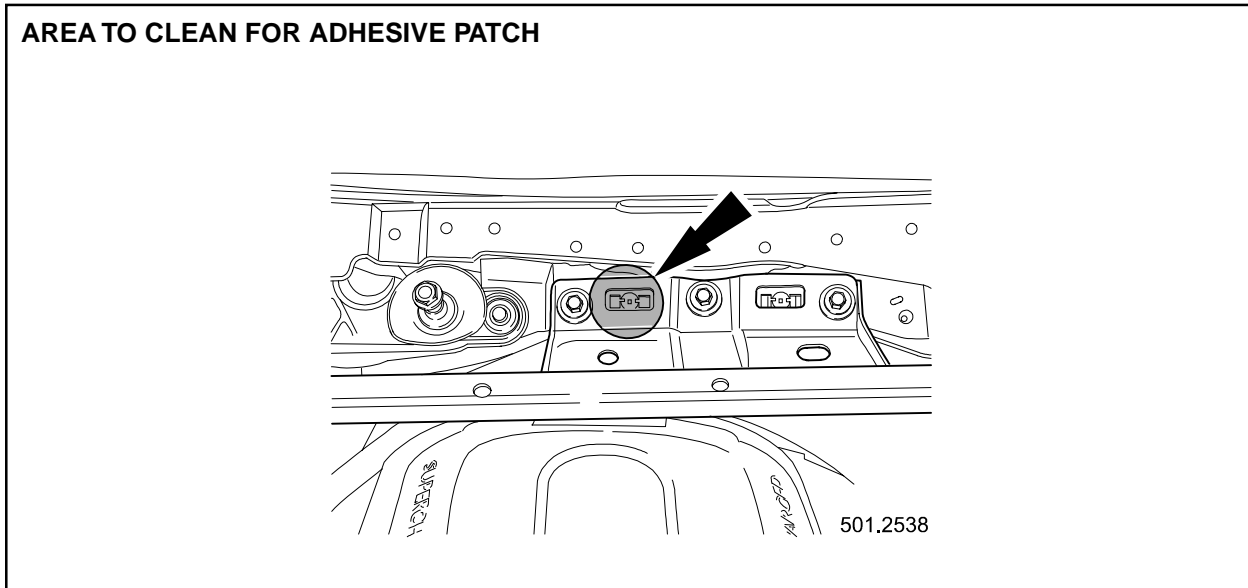
ILLUSTRATION 1

A concern has been identified on 2003-04 MY S-TYPE R vehicles within the above VIN range. It is possible that during washing of the vehicle, by car wash or jet wash, the water can run through the cowl panel grille-fixing hole into the throttle position sensor housing. This can result in the throttle position sensor failing to function, the engine management system defaults to 'limp home' mode, and a warning MIL is displayed.

- Clean the area indicated on the bracket of the suspension turret cross brace where it secures to the bulkhead (Illustration 1).

- Ensure the plastic insert is central in the rectangular hole of the brace.
- Remove and discard the backing from the adhesive patch and install the patch centrally over the right hand rearmost rectangular hole (Illustration 1) of the suspension turret cross brace.
- Reinstall the cowl panel grille, see Workshop Manual, JTIS CD ROM, section: 501-02, SRO 76.10.01.
- Remove fender protection kit and close hood and door.
