**Models:** X200 - S TYPE

**Symptom:** 112000 Latches/Locks & Security

**Content:** Chrome peeling from the locking flag - The Chrome cover on the locking flag of the interior door release handle assembly is now available as a separate service part which is easy to replace with the assembly in situ. This negates the requirement to remove the door casing to effect a repair.

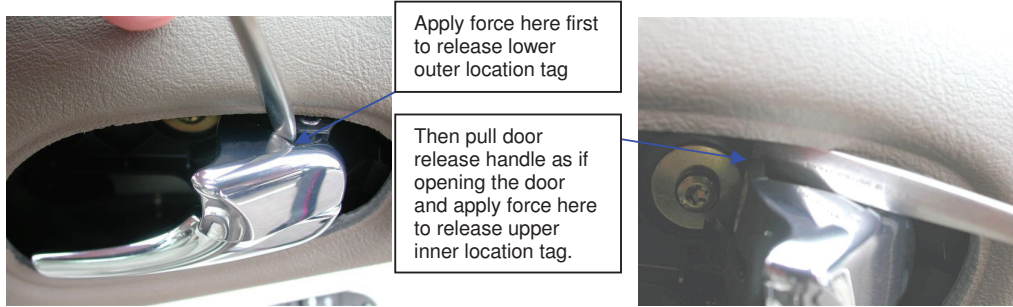
Using a small flat bladed screwdriver or similar prize off the existing cover, gently levering in positions shown in the photographs.

Carefully remove the door release escutcheon cover from the door casing to gain access for the removal of the locking flag chromed finisher cover.

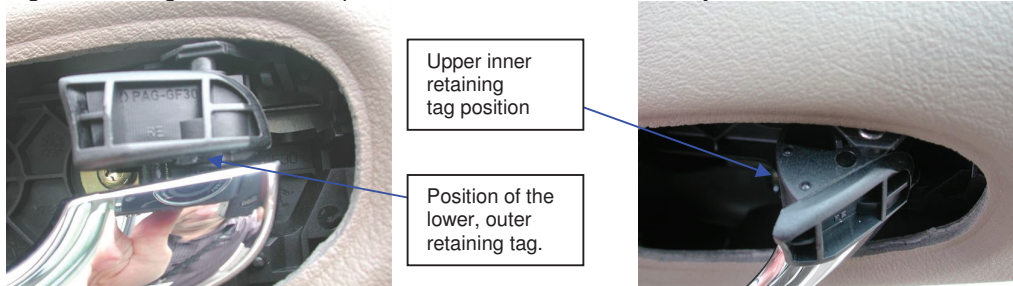
Applying force in the order and in the positions shown, releases the cover from the two small retaining tags on the flag lever which is part of the door release assembly.

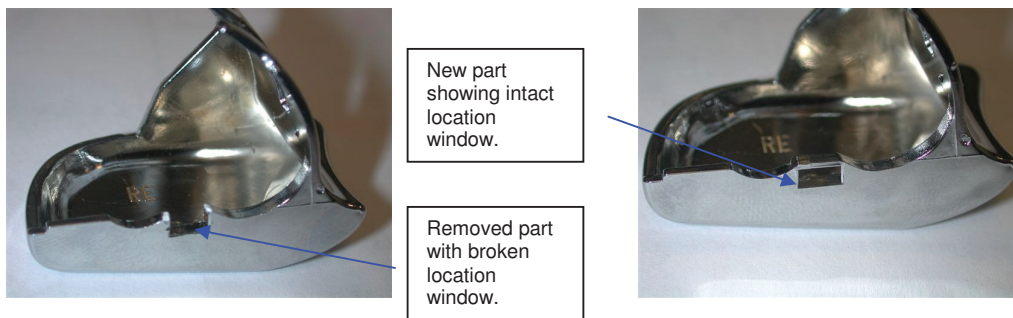
When the lower position tag is released a small part of the retaining tag location window on the chrome cover will fracture as the force to release it is applied - see photo below.
