© D. Jensen 2006	REPLACEMENT OF V8 SECONDARY TIMING CHAIN TENSIONERS	V. 1.0 June 2006
Distribution: www.jag-lovers.com

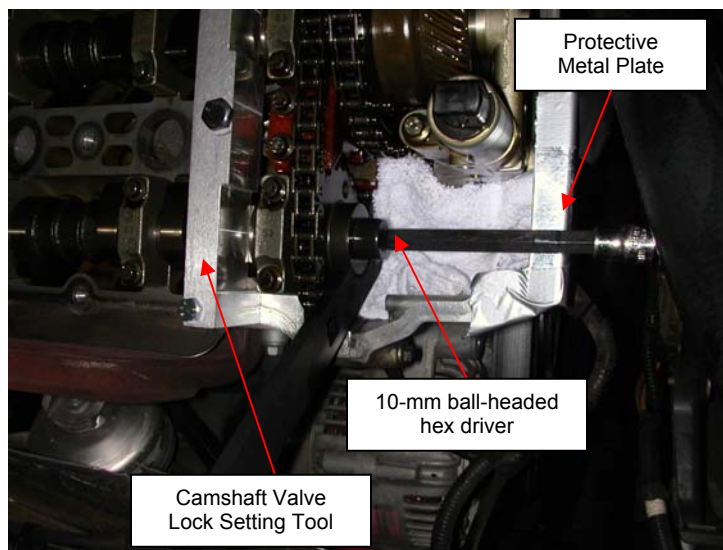
Fig. 6 shows the right side of the engine after installation of Camshaft Valve Setting Lock Tool and 10-mm ball-end hex driver. As per the instructions, I first attached a short piece of metal plate to the timing cover, taped in place, to prevent damage to the timing cover/cam cover mating surface. While not obvious in the photo, the hex driver enters off center a few degrees. Note the rag stuffed into timing chain cover to avoid potential disaster.

Fig. 6 View of right side with camshaft setting tool, 10-mm ball-end hex driver and protective metal plate in place

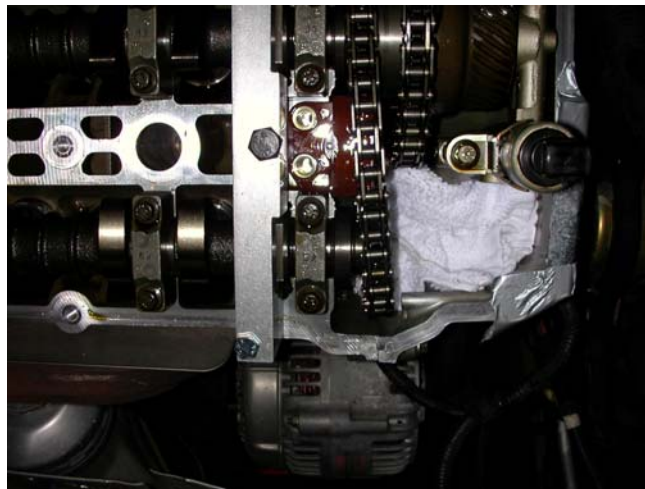
As shown in Fig. 7, I used a ½-in.-drive torque wrench and ½-in. breaker bar, inserted into the square opening in the Timing Chain Tensioning Tool, to loosen the bolt securing the sprocket to the camshaft. This is a long bolt that, surprising to me, is hollow (per a local Jag specialist I deal with). Figure 8 shows the sprocket as it was nearly off of the camshaft.

Fig. 8 Sprocket moved forward off of camshaft

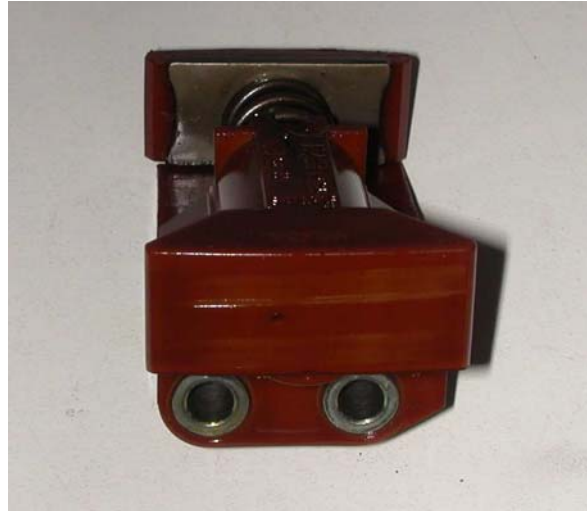
The final question: were my tensioners cracked? A look inside the engine showed it was extremely clean, reflecting the frequent oil changes it has had. It also has not had any overheating issues. The tensioner plastic was reddish-brown, as is characteristic of all used-tensioner pictures I have seen. Surprisingly, there was little wear on the slipper pad, as shown in Fig. 10. I don't know if the left tensioner was cracked or not since it broke during removal as I tapped it lightly with a hammer to loosen it. However, the right one was definitely cracked, as can be seen in Fig. 11. For comparison, I have seen tensioners at my local Jag specialist that were much worse than this on other, higher-mileage V8s.

Fig. 10 Slipper surface showing minimal wear

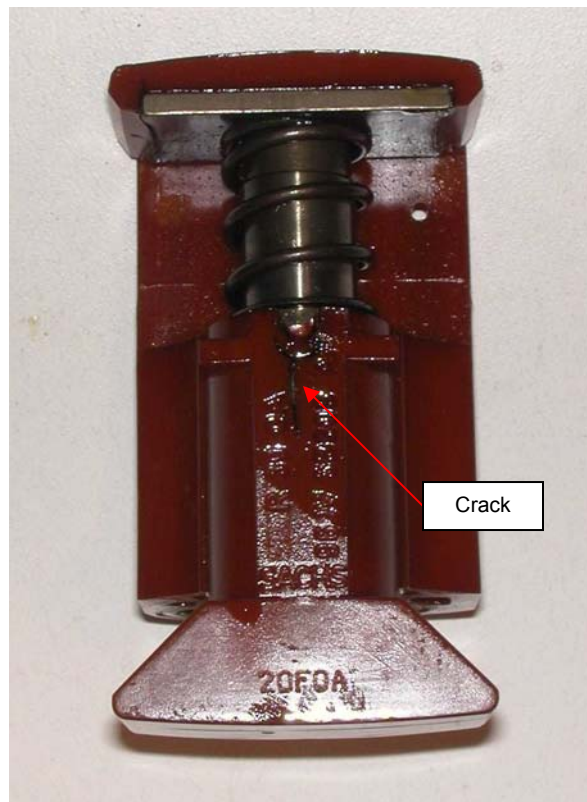
Fig. 11 Right-side tensioner showing crack
