**S-TYPE**

TECHNICAL BULLETIN

MIL Illuminated – 3.0 L V6 –
False Flagging of DTC P1383 or P1388 –
Reprogram PCM

MODEL 2000-02 MY
S-TYPE 3.0 L
VIN L00001-M44997

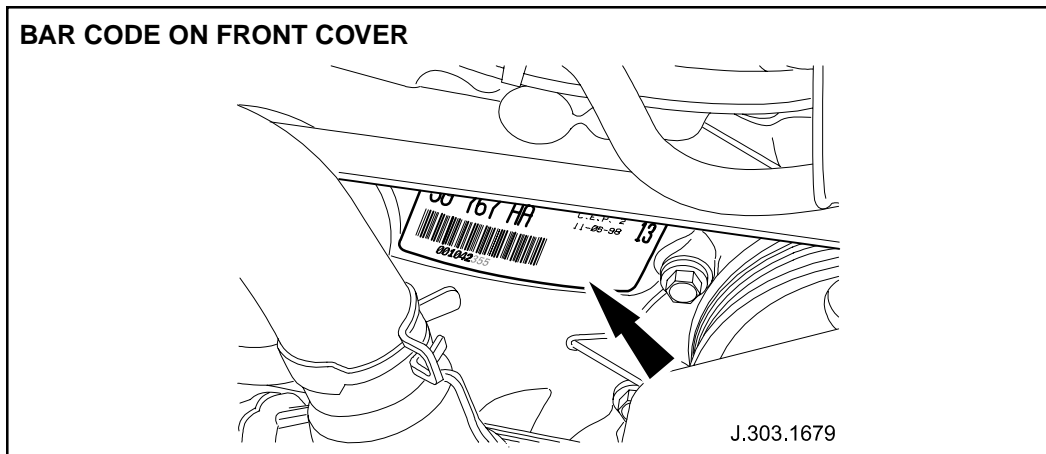
ILLUSTRATION 1

Note: The engine number is located on the bar code label on the engine front cover (Illustration 1) or on the left-hand side of the engine bedplate (Illustration 2). Position the vehicle on a lift as needed to gain access.
