ROOF OPENING PANEL DOES NOT CLOSE ON ONE-TOUCH OPERATION AND 'BOUNCES BACK'

Model: S-TYPE

Year: 2002.5 to 2004

S501-21: This Technical Bulletin has been issued to address customer concerns that the roof opening panel does not close on one-touch operation and 'bounces back'.

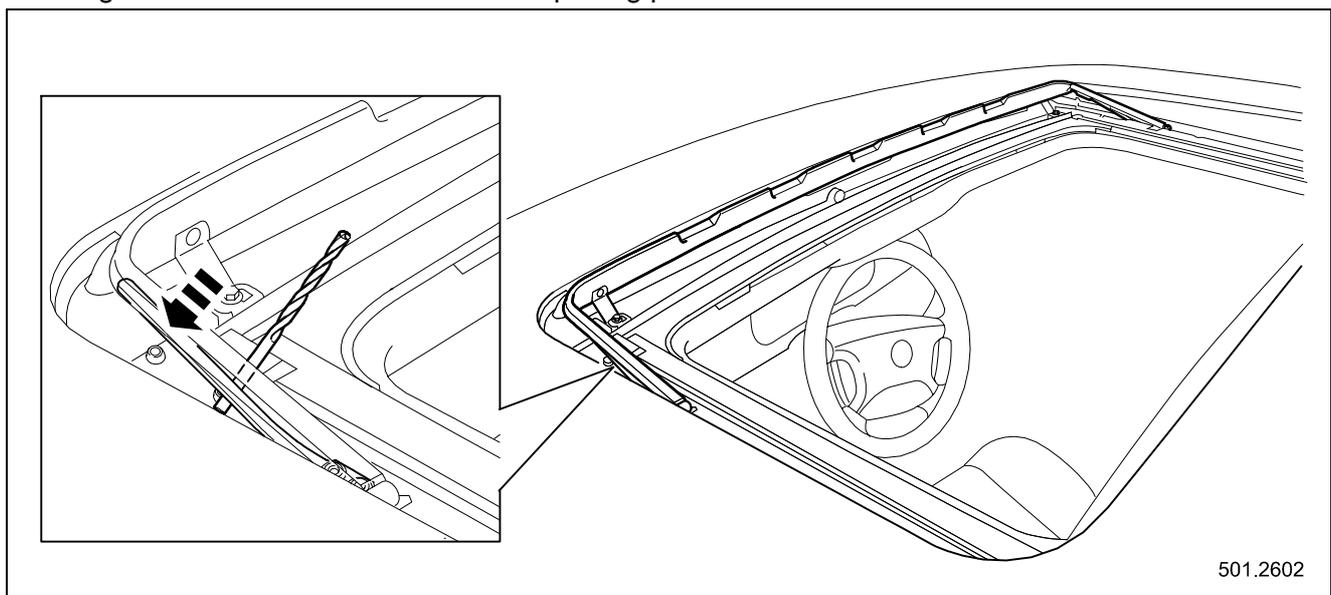
Fig. 1

There is a possibility that the roof opening panel may not close on, one-touch operation, and may 'bounce back', due to excessive wind deflector spring strength. The roof opening panel motor will have to have a de-synchronization and synchronization procedure carried out, and carry out a re-profile of the wind deflector spring. Should a customer express a concern, follow the workshop procedure outlined below.

- 5 Position shank of a 4.0mm twist drill under base of the spring by the rivet head, and push the deflector down over the drill until it bottoms out to re-profile the spring (see Fig. 1).
- 6 Carry out step 5 for the right hand side of the roof opening panel.
- 7 Close driver's door.
