MODEL
XJ, S-TYPE,
X-TYPE

NUMBER
JTB00055

TECHNICAL BULLETIN

Power Steering System Squeaking Noise Repair Procedure

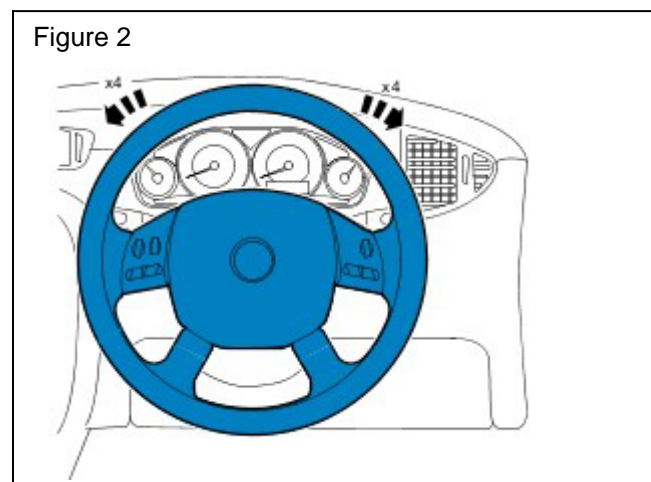
1. Turn ignition 'ON' and start the engine.
2. With the engine idling, turn the steering wheel from lock to lock four times to cycle the fluid additive into the system. (Figure 2)

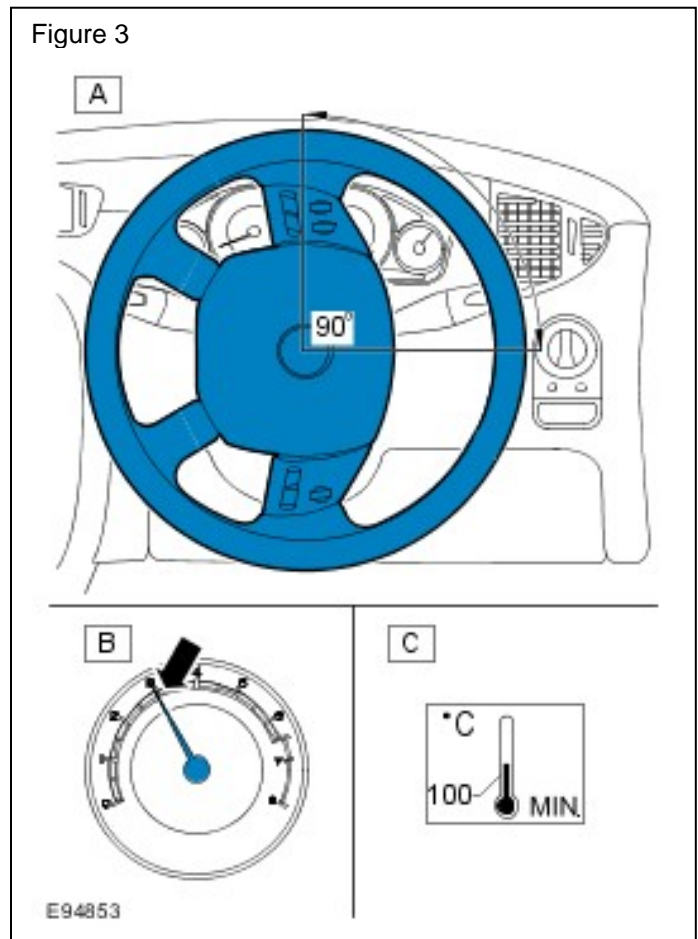
3. While stationary and with the steering wheel in the center position (road wheels in the straight ahead position), turn the steering wheel 90° (quarter turn) right and hold firmly with both hands. (Figure 3)

- Increase the engine speed to 3000rpm.
- Monitor the power steering fluid temperature until 100±5°C (212°F±10°F) is reached.
