Technical Service Bulletin

No.JTB00053v2
09 August 2007

Subject/Concern: Whine from Rear of Vehicle at 60 mile/h (96 km/h)

Models:
S-TYPE

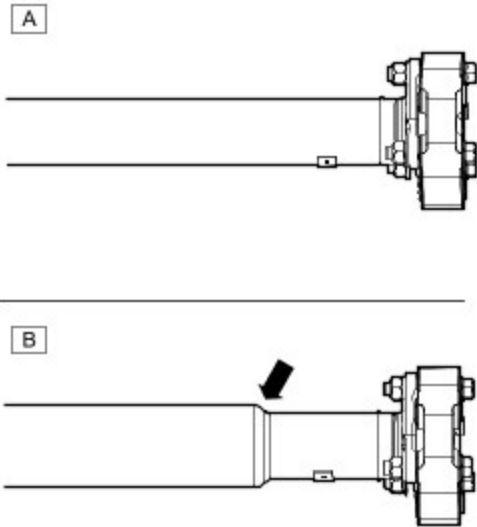
E94695

- NOTE:** The latest level driveshaft can be identified by a diameter reduction in the tube (B) approximately 150mm from the rubber coupling at the differential end of the shaft. Older level parts have a straight (A) rear tube (see E94695).

Install a new Driveshaft (see Global Technical Reference GTR Workshop Manual, section 205-02 (47.15.01)).
