Rattling Defroster Vents –
New Vent Plug –
Repair Procedure

MODEL 2002-04 MY
X-TYPE

VIN C00294-D84594

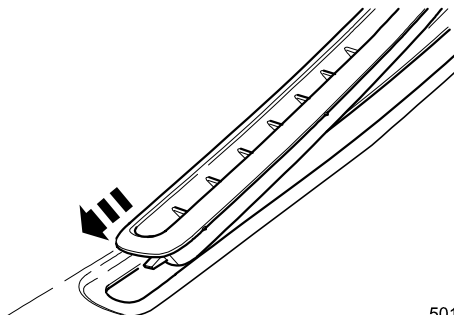
ILLUSTRATION 1

INSERT LOCATOR TAB

2. Install the inner end of the new defrost vent with the new locating feature first (Illustration 1).
