Exterior Front Door Handle Hard to Open –
Deflection Of Link Rod –
Replace Link Rod

MODEL 2002 MY-ON
X-TYPE

VIN C00001-ON

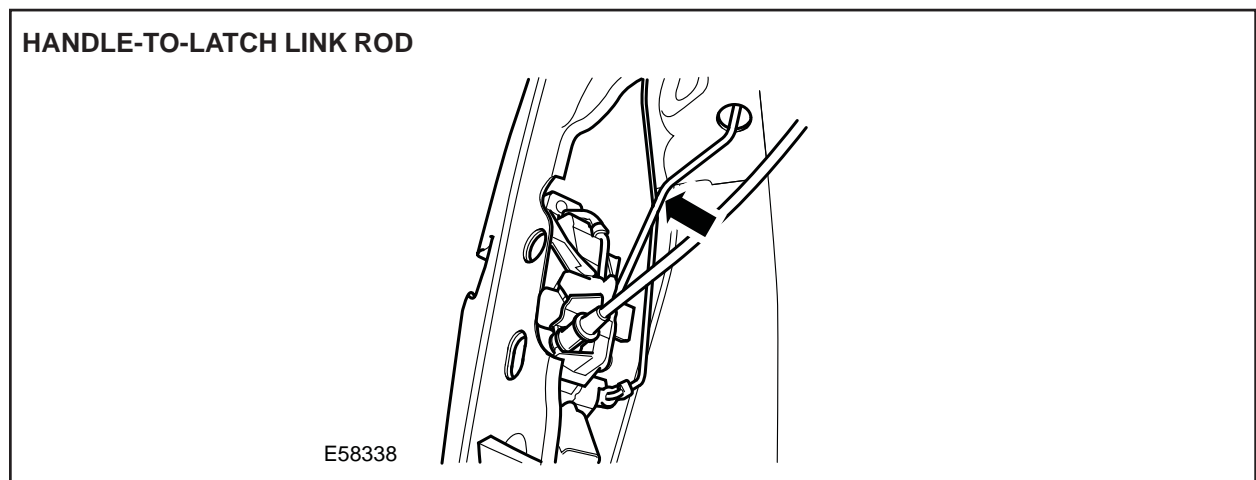
ILLUSTRATION 1

Link rod between the exterior door latch and door handle deflects.

1. Remove the exterior front door handle (see Global Technical Reference GTR Workshop Manual, section: 501-14, SRO 76.58.01).
2. Install a new exterior door handle to door latch link rod.
