V8 XJ Series/XK8

413-04

## TECHNICAL BULLETIN

Erratic Operation – Instruments –  
Repair Procedure

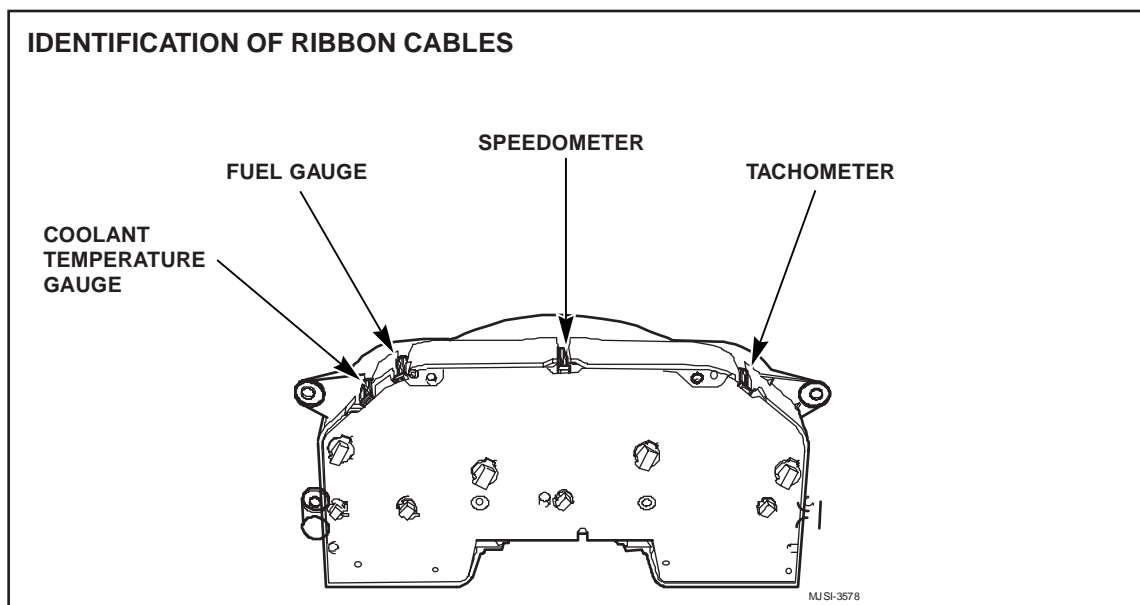
ILLUSTRATION 2

- Needle erratic/wavering. Gauge indication possibly excessively high. - **Connector loose.**
- Gauge needle stationary. Needle may be in an unusual position if the connector was loose before complete disengagement. - **Connector disconnected.**

4. Refer to Illustration 2. Check the connector of the appropriate ribbon cable for a secure fit at the master printed circuit board.
5. Reinstall the back plate and its securing screws.
6. Reinstall the instrument pack to the vehicle, but without installing the retaining screws.
7. Reconnect the multiplug connector to the main vehicle harness.
8. Reconnect the battery negative cable. Switch on the ignition. Check the operation of the gauges.
9. If the gauges now operate correctly, switch off the ignition and complete the reinstallation of the instrument pack.
10. Should a fault still exist, the problem may be within the instrument pack requiring replacement of the pack. Refer to the VCATS label to determine the correct part number of the instrument pack. Disconnect the battery negative cable before disconnecting the multiplug connector prior to removal of the suspect instrument pack.
