JTB00248V3

TECHNICAL BULLETIN

XJ Outer **Door Handle** Sticking in Operation

MODEL:	MODEL YEAR:	VIN:
XJ Range (X351)	2014 Onwards	J76001 Onwards
XJ Range (X351)	2010 Onwards	V00001 Onwards

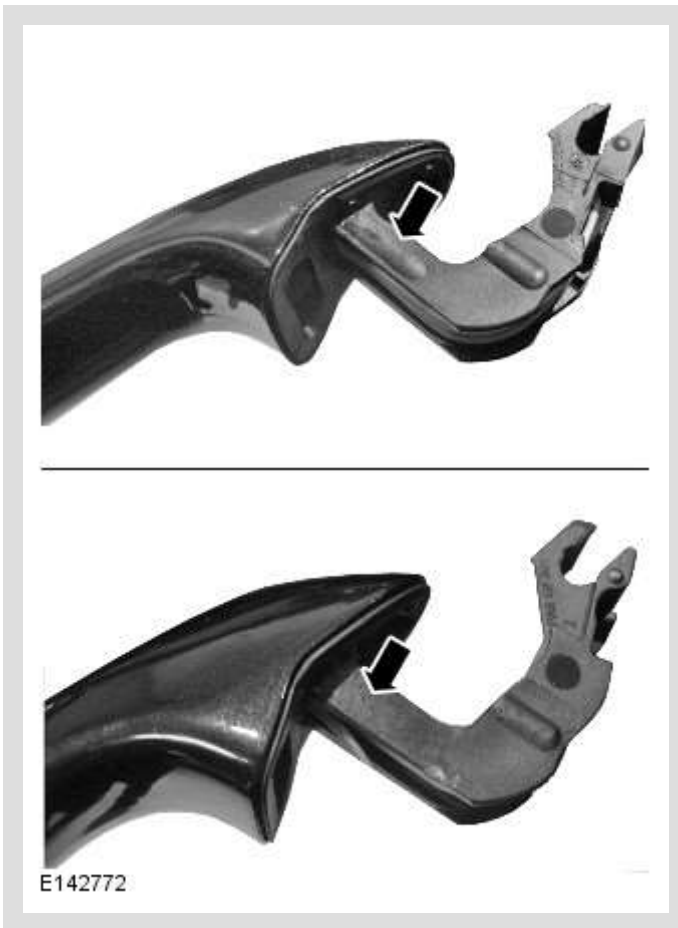
Raised moulding rib can foul the aperture resulting in the **handle** sticking open. **Handle** binding between the **door** body panel. **Suggested Customer Concern Code L08.**

Using a suitable tool remove the moulded rib on both sides of the **handle**, shown in graphic E142772.

- 1 Make sure that all the excess plastic has been fully removed from the **door handle**.
