## **New Jaguar XJ Panoramic roof blind Re-tensioning procedure**

**In the event of a blind being inadvertently de-tensioned, the following procedure is a step by step guide to re-tensioning the blind.**

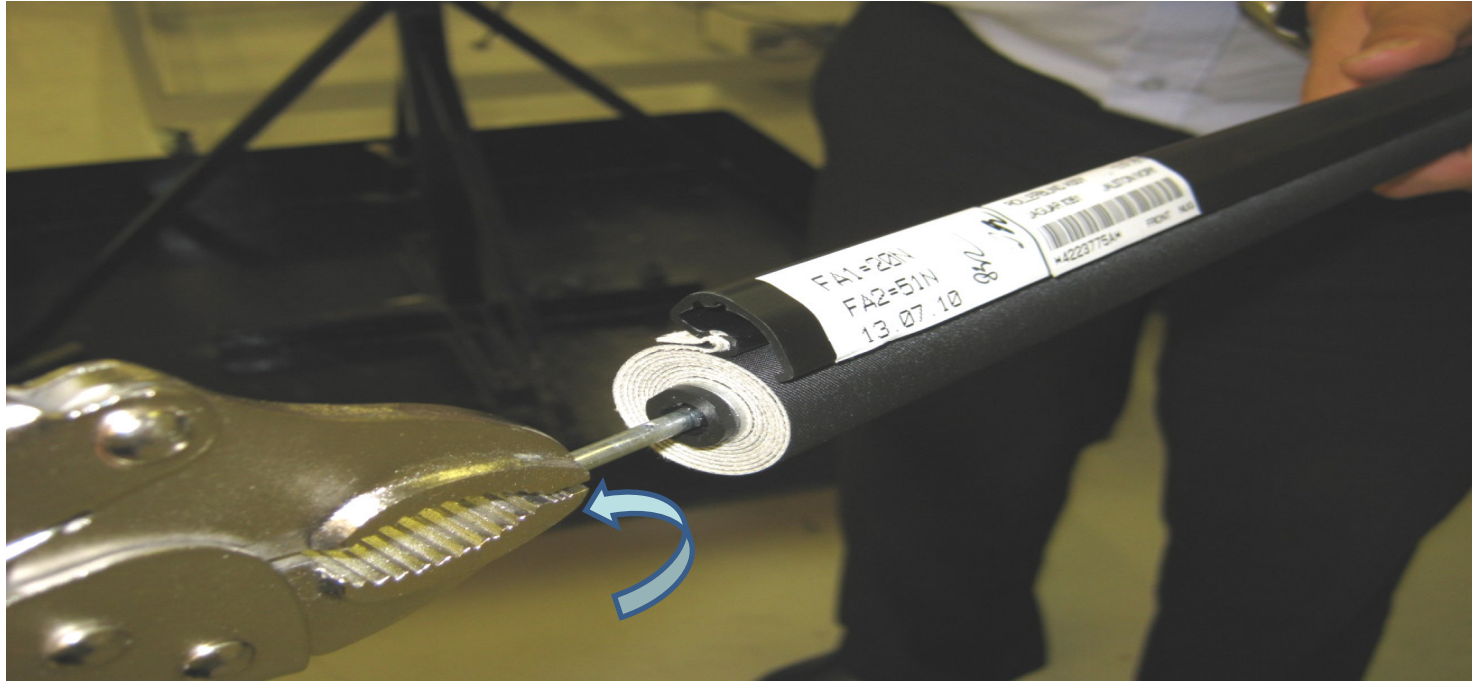
With blind in unwound state, hold in orientation shown, grip flat of metal shaft tightly in locking pliers. Hold blind in position and rotate locking pliers **anticlockwise** to increase tension.

Factory set winds based on load measurement, however normally:-

Front blind – 13 full rotations

Rear blind LWB – 12 full rotations

Rear blind SWB – 11 full rotations

If blind is baggy whilst functioning after installation additional winds may be required.

**Note – Attempts to rotate the blind spindle clockwise will result in permanent damage to the tension spring**

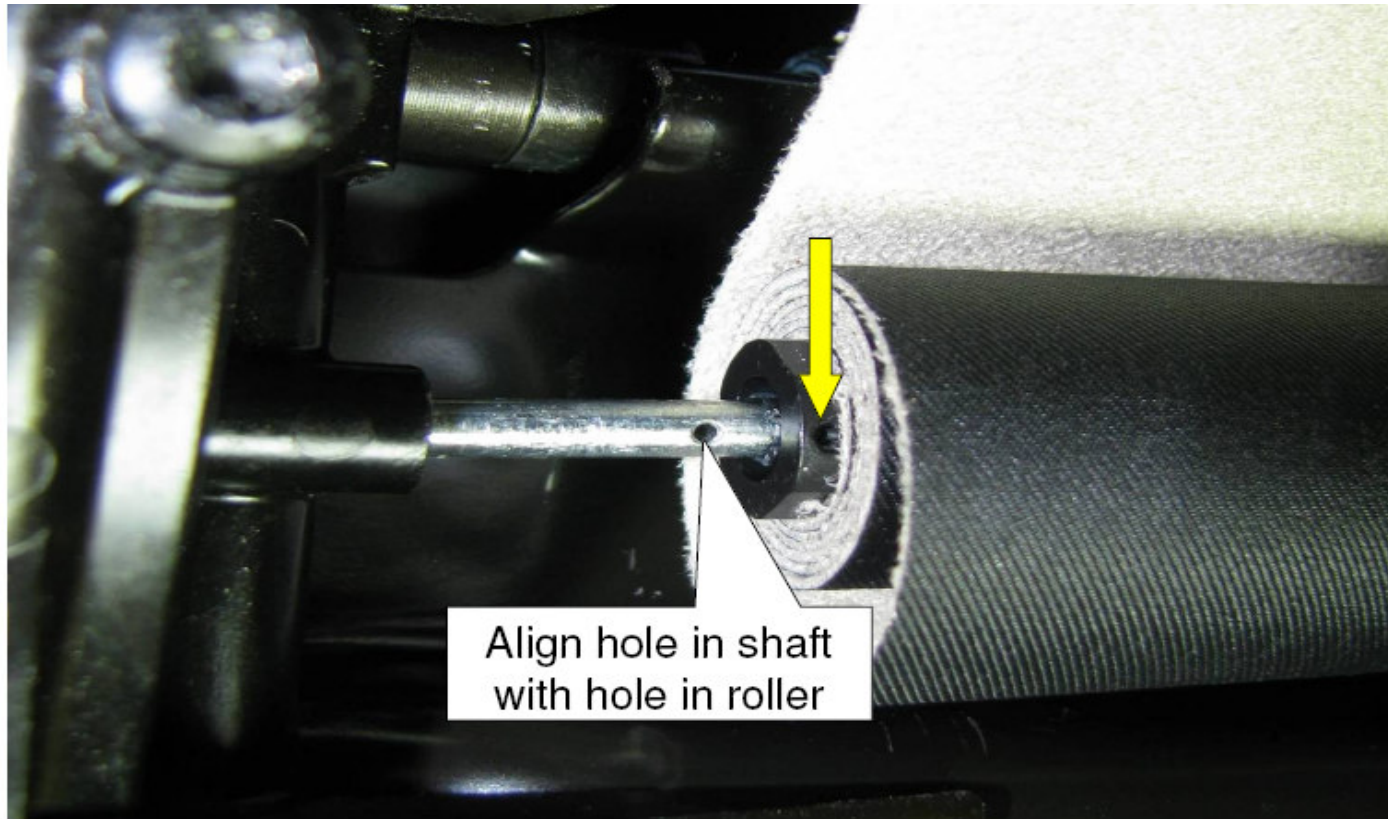
Note the location of the hole in the shaft and line up the hole in the roller to it for pinning.

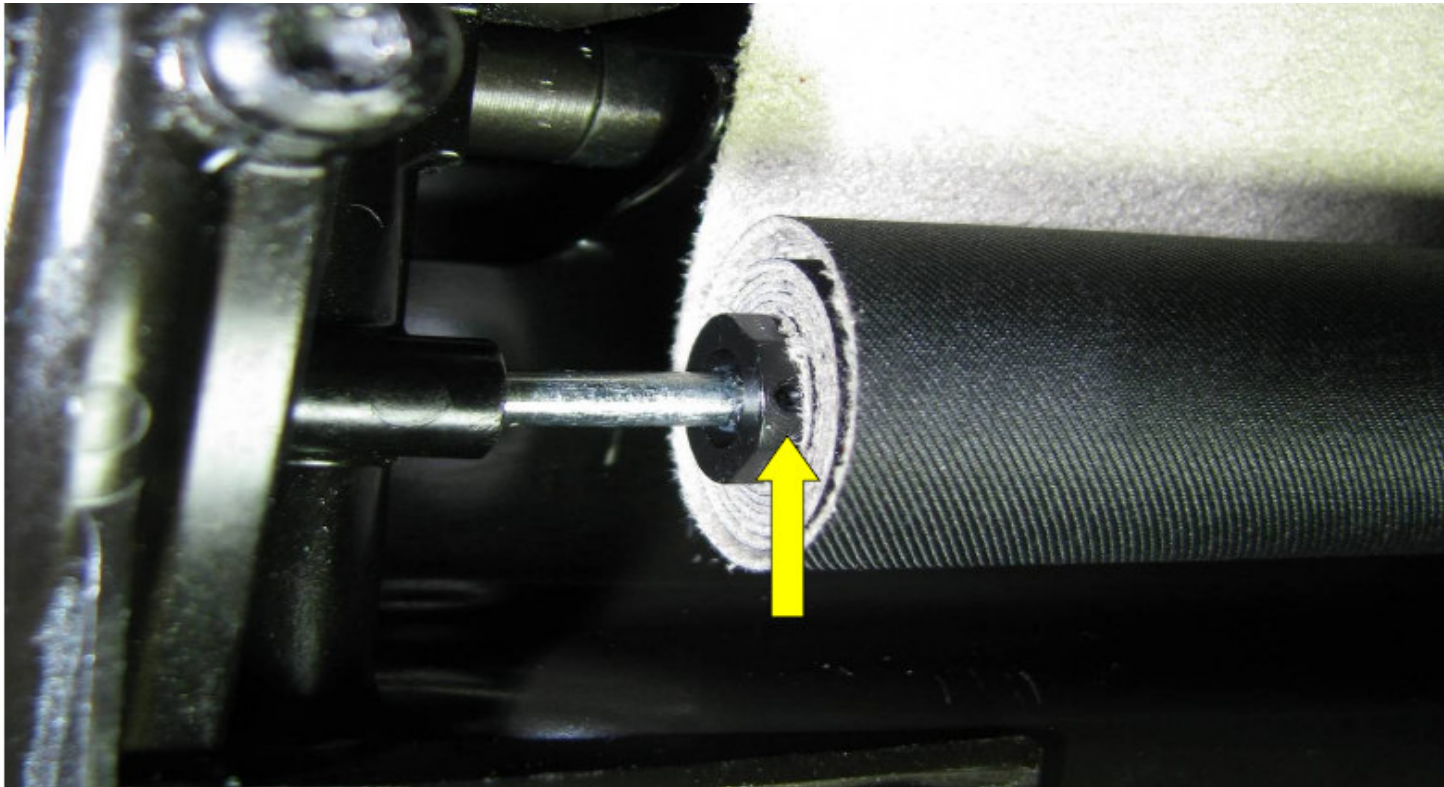
Once lined up insert a pin into the hole to lock the blind in place. Note: Use the correct blind pin, but if unavailable use a hardened pin like an Allen key or drill bit, the diameter of the pin is approx 1mm.

**Do not use a paper clip as the spring tension will bend it, making it difficult to remove.**

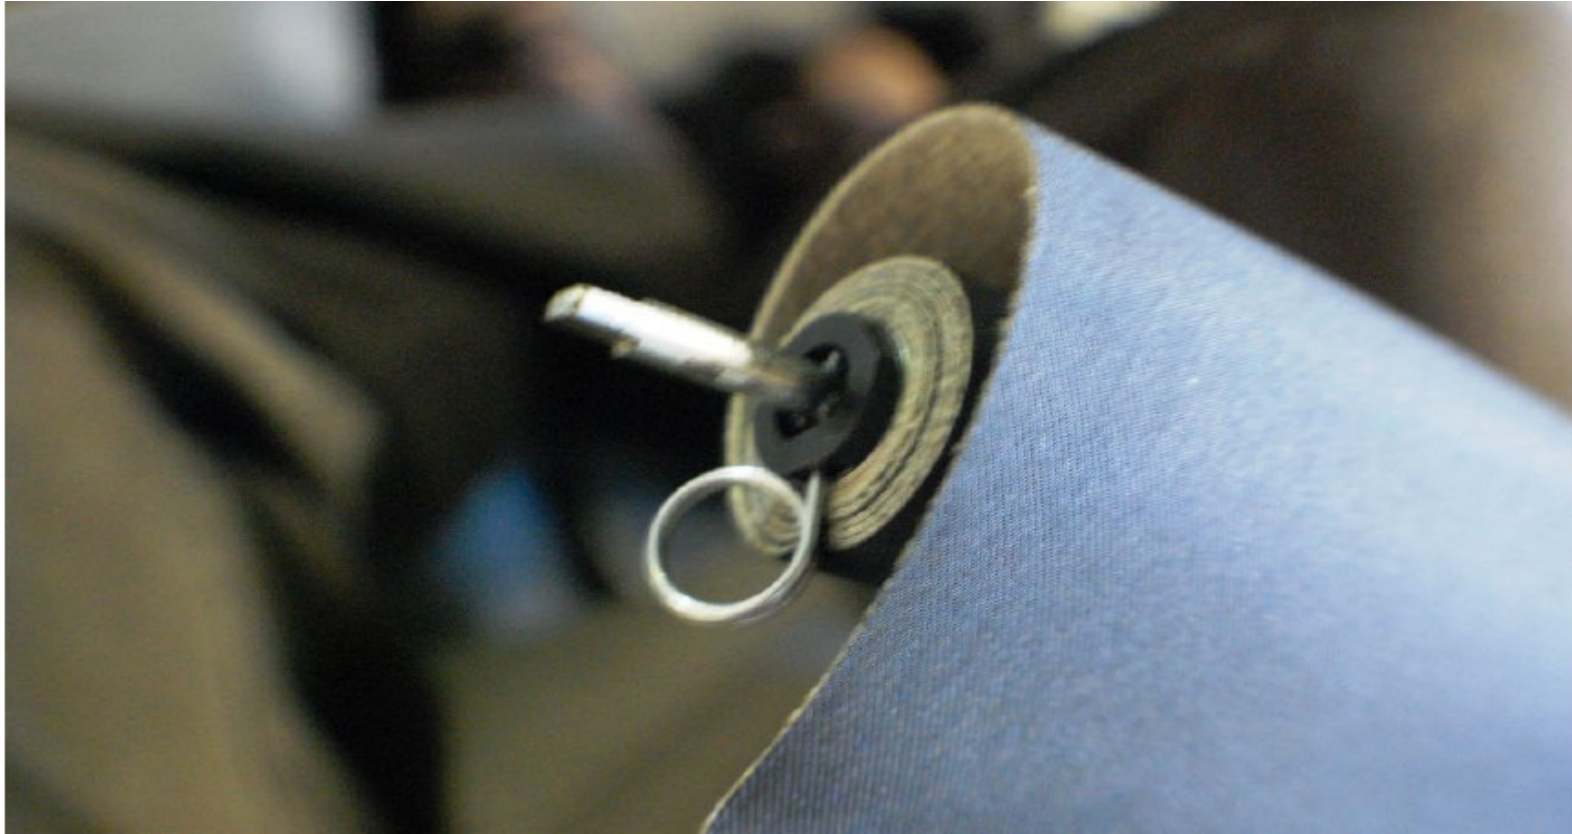
Once the pin is fully installed, remove the locking pliers, the blind is now ready for fitment.
