TECHNICAL BULLETIN

UPS5511-1bNAS2

Update Prior to Sale: Panoramic Roof 'Creak'

XJ (X351)

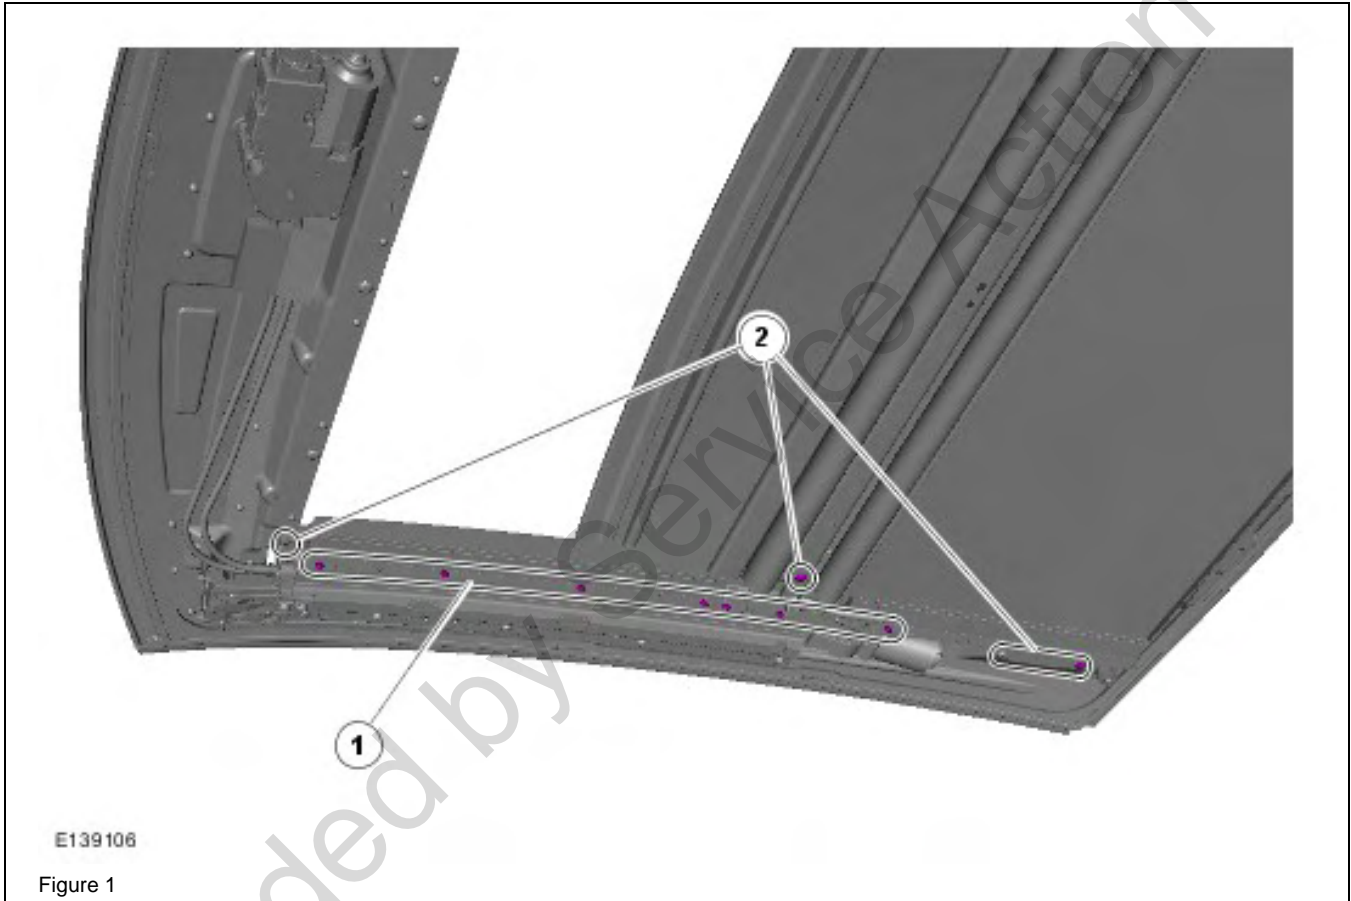
Figure 1

- ① - rigid fixings.
- ② - free-to-slip fixings.

1. Note the fixings affected by this re-work. (Figure 1)

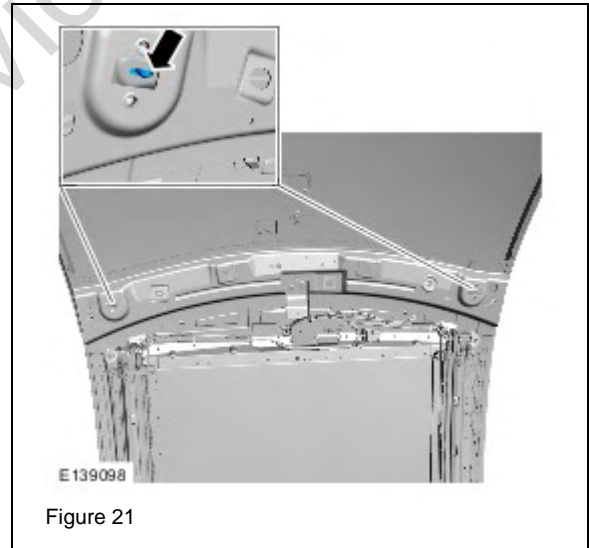
Figure 21

⚠ CAUTION: Make sure when snapping off the alignment pegs that they do not protrude through the slot in the body as this can cause a noise.

26. If present, remove the front windshield locating pegs. (Figure 21)
- Using a suitable 5.5mm, deep socket and extension bar, snap off the pegs.
