SERVICE ACTION

Service Action
Number: K117

Subject: Panoramic Roof Creak	Publication No.:	501-K117v3
	Model:	XJ
	Model Year:	2010-2012
	VIN Range:	V00001 to V24464 (SWB) V00001 to V24700 (LWB)
	Date of Issue:	9 th August 2012
	Expiration Date:	28 th February 2014

RE: Panoramic Roof Creak

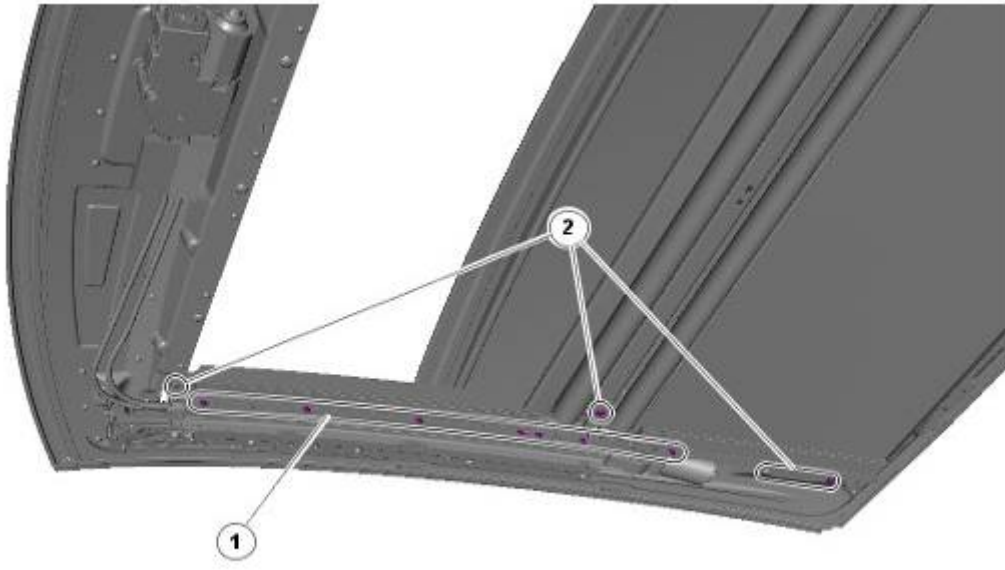
<p style="text-align: center;">Fig. 1</p>
1	<p>NOTE: RH side shown, LH side similar. NOTE: LWB shown, SWB similar.</p> <p>Note the fixings affected by this re-work (see Fig.1).</p> <ul style="list-style-type: none"> • Fixings required to be rigid (see 1 in Fig.1). • Fixings required to be free to slip (see 2 in Fig.1).
2	<p>CAUTION:

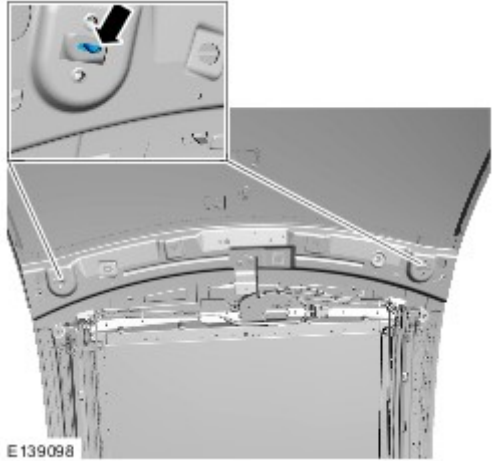
<p>E139098</p>
		<p>Fig. 37</p>

Make sure when snapping off the alignment pegs that they do not protrude through the slot in the body as this can cause a noise.</p> <p>NOTE: Apply a small amount of grease to the inside of the socket to prevent the broken peg remaining in the vehicle.</p> <p>If present, remove the front windshield locating pegs (see Fig. 37).</p> <ul style="list-style-type: none"> Using a suitable socket (5.5mm deep) and extension bar, snap off the pegs.

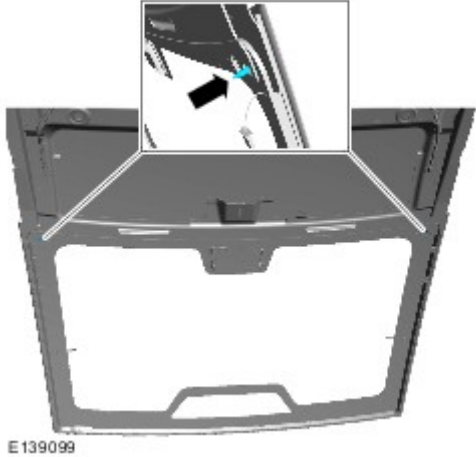
Make sure when snapping off the alignment pegs that they do not protrude through the slot in the body as this can cause a noise.</p> <p>If present, repeat the above step to the rear windshield locating pegs (see Fig. 38).</p>
