JTB00250V4

# TECHNICAL BULLETIN

19 FEB 2014

A-Pillar Creak Noise

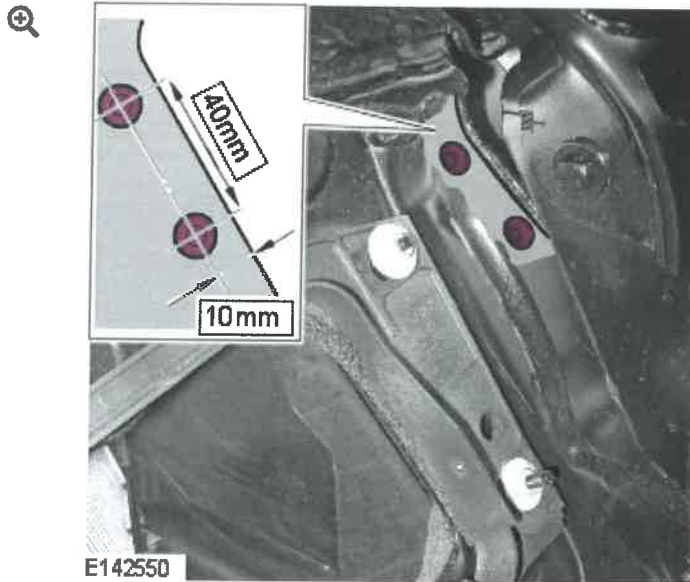
3.

Right or left A-pillar creak noise heard from within the car. The noise may be heard from the right or left side of the facia panel.

Issue with the bonded body panels at the seam joint. **Suggested Customer Concern Code - B09.**

Measure 10mm from the panel edge.

- Using a suitable tool, mark the first fixing.
- Measure and mark the second fixing 40mm from the first fixing.

Using a suitable 6.5mm drill, drill out the marked fixings.
