JTB00380NAS6

# TECHNICAL BULLETIN

412-03: Air Conditioning

Inadequate A/C Performance

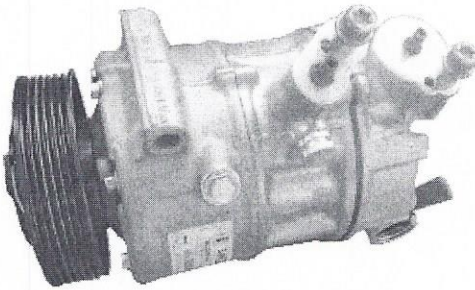
E165840

Make sure foreign materials do not enter the Direct Pressure Sensing (DPS) valve hole on the cylinder head when the DPS valve is removed.

Using compressed air or similar, remove all foreign materials from the DPS valve/cylinder head.

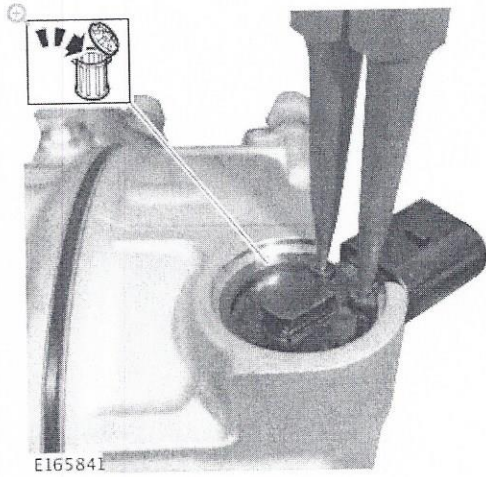
Make sure to not damage the circlip housing in the cylinder head.

Place the A/C compressor on a clean flat work surface.

- Using a suitable tool, remove and discard the circlip that retains the DPS valve in the compressor cylinder head.

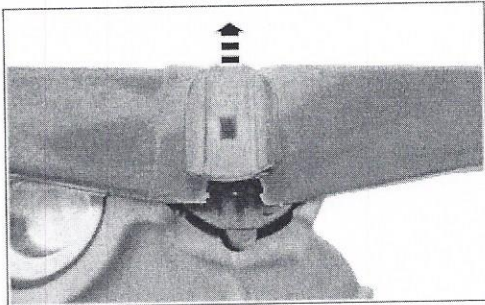
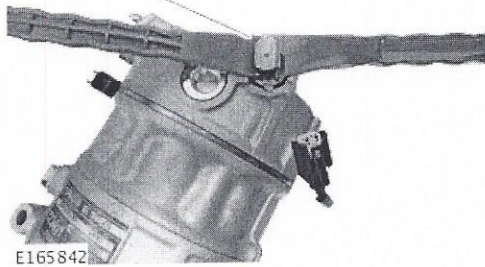
Make sure to not damage the housing in the cylinder head.

Using suitable tools, release the DPS valve.

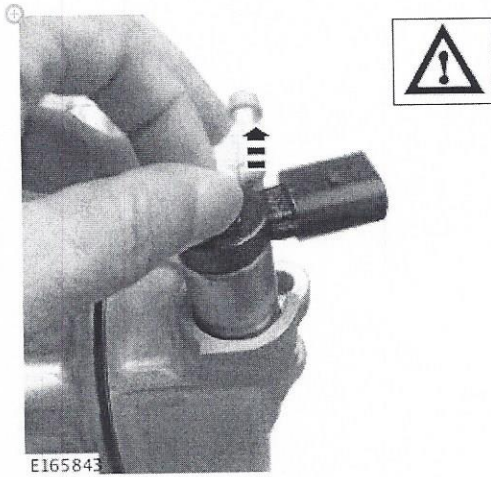
Use care to remove the DPS valve in a vertical direction to avoid damage to the inside wall of the cylinder head.

Remove by hand the DPS valve from the A/C compressor cylinder head; discard the DPS valve.

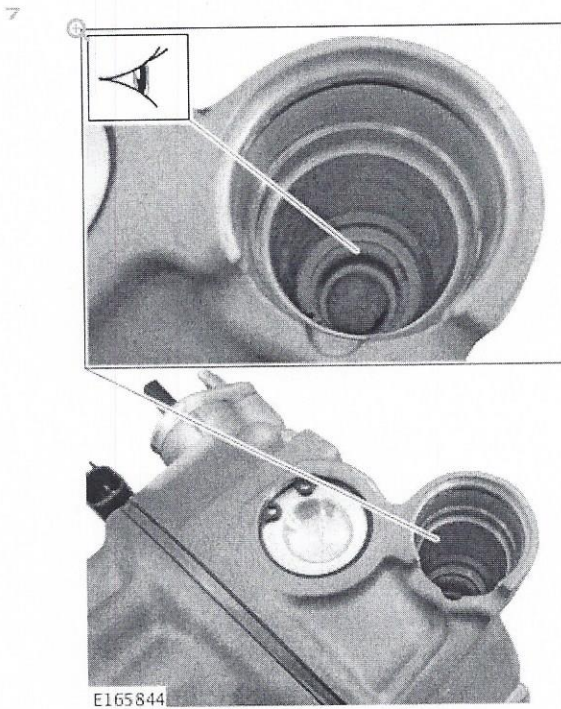
Inspect the inside wall of the cylinder head for scratches, scoring, or foreign material.
