TECHNICAL BULLETIN

412-00

Poor Air Conditioning (A/C) Performance.

XK Range (X150)	2010-2015	B32753-B56794	Castle Bromwich
F-TYPE (X152)	2014 Onwards	K00103 Onwards	Castle Bromwich
XJ Range (X351)	2010 Onwards	V00325 Onwards	Castle Bromwich
XF (X250)	2012-2015	T00001-T03748	
XF (X250)	2010-2015	R59504-U88785	Castle Bromwich
XE (X760)	2016 Onwards	995000 Onwards	
XE (X760)	2016 Onwards	900000 Onwards	Solihull
F-PACE (X761)	2017 Onwards	045000 Onwards	Solihull
XF (X260)	2016 Onwards	Y00001 Onwards	Castle Bromwich
XE (X760)	2017 Onwards	P00001 Onwards	Castle Bromwich

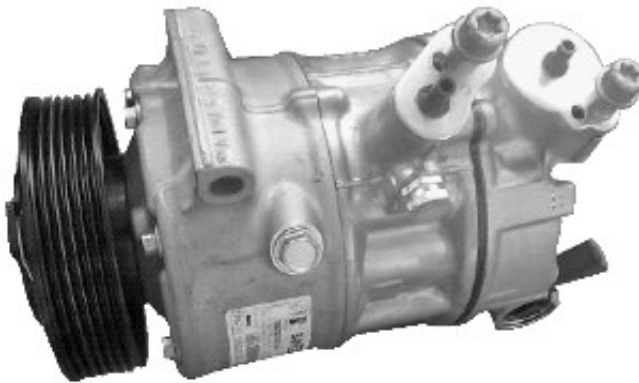
E165840

Make sure to avoid foreign materials entering the DPS control valve hole on the cylinder head when the DPS valve is removed.

Using compressed air or similar, remove all foreign materials from around the DPS valve/A/C compressor cylinder head.

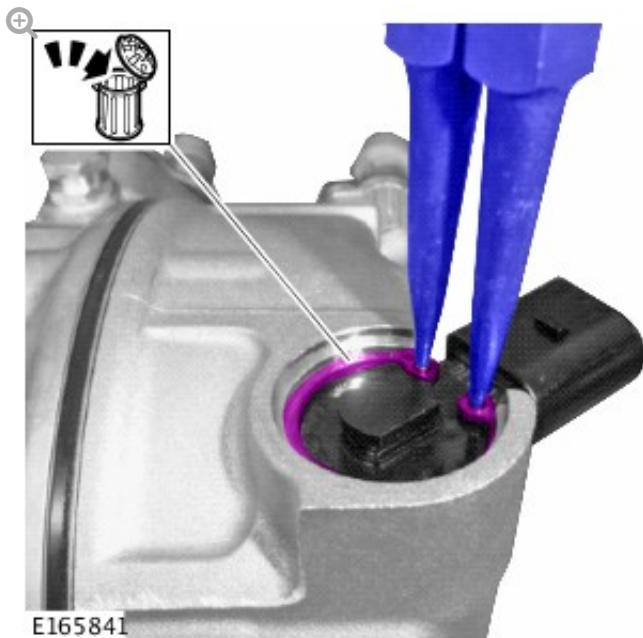
Make sure not to damage the circlip housing in the A/C compressor cylinder head.

Place the A/C compressor on a clean flat work surface.

- Using a suitable tool, remove and discard the circlip that retains the DPS valve in the A/C compressor cylinder head.

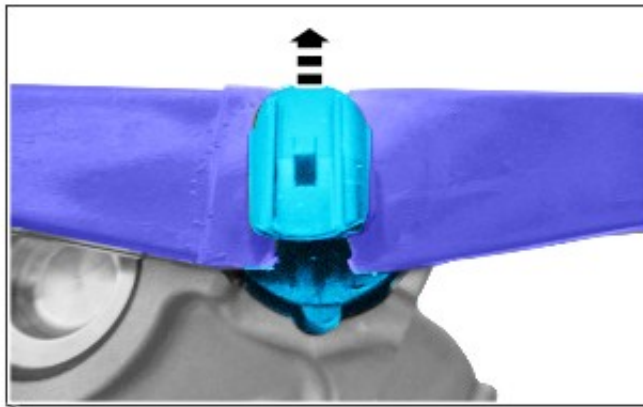
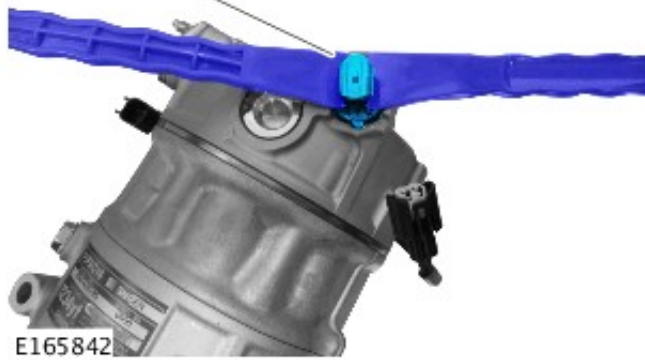
Make sure not to damage the housing in the A/C compressor cylinder head.

Using suitable tools, release the DPS valve.

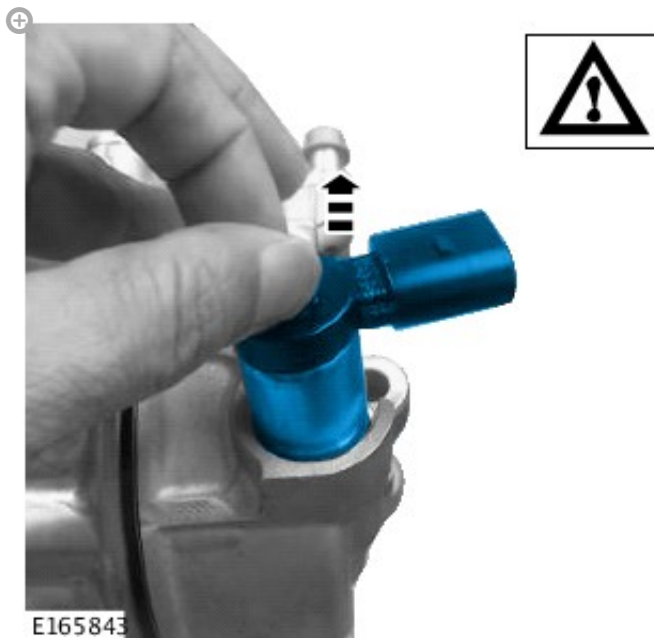
Take care to remove the DPS valve in a vertical direction to avoid damage to the inside wall of the A/C compressor cylinder head.

Remove by hand the DPS valve from the A/C compressor cylinder head, and discard.

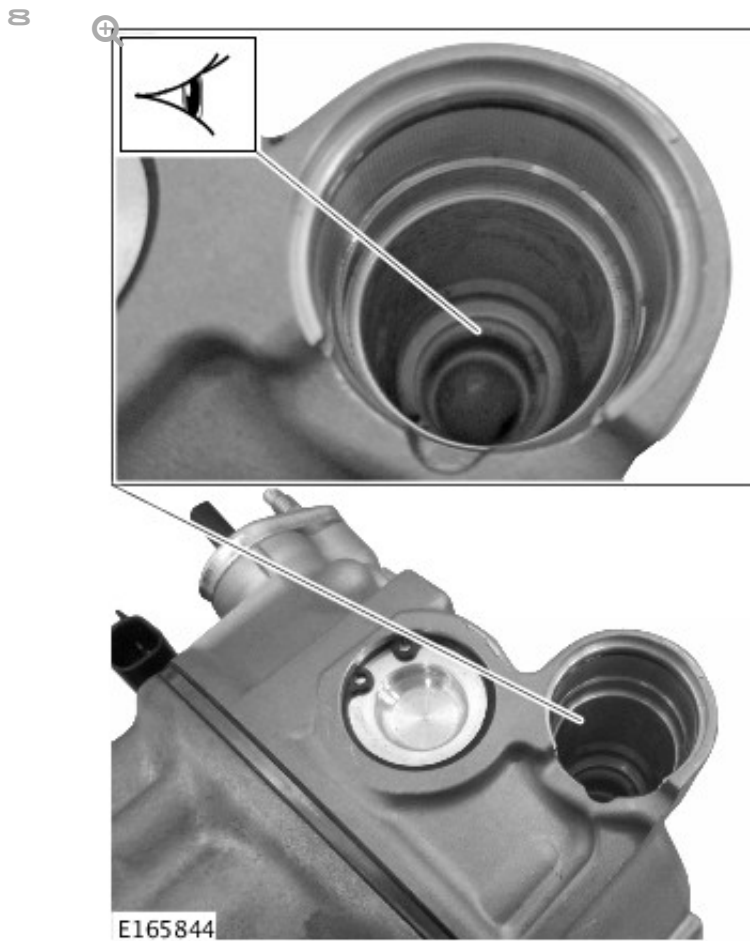
Inspect the inside wall of the A/C compressor cylinder head for scratches, scoring, or foreign material.
