Entry Of Water Into Vehicle –
Possible Sources

MODEL 2004 MY-ON
XJ range

VIN G00001-ON

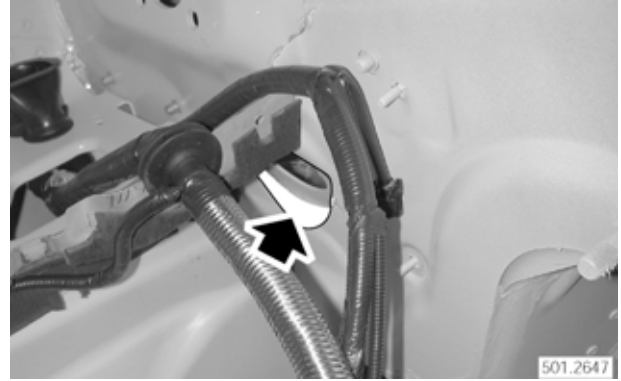
ILLUSTRATION 7

Water ingress into the driver's footwell.

Water can track between the body panels where the lower steering column exits the bulkhead.

Note: Apply a suitable wet sealant to the area shown (Illustration 7).

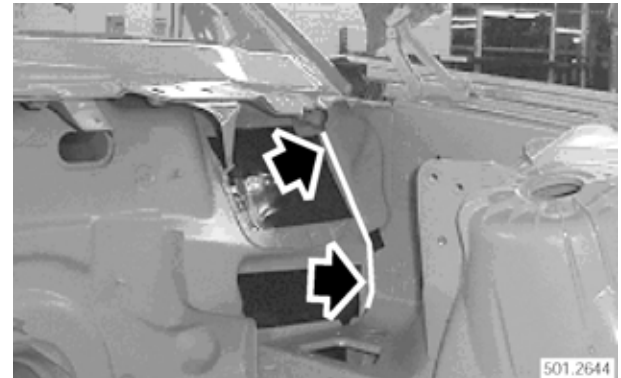
ILLUSTRATION 8

Water ingress into the front footwells.

Seams between inner front fender and bulkhead are leaking (Illustration 8).

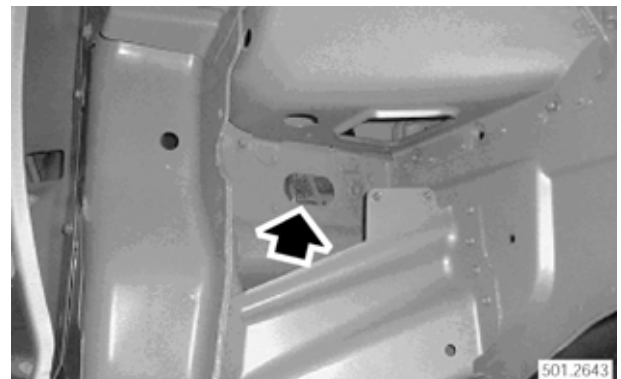
ILLUSTRATION 10

Water ingress into the front footwell.

Water ingress from harness grommet under front wheel arch (Illustration 10).

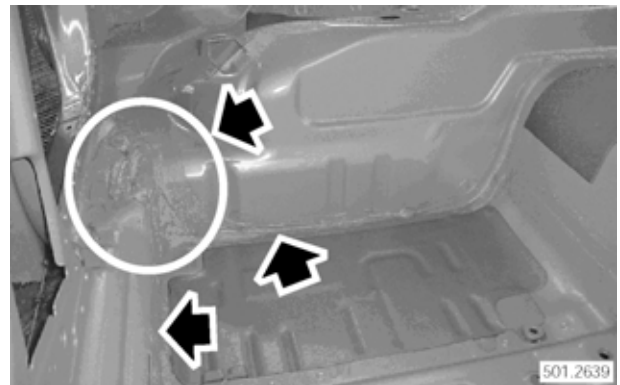
ILLUSTRATION 14

Water ingress into the rear of the cabin.

Water ingress through the seams by the rear seat (Illustration 14).

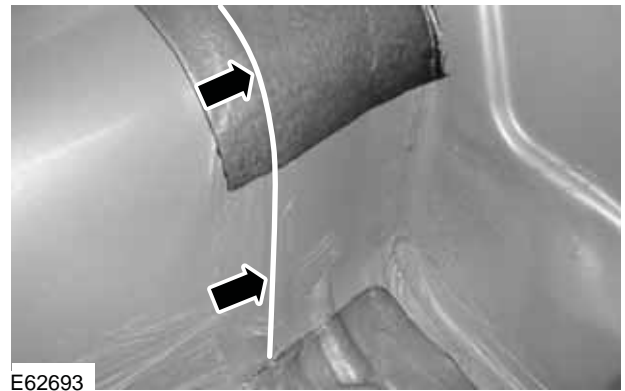
ILLUSTRATION 15

Long Wheel Base Vehicles Only - Water ingress into the left-hand and right-hand rear footwells.

Water ingress through the long wheel base extension seam, left-hand and right-hand side (Illustration 15).
