TECHNICAL BULLETIN

No: J019
Issue: 1
Date: 17 NOV 2010

Safety Recall: Wiper Arm Securing Nut Check

XJ (X351)

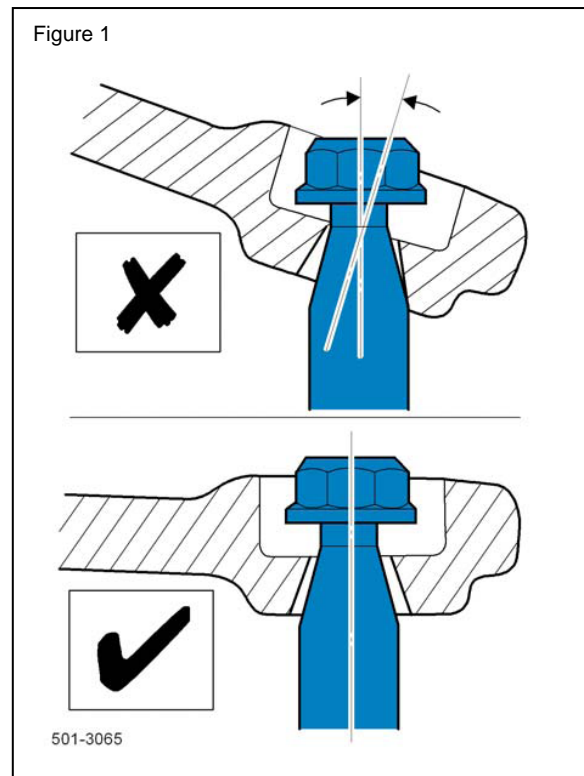
Situation: A concern has been identified with certain 2010 - 2011 model year Jaguar XJ vehicles whereby the wiper arm securing nuts may suffer torque relaxation as a result of an insufficiently controlled vehicle manufacturing assembly process.

Torque relaxation of the securing nut could potentially result in loss of wiper arm synchronization which can cause a clash of the wiper arms. If the wiper arms lose synchronization and clash, they could detach from the vehicle and, in certain circumstances, the driver's forward vision could be impaired.

3. Remove and retain the left-hand (LH) wiper arm spindle nut cover.
4. Loosen the wiper arm securing nut sufficiently to allow the wiper arm knuckle to realign with the wiper spindle.
5. Apply hand pressure on the wiper arm to ensure correct arm alignment to the spindle. (Figure 1)
6. Tighten the wiper arm spindle nut to **25Nm (18.5lbf ft)**.
7. Install the wiper arm spindle nut cover.
8. Repeat steps 3 -7 to the right-hand (RH) wiper arm.
9. Close the hood.
