Technical Service Bulletin

No. B501-07v2
22 April 2005

Subject/Concern/Concern:	Possible Causes of Water Ingress into the Vehicle
---------------------------------	---

XJ Range	VIN-range: G00442 Onwards
----------	---------------------------

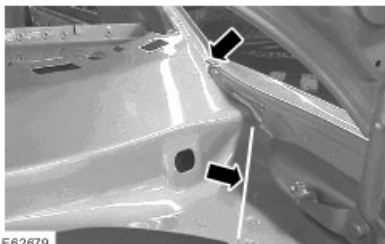
E62679

- 11 . **Issue:** Water ingress into the spare wheel well and the luggage compartment carpet is wet towards the front of the luggage compartment. **Possible Cause:** Hole in sealer between the rear fender and bottom corner of backlight panel, or forward channel seam leaking.

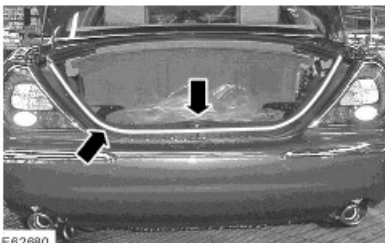
E62680

- 22 . **Issue:** Water ingress into the spare wheel well and the luggage compartment carpet is wet. **Possible cause:** Water tracking underneath the luggage compartment aperture seal.

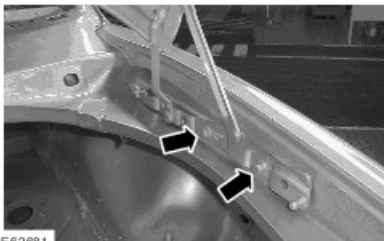
E62681

- 33 . **Issue:** The luggage compartment carpet is wet at one or both sides. **Possible cause:** Water ingress through luggage compartment lid hinge securing bolts.

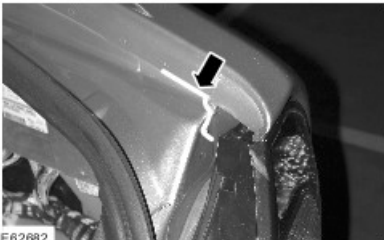
E62682

- 44 . **Issue:** The luggage compartment carpet is wet towards the rear of the luggage compartment. **Possible cause:** Rear fender seam leaking.

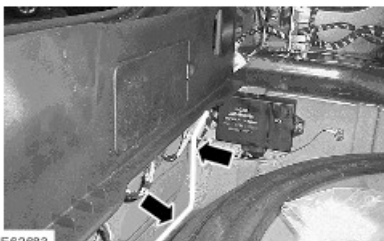
E62683

- 55 . **Issue:** Water ingress onto the spare wheel well. **NOTENOTE:** Water leak mainly from vertical part of the seam.

Possible cause: Luggage compartment floor seams leaking.

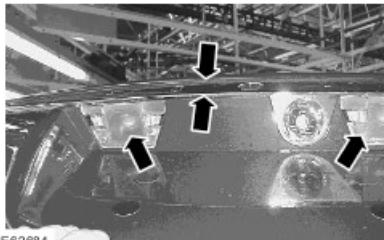
E62684

- 66 . **Issue:** Water ingress into the rear number plate lamps. **NOTENOTE:** Foam attached to finisher may be distorted.

Possible cause: Luggage compartment trim finisher not correctly sealed to the luggage compartment lid.

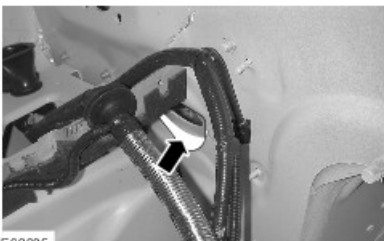
E62685

- 77 . **Issue:** Water ingress into the driver footwell. **NOTENOTE:** Apply a suitable wet sealant to the area shown.

Possible cause: Water can track between the 'body in white' panels where the lower steering column exits the bulkhead.

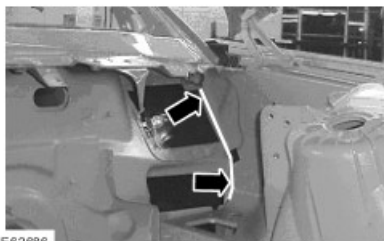
E62686

- 88 . **Issue:** Water ingress into the front footwells. **Possible cause:** Inner front fender to bulkhead seams leaking.

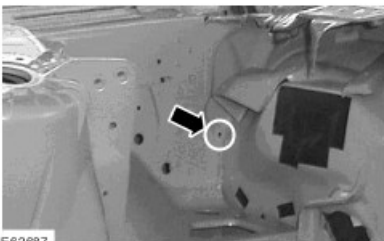
E62687

- 99 . **Issue:** Water ingress into the front passenger footwell. **NOTENOTE:** On driver side this hole is used to mount the plenum drain tube. On passenger side a blanking patch is installed.

Possible cause: Patch over hole can leak water.

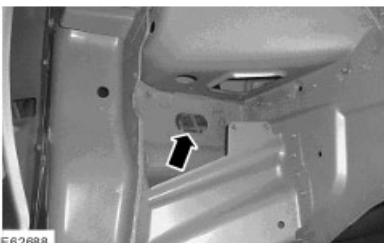
E62688

- 1010 **Issue:** Water ingress into the front footwell. **Possible cause:** Water ingress from harness grommet under front wheel arch.

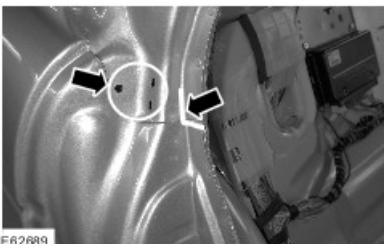
E62689

- 1111 **Issue:** Sill carpet wet at rear. **NOTENOTE:** Remove rubber finisher and apply a suitable wet sealant (to the areas shown) to block the water path.

Possible cause: Water tracks under the rubber finisher along the C-pillar/door shut joint and/or behind the rubber finisher fixings, then down along draft welt.

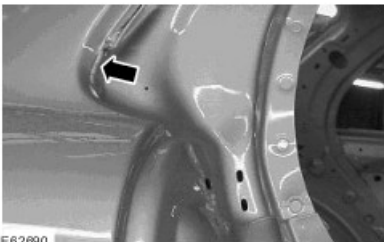
E62690

- 1212 **Issue:** Water ingress into the cabin. **Possible cause:** Water can run from the drain channel, behind the putty, and then down onto the inner wheel arch. From here the water can run forwards into the cabin.

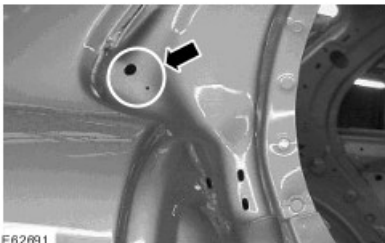
- 1313 **Issue:** Water ingress into the cabin. **NOTENOTE:** Pull away finisher for access, remove two fixings securing the drain channel clip and apply a suitable wet sealant around the fixing holes (areas shown) to block the water path.

Possible cause: Water ingress through the drain channel finisher fixings.

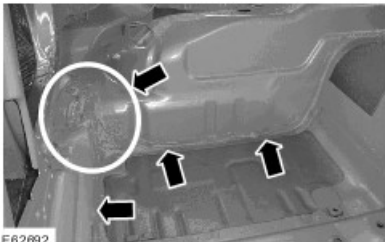
1414 **Issue:** Water ingress into the rear of the cabin. **Possible cause:** Water ingress through the seams by the rear seat.

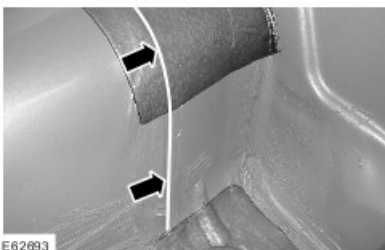
1515 **Issue:** Long Wheel Base Vehicles Only - Water ingress into the left-hand and right-hand rear footwells.
NOTENOTE: Illustration, right-hand shown left-hand similar.

Possible cause: Water ingress through the long wheel base extension seem, left-hand and right-hand side.
