Technical Service Bulletin

No.JTB00039
19 April 2007

Subject/Concern: Noise From Windshield Area at High Speed

XJ Range | | VIN-range: G49701 Onwards

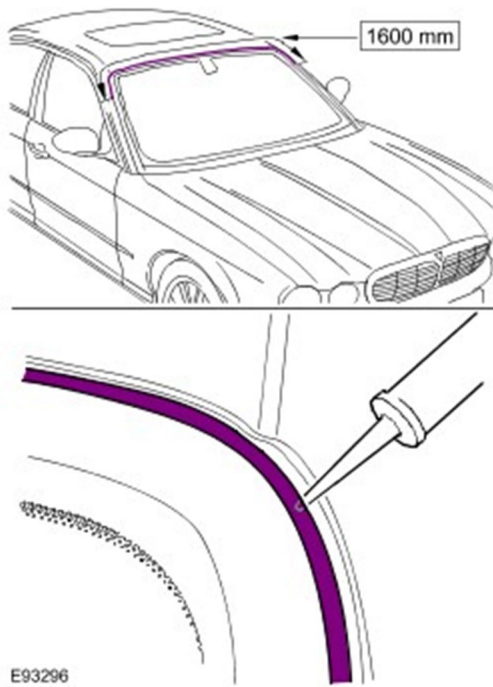
E93296

Cause: The edge of the windshield flip seal lifting at high speed, causing the seal to vibrate in the airflow.

Apply 3M™ Auto Bedding and Glazing Compound 08509 under the flip seal to prevent vibration of the seal at high speed.
