Sedan Range

TECHNICAL BULLETIN

Cooling System Fan Fuse Failure – Single Pressure Switch – Service Modification

MODEL 1995-96 MY
Sedan Range

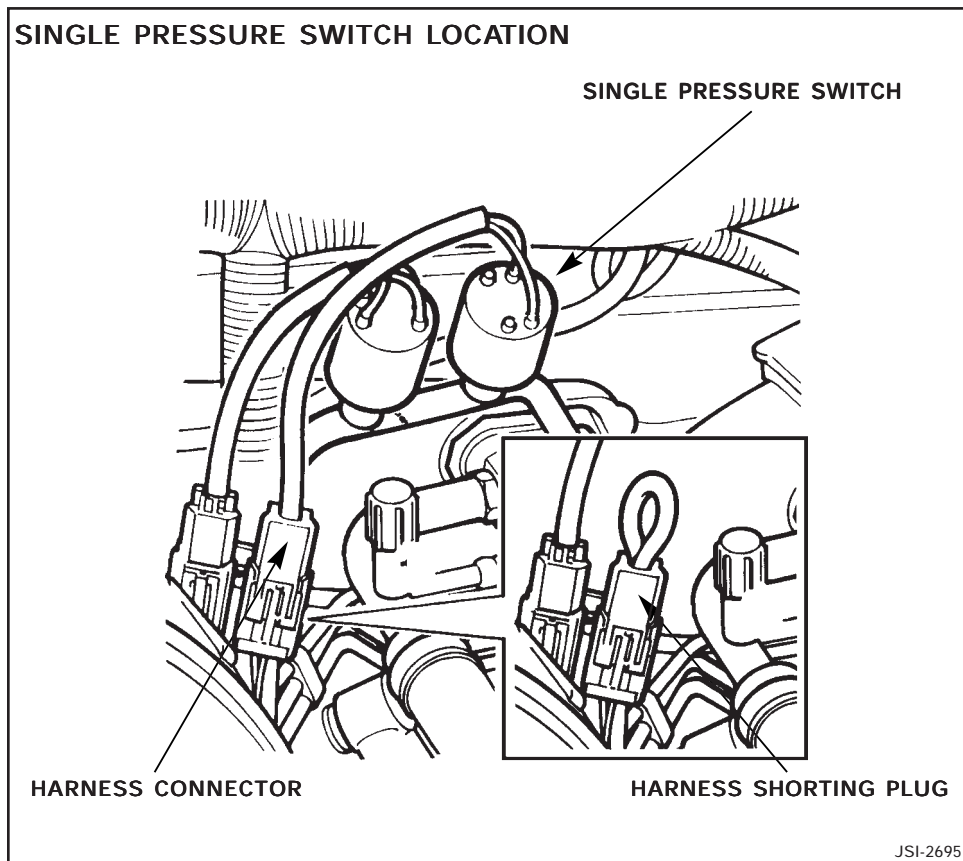
ILLUSTRATION 1

Technical Bulletin 14-04, Dated 10/95 described cases of repeated cooling fan fuse failure caused by failure of the single pressure switch, which controls slow fan speed operation.

If the cooling fan relay module has failed in either a short circuit or open circuit mode, the cooling fan circuit **must** be modified as described on the next page in addition to replacing the relay module. The modification is necessary because of the known failure mode of the pressure switch, which may cause sticking of the relay contacts and/or may switch the fans into a parallel circuit condition (high speed mode), causing the fan fuses to blow.

1. Identify the single pressure switch (Illustration 1) and disconnect the harness connector.
2. Unscrew and remove the single pressure switch from the Schrader valve connection (Illustration 1) on the refrigeration line.

3. Install and tighten the dust cap provided in the modification kit on the exposed Schrader valve connection.
4. Remove the harness connector from its mounting bracket.
5. Insert the shorting plug supplied in the modification kit into the harness connector. Insert the harness connector into its bracket.
6. Turn the ignition switch to position II and check that the cooling fans run at the slow speed.
