TECHNICAL BULLETIN

JAGUAR SERVICE	Recall T493 - 1995 MY/Recall R493 - 1996 MY – AJ16 EGR System – Replace PROMs and EGR Valve	17-12 Amended 08/02
	MODEL 1995-96 MY XJS 4.0L VIN 194775-226645	DATE 11/01

ISSUE:

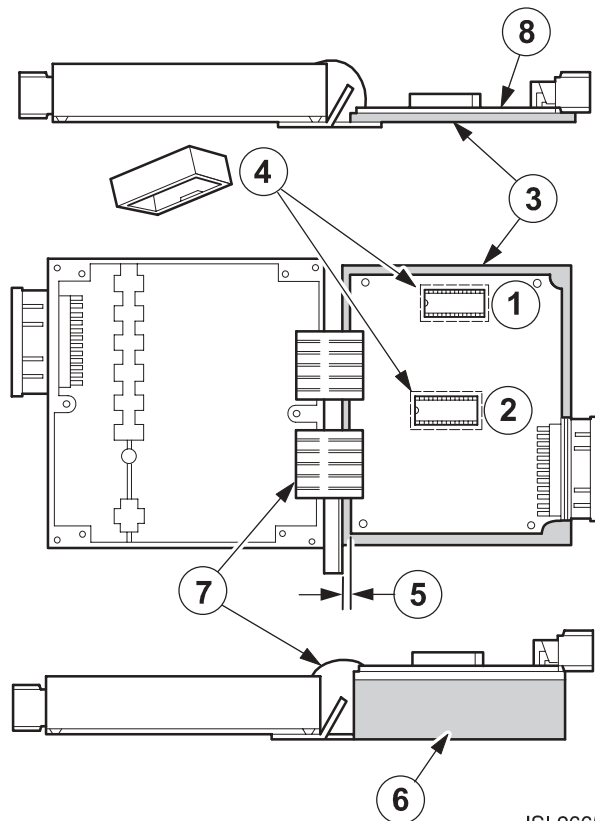
ILLUSTRATION 2

- 1 - 28 PIN PROM
- 2 - 32 PIN PROM
- 3 - ECM COVER
- 4 - PROM COVERS
- 5 - CLEARANCE SPACE
- 6 - WOOD SUPPORT
- 7 - RIBBON CABLES
- 8 - PRINTED CIRCUIT BOARD

5. Remove the seven retaining screws of the printed circuit board (8, Illustration 2). Fold the printed circuit board away from the body of the ECM unit and support it on a block of wood (6, Illustration 2) so that no strain is placed on the ribbon connectors (7, Illustration 2). Allow a clearance space (5, Illustration 2) so that no damage can occur from contact with the mounting brackets.
6. The modification kit contains two microchips, one each of the 28-pin (1, Illustration 2) and 32-pin (2, Illustration 2) design.
7. Remove the covers (4, Illustration 2) from the microchips on the printed circuit board. Remove each cover by applying a side-to-side rocking action, gripping the cover lightly with combination pliers midway along each long side.

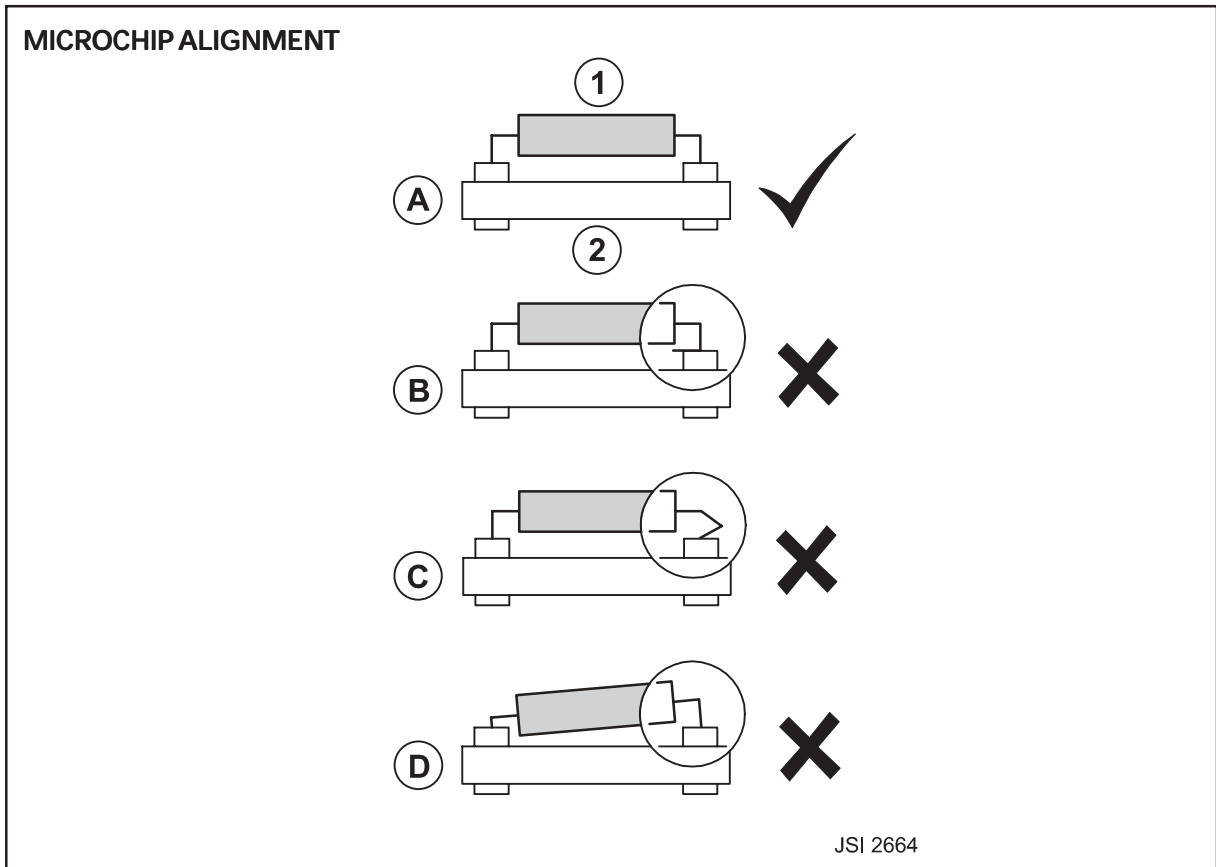
ILLUSTRATION 6

⚠ Caution: Permanent damage to the microchip is likely in conditions B or C. Malfunctions will occur with partial engagement, as in condition D.

12. Use great care to achieve condition '1' in Illustration 6. The microchip must lie parallel to the printed circuit board, with all pins fully engaged into their corresponding locations in the socket.

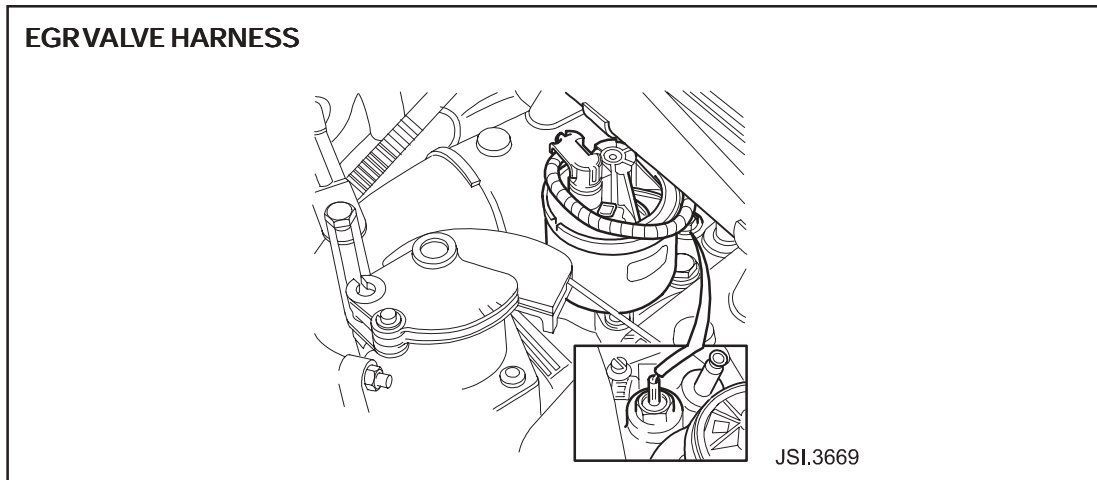
ILLUSTRATION 8

Since the introduction of the AJ16 engine Jaguar has seen a high rate of replacement of EGR valves following illumination of the malfunction indicator lamp (MIL). This is understood to be a result of accumulated contamination within the EGR valve that can produce possible drivability issues such as rough idle, hesitation, and difficult starting.

1. Open the hood and place covers over the fenders.
2. Disconnect the EGR valve harness connector (Illustration 8).
3. Remove the EGR valve securing bolts.
4. Remove the EGR valve and valve gasket.
5. Clean the valve mating faces.
6. To reinstall the new EGR valve and gasket, reverse the EGR valve removal process.

Note: Care must be taken not to damage the EGR valve securing bolts. Torque figure: 23–27 Nm (17–20 lb ft).
