## AJ16 Top Timing Chain Tensioner Fiasco.

This is what I have FINALLY found with my noisy AJ16 engine.

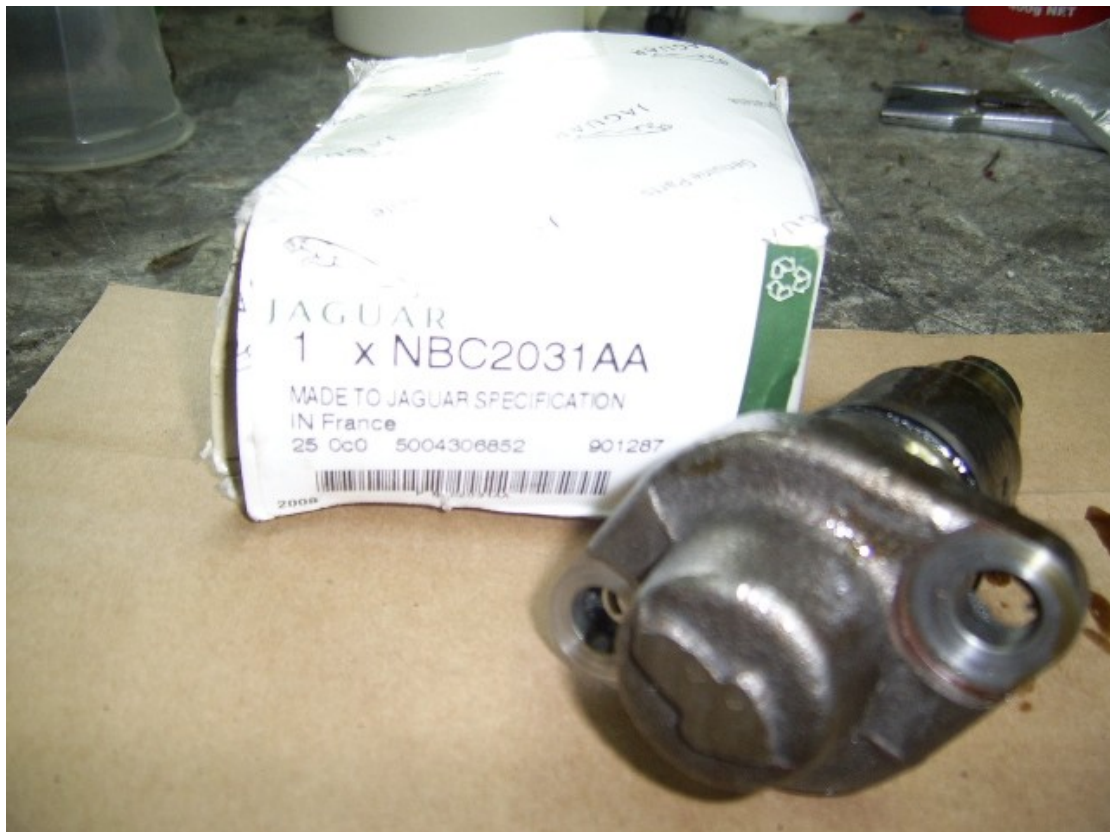
**Figure 1**Tensioner as received

Picture “1” shows the unit as received from Jaguar, including the box with the latest Part No.

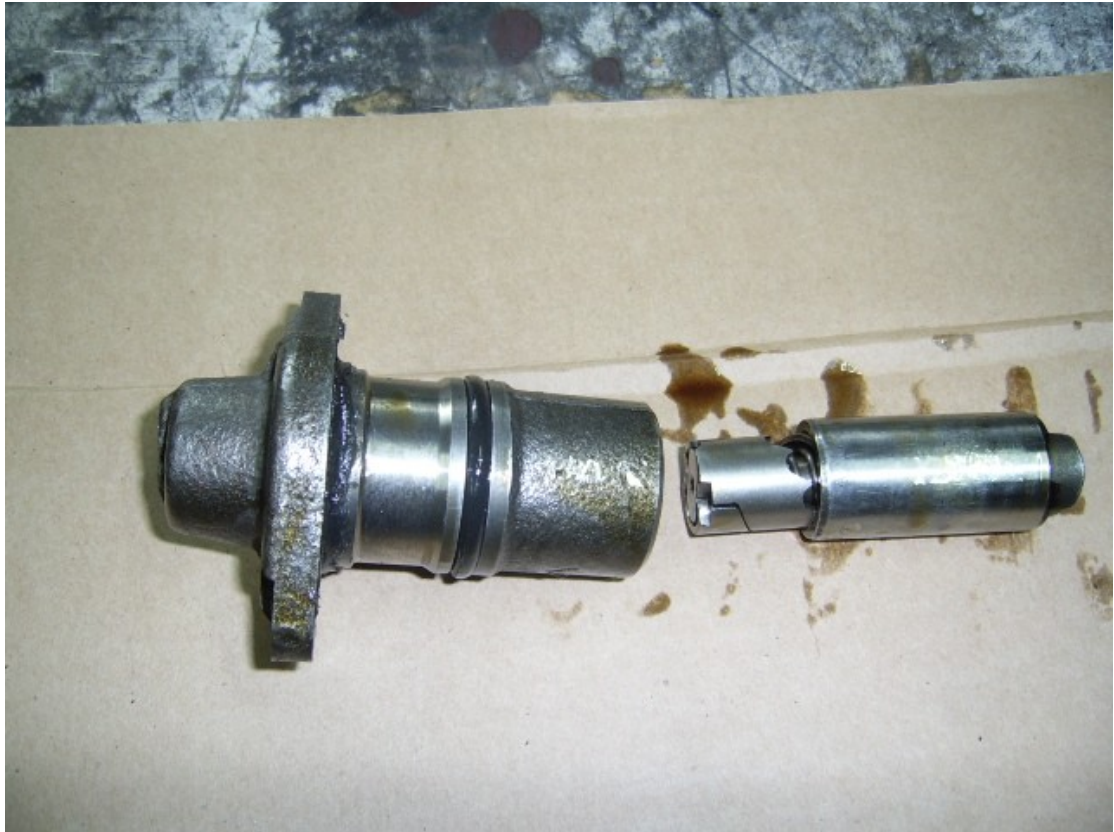
**Figure 2** The 2 main components, spring loaded plunger on the right.

Picture “2” shows the 2 main items, the housing, and the plunger assembly.

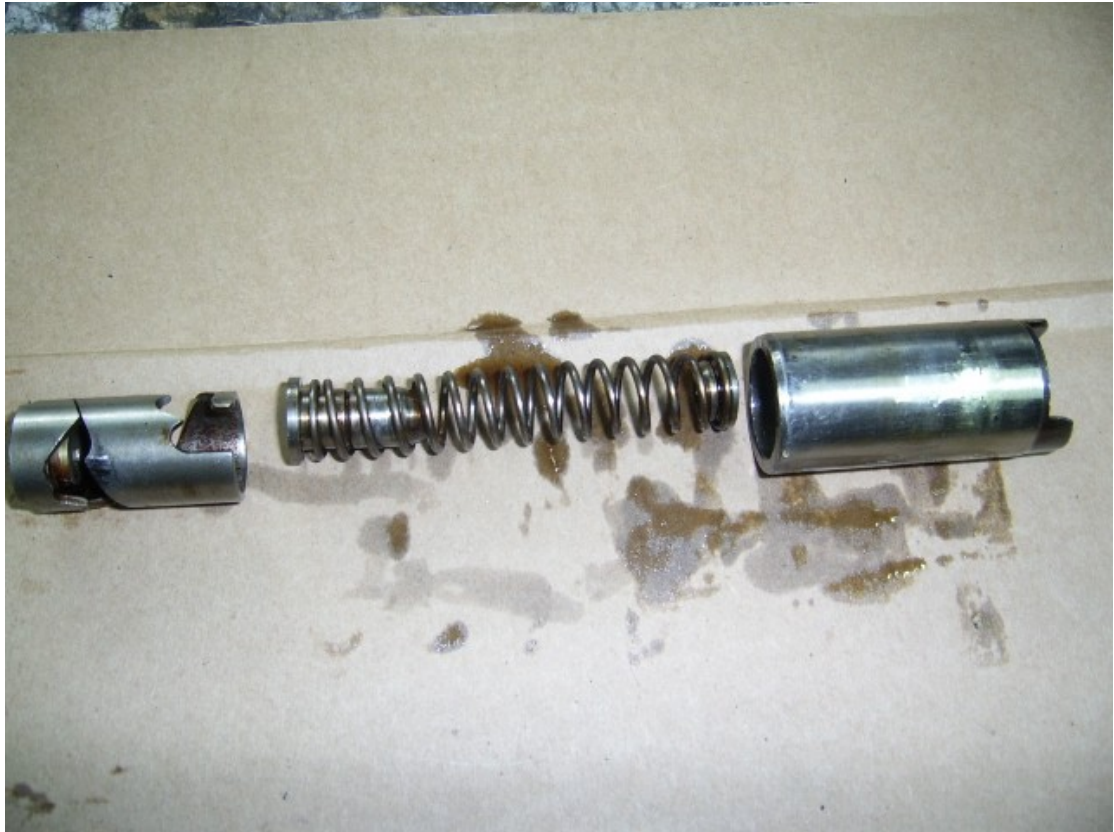
**Figure 4 Spring assembled correct as supplied from Jaguar.**

Picture “4” shows the plunger dismantled, with ALL the components in CORRECT fitment position.

I did install a washer, about 2mm thick, over the “shaft” of that rivet, so as to sit under the head, thus applying 2mm more spring pressure to the assembly whilst waiting for oil pressure to arrive.

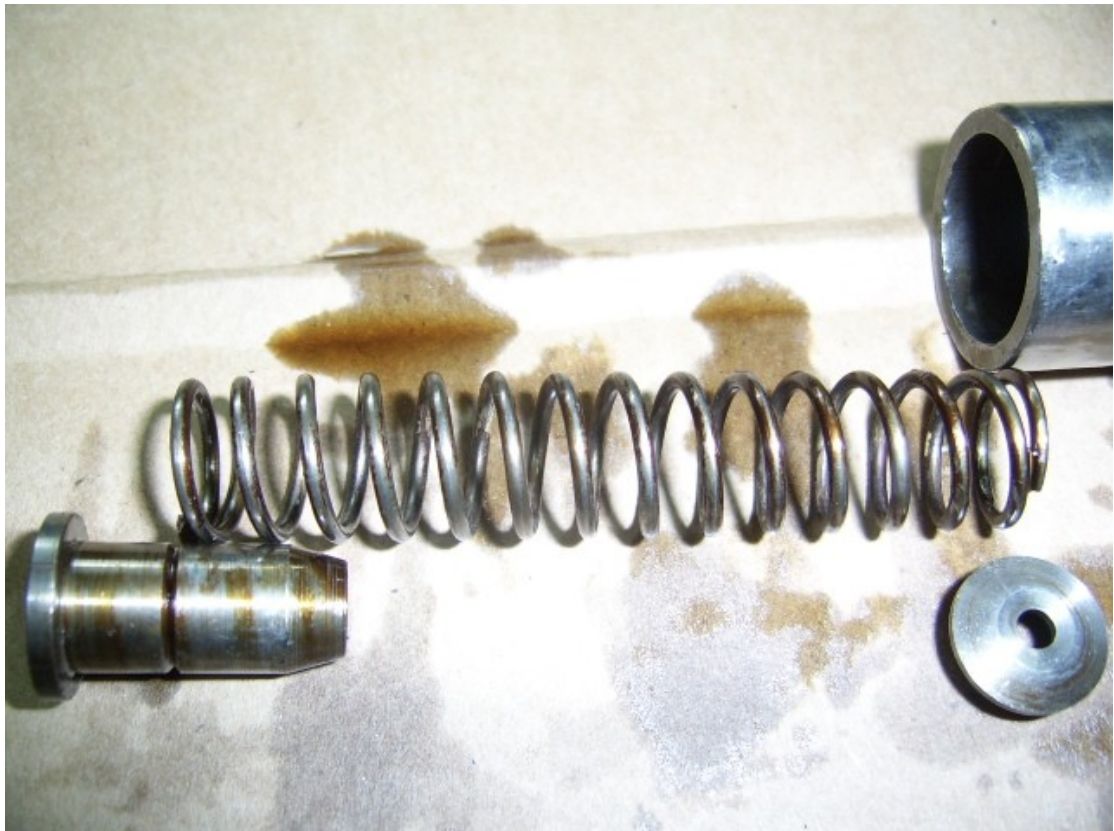
The attached photos will show clearer what I cannot put into words. Basically the “rivet” looking thing in one end of the spring goes INSIDE the piston that goes inside the plunger, and the “jet” looking thing, goes inside the plunger that pushes on the top chain blade. This is very confusing, coz oil is required to pass through the end of the plunger, where there is a tiny hole in the end face, to lubricate the chain blade pivot point, so a “jet” here would be sensible, but without knowing the intentions of the designer, “seat of pants thinking” was used.

**Figure 5 Showing the rivet and jet I was talking about above.**

Picture “5” shows the “rivet” and “jet” that sit in the ends of the spring.

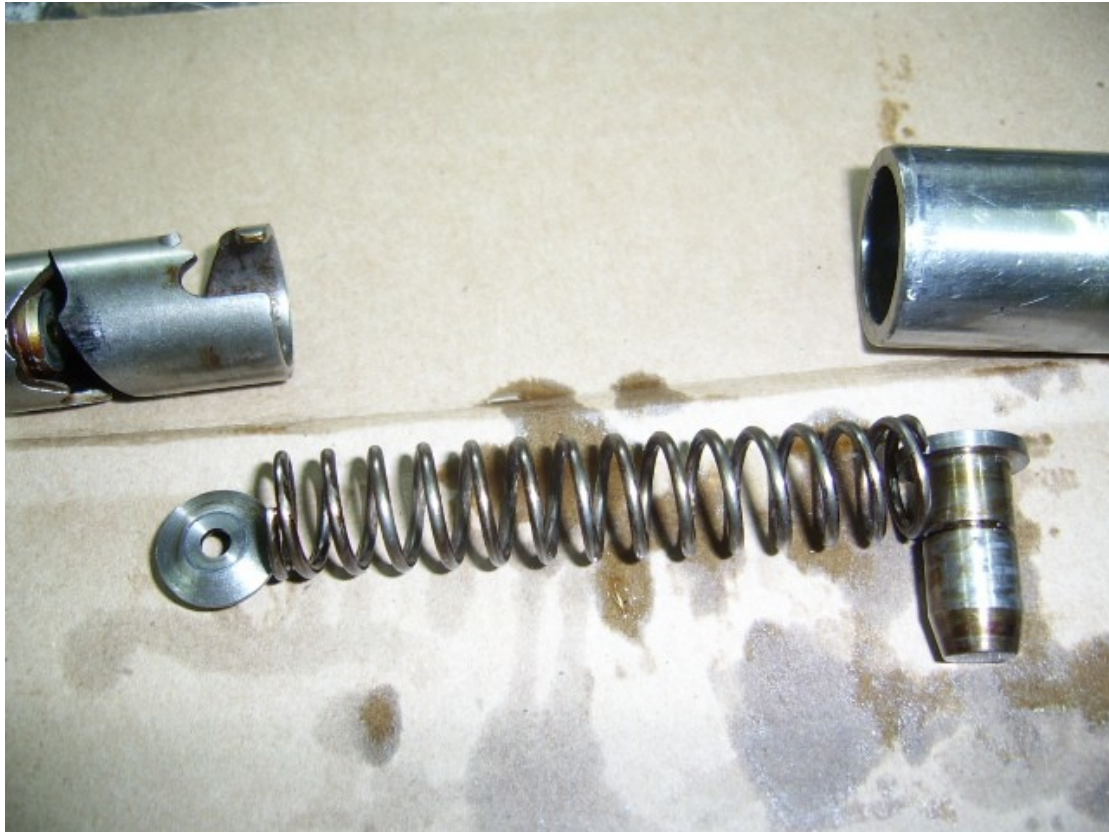
Removed the tensioner, simply enough task, up on the bench, and dismantled it CAREFULLY, as I wanted to see just what was what inside this thing. I also dismantled the old unit, in a separate tray, and noted the spring was assembled different. By that I mean that the spring has a different fitting in each end, and the old unit was reverse of the new unit, WHO’S RIGHT

**Figure 6 This is the INCORRECT assembly**

Picture “6” shows the spring/plunger in INCORRECT assembly order.

assembled it as it came from Jaguar, deciding the OLD unit was incorrectly assembled by some previous unknown and refitted the thing to the car, started the engine and once the initial “unholy rattle” disappeared, the annoying rattle was no more, too good to be true, I am NOT that lucky, went for a drive, no more rev range rattle, parked for a quiet beer under a shady tree, and about 30 minutes later fired it up, NO rattle, fair dinkum, this thing always gave that “ching” at hot start, but no more, drove home, waited again, started it again, and again, all quiet, consumed much beer, then typed this.

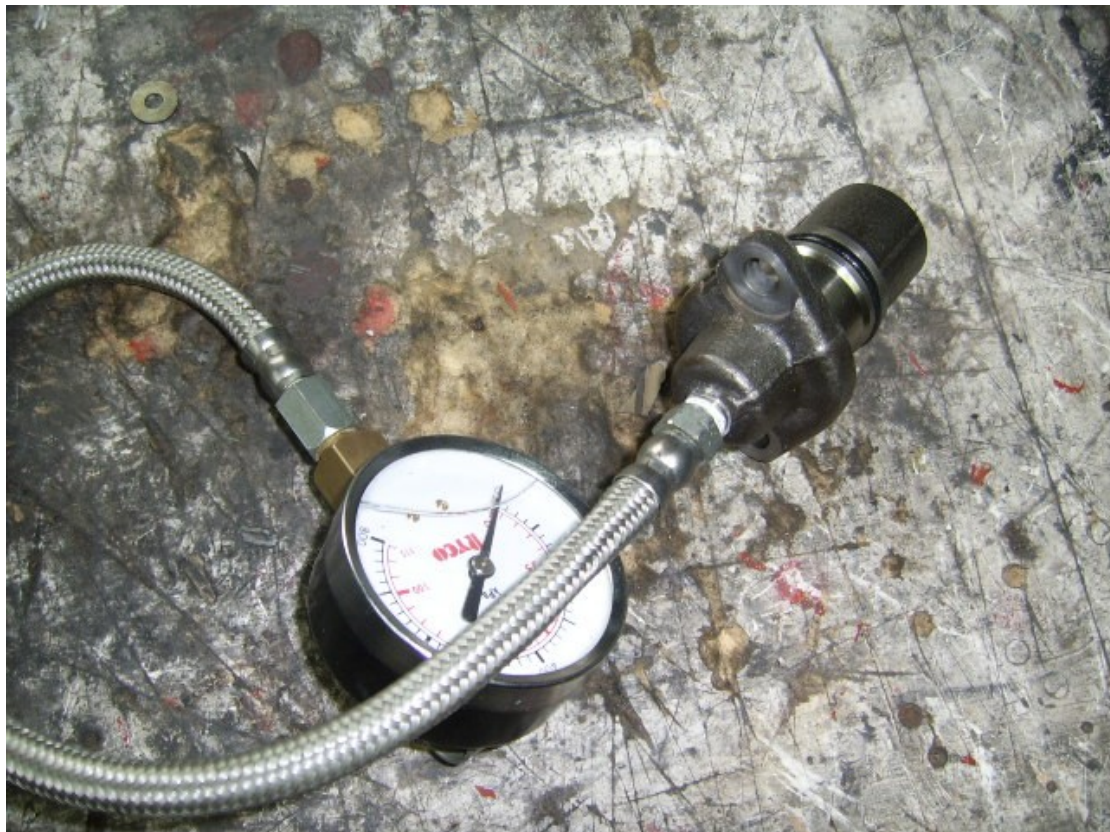
I took the old top tensioner assembly, and drilled a hole in the middle of the “arrow” in the end of the unit, and duly tapped a 1/8” BSP thread in it to accommodate my master oil pressure gauge. I installed this in the engine and noted the oil pressure AT THE TENSIONER. What a surprise 80-85psi cold. I was NOT expecting that, and the pressure stayed there even when HOT, and did not alter from idle to 2500rpm, so enough oil pressure is definitely available to operate this assembly. I ran the engine until the thermo fans cut in, shut it down, waited 20 minutes, started it again, and noted a slight rattle which I ignored due to using the old tensioner, but noted that oil pressure took only a short time to arrive, basically the needle started rising as the starter cranked the engine, but full pressure

took about 1.5 seconds to arrive, and once it arrived all noises ceased. There is a photo below showing the oil pressure arrangement I used.

Figure 7 Old unit with pressure gauge attached
