Sedan Range

14-04

## TECHNICAL BULLETIN

### Cooling System – Fan Fuse Failure

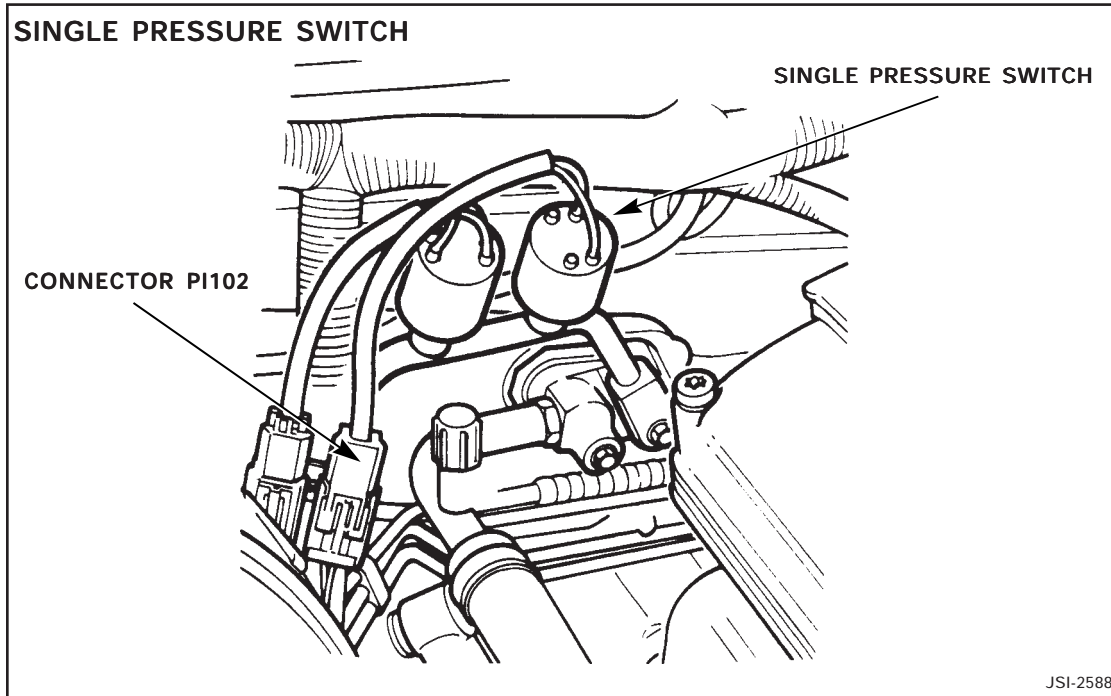
ILLUSTRATION 1

If the single pressure switch is defective, and refrigerant pressure rises enough to close the triple pressure switch, the fans will switch directly to high speed mode from off. This results in a higher current draw than the normal sequence of switching from low to high speed. The higher current draw may blow either or both fuses F11 and F17.

3. Disconnect the wiring harness of the single pressure switch at the white 2-way connector (PI102), Illustration 1.
4. Jump the terminals on the harness side of the connector. Switch the ignition ON and check if the cooling fans run at slow speed.

- If the cooling fans operate at slow speed, the single pressure switch is suspect; continue with step 6.
  - If the cooling fans do not operate, the switch is probably OK. Perform normal electrical fault tracing on the fan circuit.

5. Switch the ignition OFF and remove the jumper from the harness side of the connector. Leave the connector disconnected.
6. Connect a volt-ohmmeter across the terminals of the single pressure switch connector. Set the meter to as high a range as possible (greater than 100,000 Ohms).

- If the resistance is 1 Ohm or less, no fault is currently present at the switch. Reconnect the connector, run the engine with the climate control system set to the maximum cooling setting. Check that the cooling fans run at slow speed (series operation) within a few seconds.

- If the resistance is greater than 1 Ohm, but less than 100,000 Ohms, the switch has high resistance and must be replaced.
  - If the resistance exceeds 100,000 Ohms, proceed to step 7.

7. Leave the volt-ohmmeter connected to the single pressure switch and run the engine with the climate control system set to maximum cooling. (If necessary, increase engine speed for a short time.) Check that the compressor clutch is engaged.
  - If the resistance suddenly drops to 1 Ohm or less, reconnect the connector. Check that the cooling fans run at slow speed (series operation) after a few seconds. If the switch resistance drops below 100,000 Ohms, but is greater than 1 Ohm, replace the single pressure switch.
  - If the cooling fans switch from OFF directly into high speed (parallel) operation, the single pressure switch is permanently open. Replace the single pressure switch.
