## BMW/JAGUAR ZF5HP24 "A" CLUTCH DRUM FAILURE

**COMPLAINT:** A vehicle with a ZF5HP24 comes in with a complaint of little or no movement forward, reverse is good.

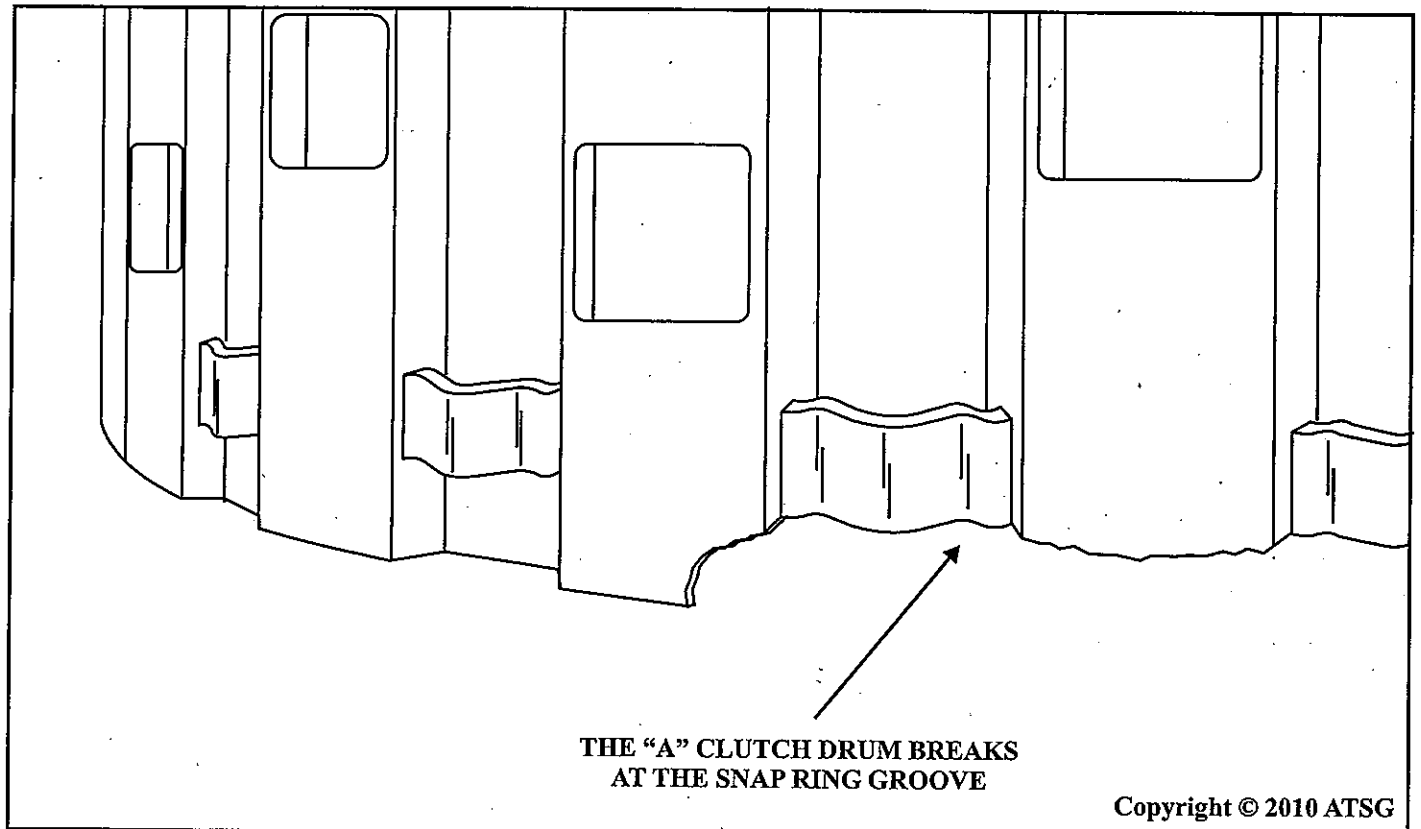
Figure 1  
Automatic Transmission Service Group

Upon disassembly of the transmission the "A" Clutch drum is found to be broken at the clutch pack retaining snap ring (Refer to Figure 1) and the snap ring has come out of the drum. The technician replaced the drum with the updated part only to have it come back with the same complaint and the same broken drum.

**CORRECTION:** Using the part numbers found under Service Information, replace the pressure regulator valve and the lower front valve body.
