V8 XJ Series/XK

413-S484

Instrument Pack Assembly – CAN Failure – Service Action S484

MODEL
2000 MY XK Range
2000 MY V8 XJ Series
VIN
A00116-A05322
F00103-F09691

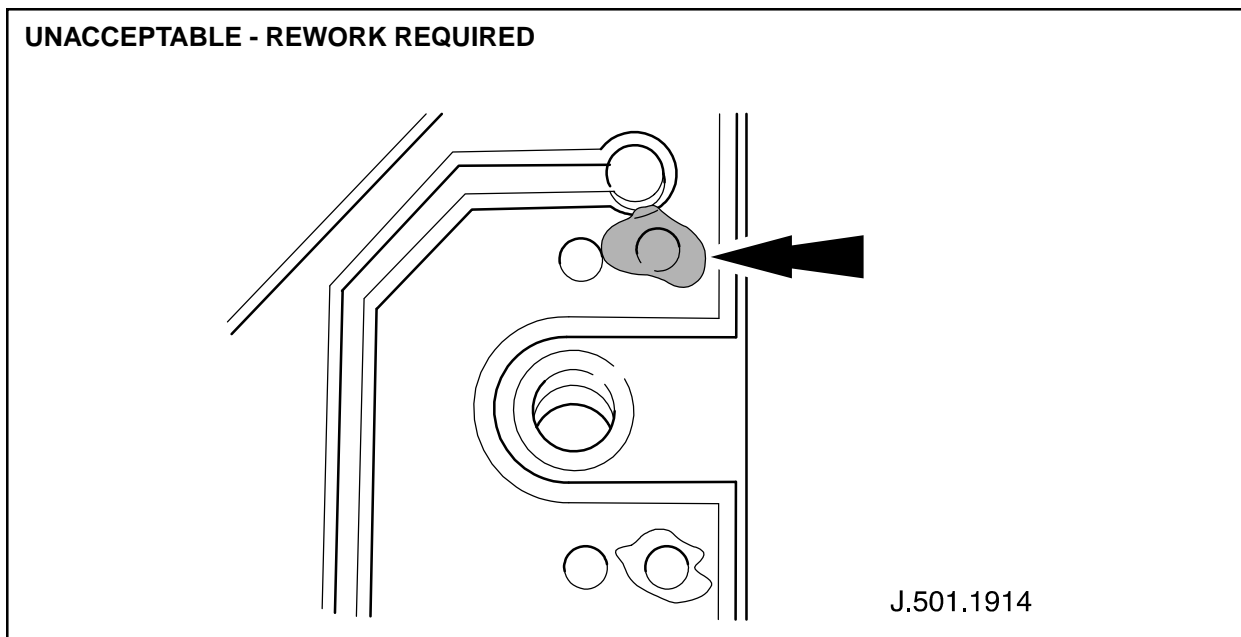
ILLUSTRATION 4

The cause of this has been identified as a Controller Area Network (CAN) failure in the instrument pack caused by a short to ground. This is due to a combination of pressure from the instrument pack back plate and possible migration of solder on certain printed circuit board contacts.

Illustration 4 shows an unacceptable case. This circuit board requires rework

If rework of the solder area is required (Illustration 4) proceed to step 11.
