www.jagrepair.com

Throttle Body Plugs P0121 Code

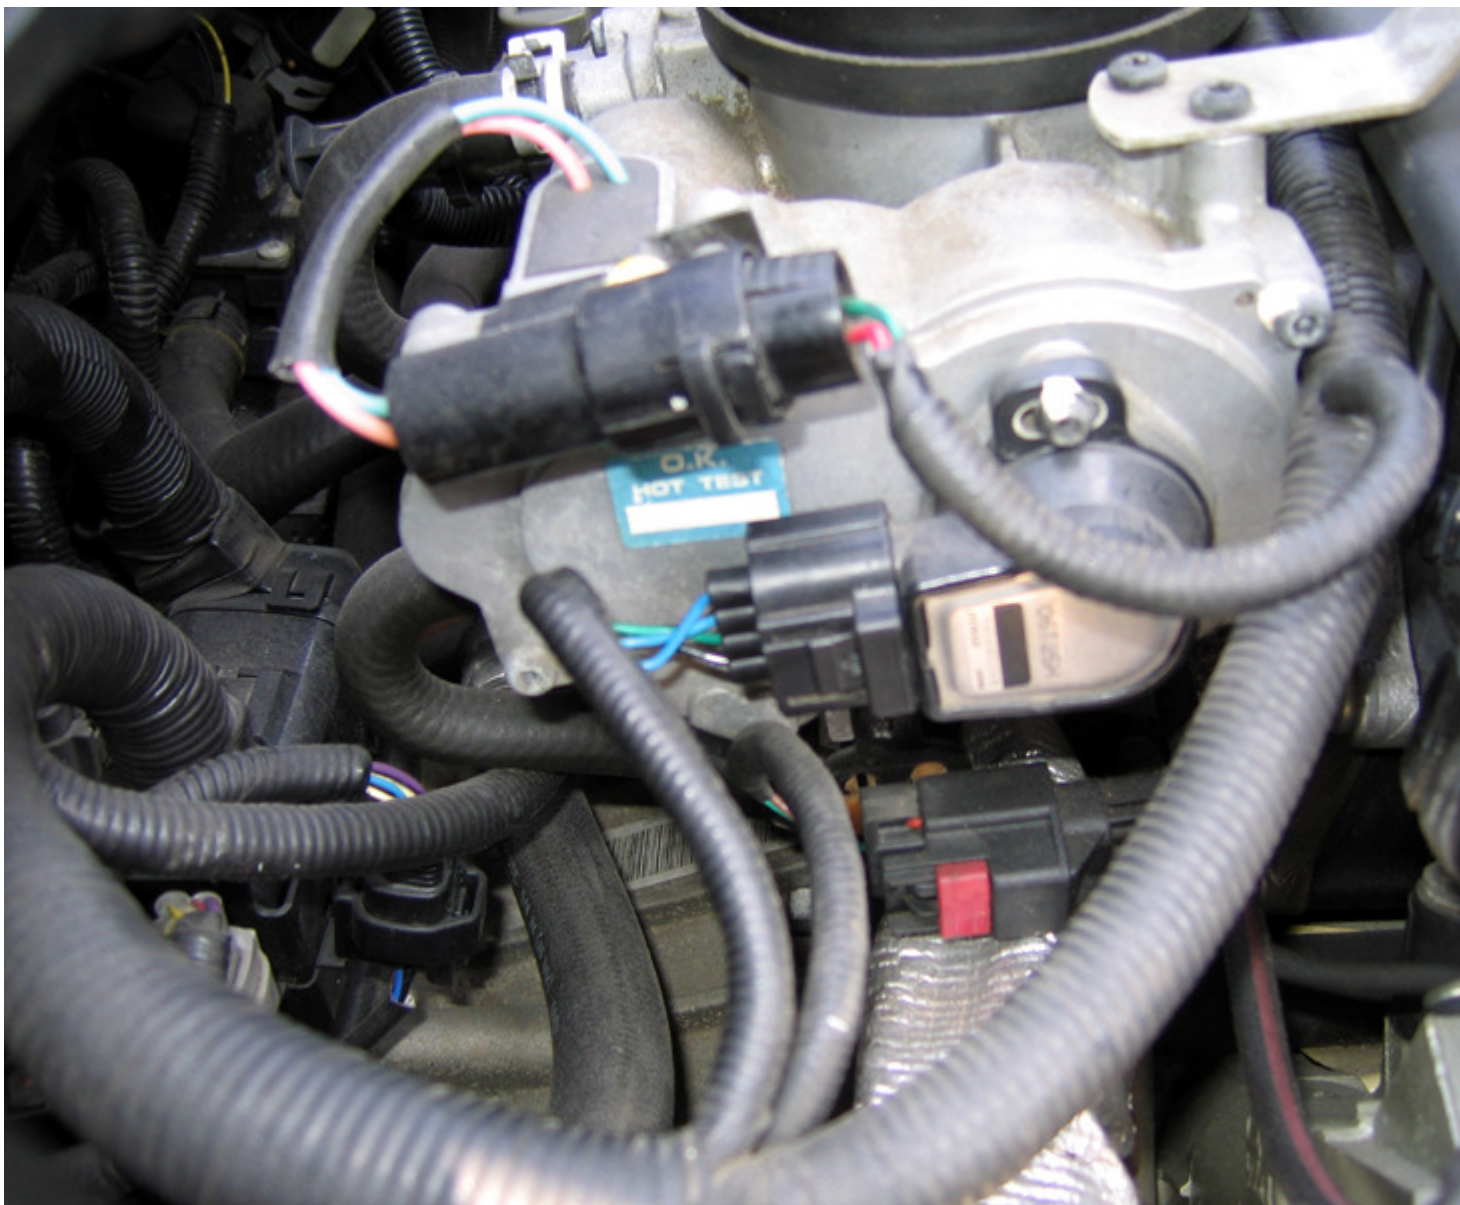
Side view of plugs

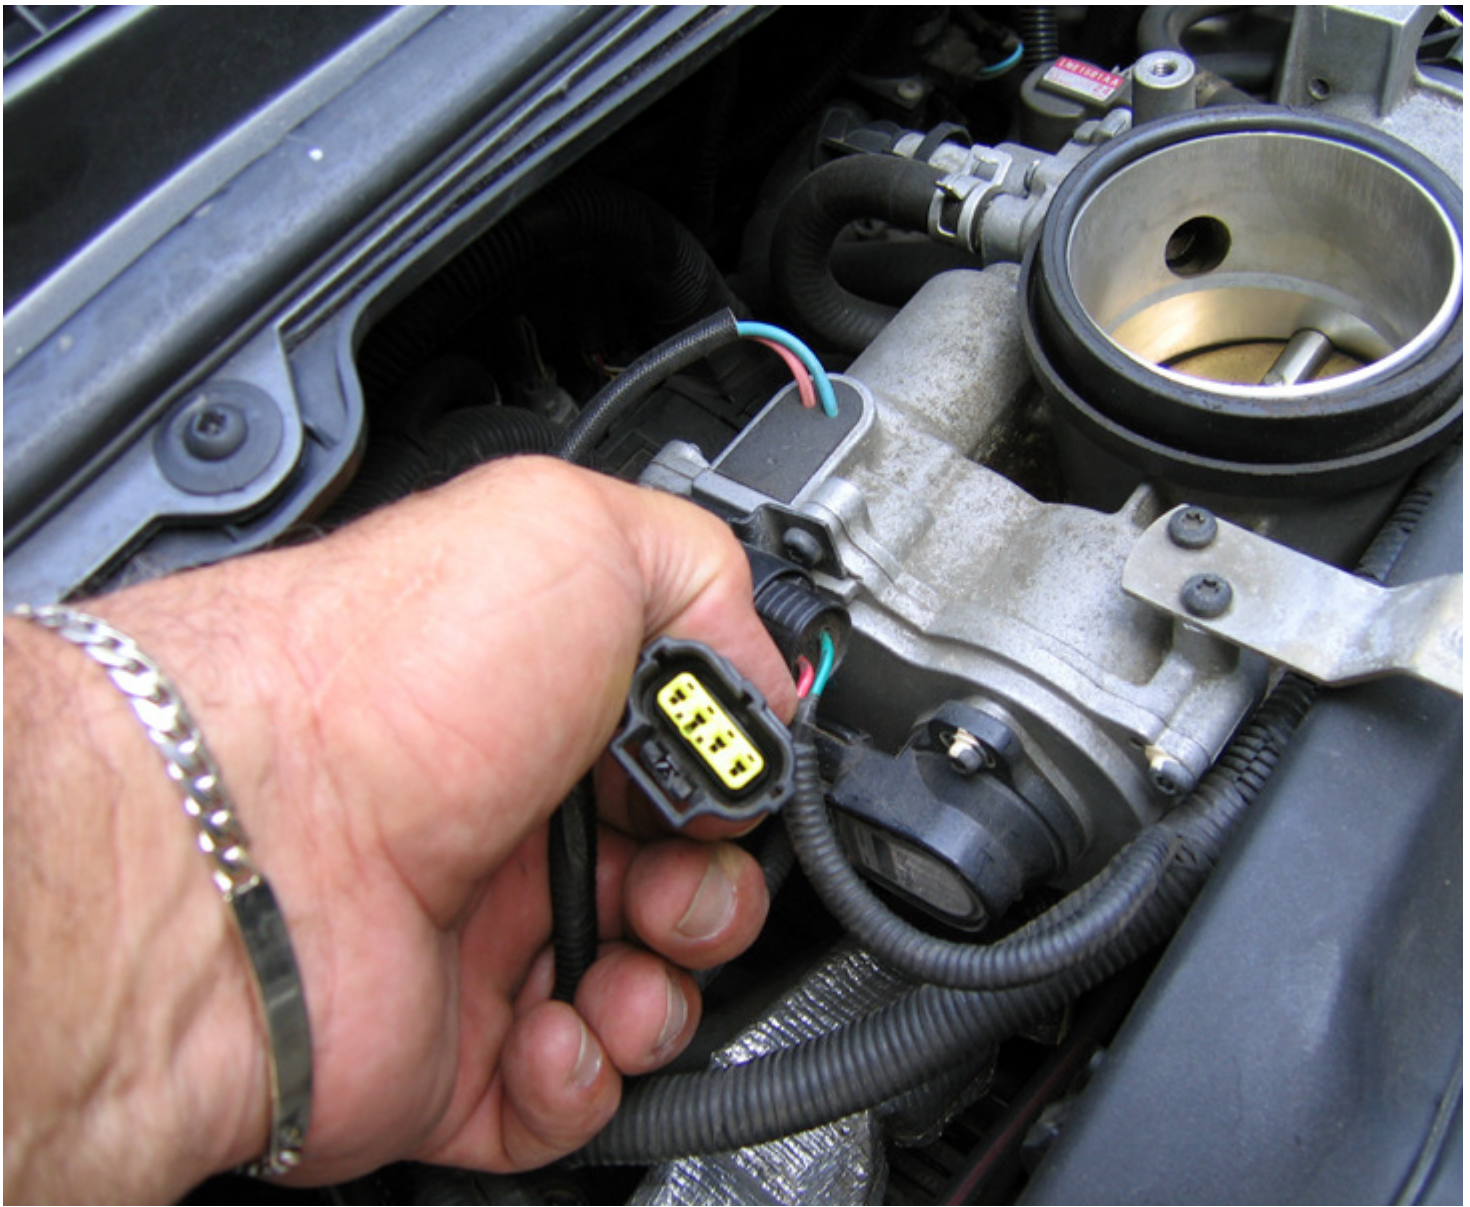
Found that the plug stays were broken

*On several occasions while driving the car I would get a Fail Safe warning and I would loose po
Thought that the TB needed cleaning. Did that and used BG 44k the problem cleared for a period c
Then it did it again with the same codes. I removed the top plug and found that the clips were loose.
them to fit tighter and had no problems for a long time until a few days ago when I was on the tol
running about 70mph. and the car lost power. I moved the TB wires and I was on the road again.
took the time necessary and checked all the connections and found that the stay for the TB plug was
allowing it to work itself loose. Alldata indicated that Jag had a service bulletin on the plug and su
that the connectors should be replaced. I went to Jag and they only had the wire connectors. They
have the plug that holds the wire connectors in place so I used a wire tie to hold it in place.*
