V8 XJ Series

TECHNICAL BULLETIN

Draft Welt Loose –
Front Door Opening –
Install Edge Finisher

MODEL 1998-2002 MY
V8 XJ Series
VIN 812256-F47334

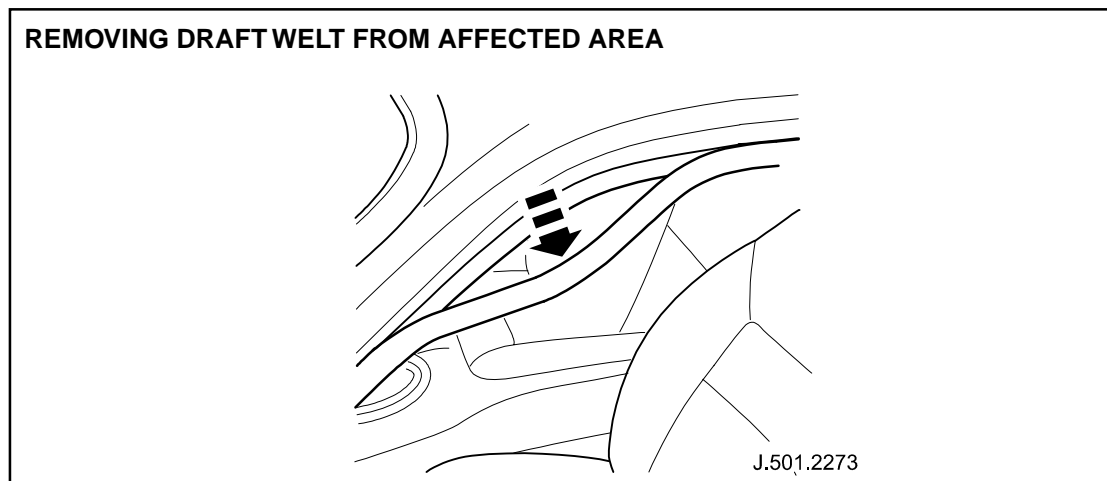
ILLUSTRATION 1

On some 1998-2002 MY V8 XJ Series vehicles within the above VIN ranges, the draft welt for the front door opening may come loose at the top front corner.

1. Displace draft welt from top of front door aperture A-post body flange (Illustration 1).
