**Intermittent Illumination of Instruments/False
Warning Messages –
Harness Connector Latch**

MODEL
1998 MY XK8 Range
1998 MY V8 XJ Series

VIN
029755-029891
849517-849885

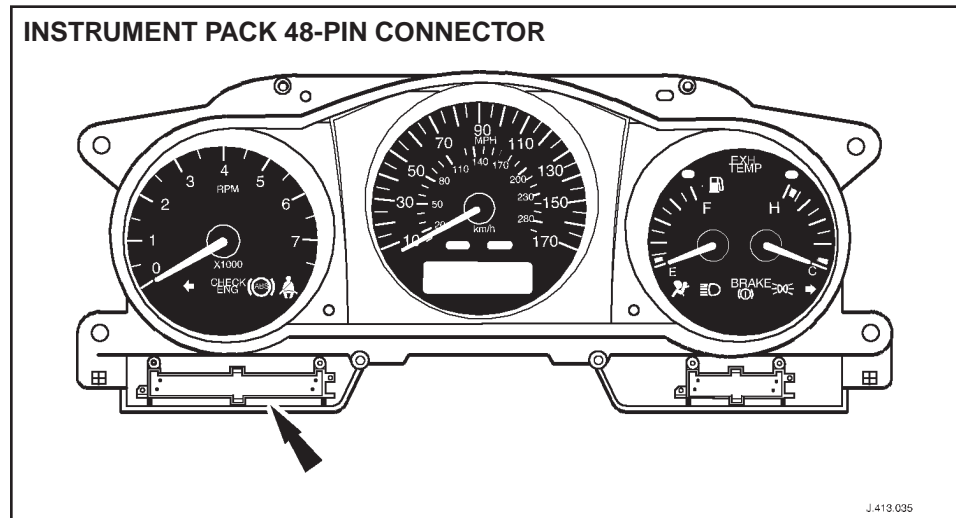
ILLUSTRATION 1

Some 1998 MY XK8 and V8 XJ Series vehicles within the above VIN ranges may experience intermittent illumination of the instruments and/or erroneous warning messages. The fault may be caused by a defective retaining latch in the Instrument Pack harness connector (arrowed, Illustration 1).

1. On V8 XJ Series vehicles, remove the veneer finisher. On XK8 vehicles, lower the underscuttle.
2. On all vehicles, gently move the harness wires at a position near the connector. If the connector has not latched into position correctly, some movement of the connector in the Instrument Pack will be noticeable.

- With the ignition switched on, move the harness to check for the erratic illumination of the Instrument Pack.

- If the connector cannot be latched securely, replace the instrument pack. Contact the Zone Parts Department to order an instrument pack.
