**Supercharged Engine (W5A580 Transmission)
– Oil Seepage From Electrical Connector
– Repair Procedure**

MODEL 1998 MY-ON
V8 XJR

VIN 812256-ON

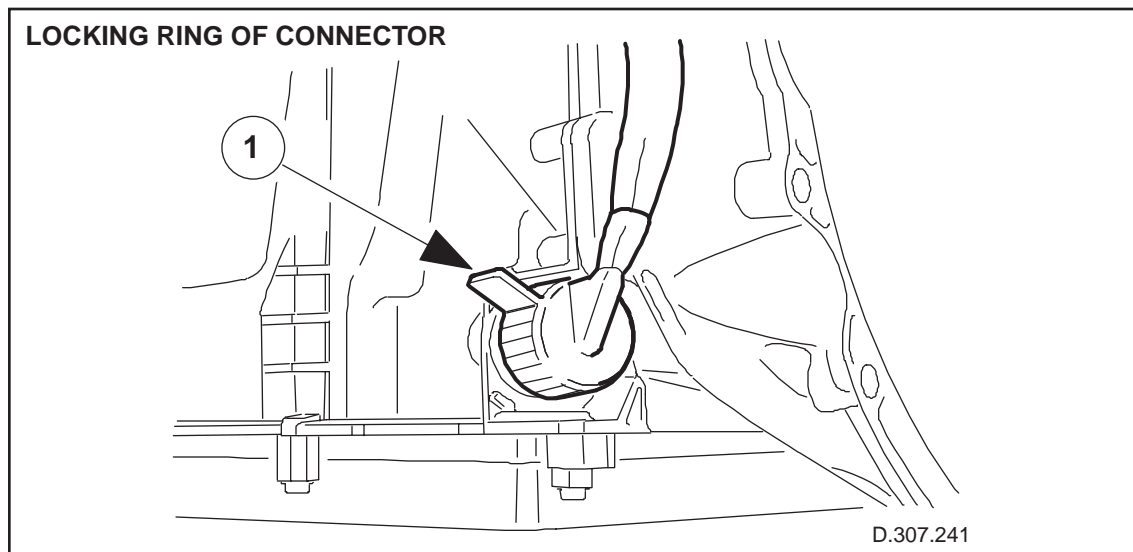
ILLUSTRATION 1

Some 1998 MY-ON XJR vehicles may experience seepage of transmission fluid from the area of the electrical connector on the right side of the transmission case. This bulletin provides a procedure for replacing the O-ring seals between the connector and transmission casing.

3. Place a new seal on the drain-plug and reinstall and torque the drain-plug to 22 Nm (16.2 lb. ft.).
4. On the right side of the transmission, remove the bolt that retains the heat shield for the multiplug connector. Remove the heat shield.
5. Rotate the lock ring counterclockwise to release the multiplug connector (Illustration 1). Disconnect the multiplug.
