**Spark Plug “Blow-by Stain”/Corona Stain –
Spark Plug Function Not Affected –
Replacement Unnecessary**

MODEL
1997 MY-ON XK Range
1998 MY-ON V8 XJ Series
VIN
001001-ON
812256-ON

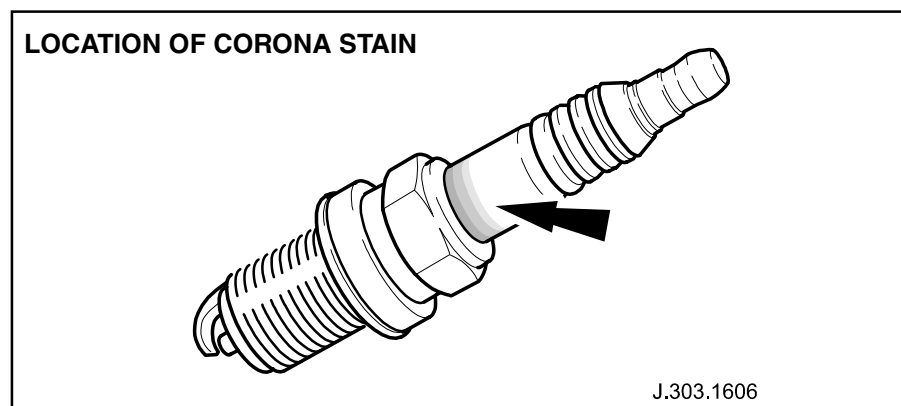
ILLUSTRATION 1

When Corona discharge has taken place, there can be a discoloration of the lower portion of the insulator surface (Illustration 1). This is what is known as ‘Corona stain’ and is orange/gray in color. Corona stain is caused by oil particles in the air that are attracted to the Corona discharge, charged and then adhere to the insulator surface.

The Corona stain has no effect on the function of the spark plug. The spark plug **should not** be changed for this reason.
