V8 XJ Series

501-46

TECHNICAL BULLETIN

Memory Buttons Hot To Touch –
Component Serviceability –
Repair ProcedureMODEL 1998 MY-ON
V8 XJ Series

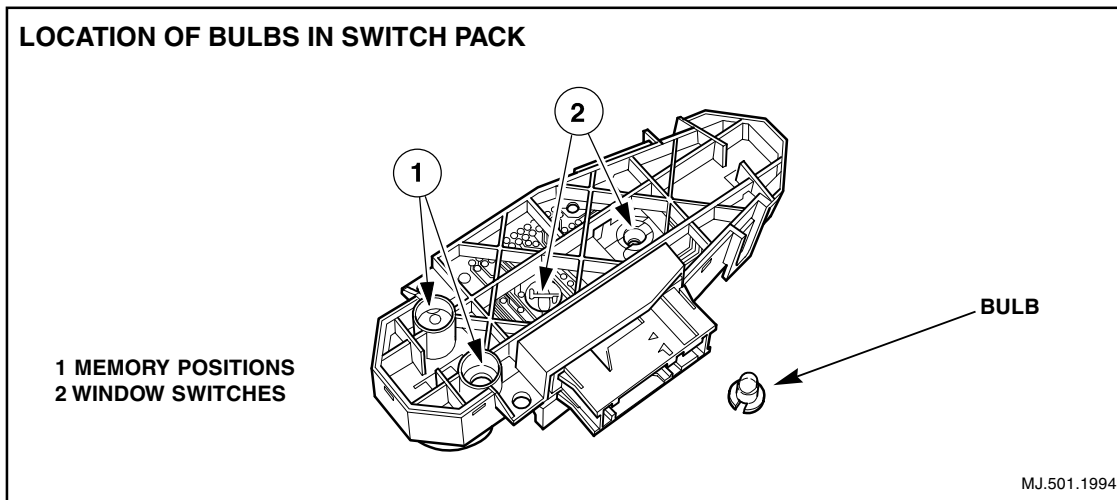
ILLUSTRATION 1

Note: The bulbs within the switch pack (Illustration 1) should only be replaced for the above complaint or if they are faulty or blown. Vehicles up to VIN F11700 were equipped with 100 ma bulbs for the seat memory control buttons, which then changed to 50 ma bulbs. Do not replace complete switch packs for such complaints, as this will result in the non-payment of the warranty claim.

2. Remove the door casing. (See workshop manual, JTIS CD ROM section 501-05, SRO 76.34.01).
3. Disconnect the switch pack connector.
4. Remove the armrest to expose the switch pack assembly. (See workshop manual, JTIS CD ROM section 501-11. SRO 86.46.12).
5. Using a screwdriver and a small pair of pointed tweezers, remove the bulb from the switch pack assembly (Illustration 1) (Refer to SRO 86.46.12). **Replace the memory position bulbs (item 1, Illustration 1) with 50 ma bulbs (blue base) only.**

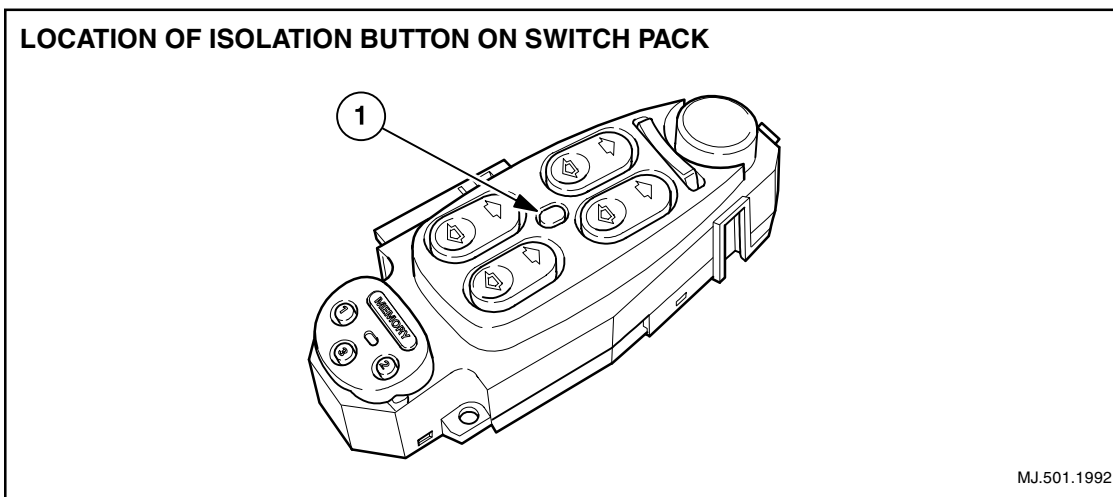
ILLUSTRATION 2

- Excessively hot memory buttons in the window switch pack – hot to touch.
- Missing window isolation button.

6. If missing or damaged, install a new isolation button into the switch pack ensuring it is fully depressed into the housing or until an audible click is heard. (See item 1, Illustration 2). Button can be removed with a small pair of tweezers/pliers.
