### BMW/JAGUAR ZF5HP24 "A" CLUTCH DRUM FAILURE

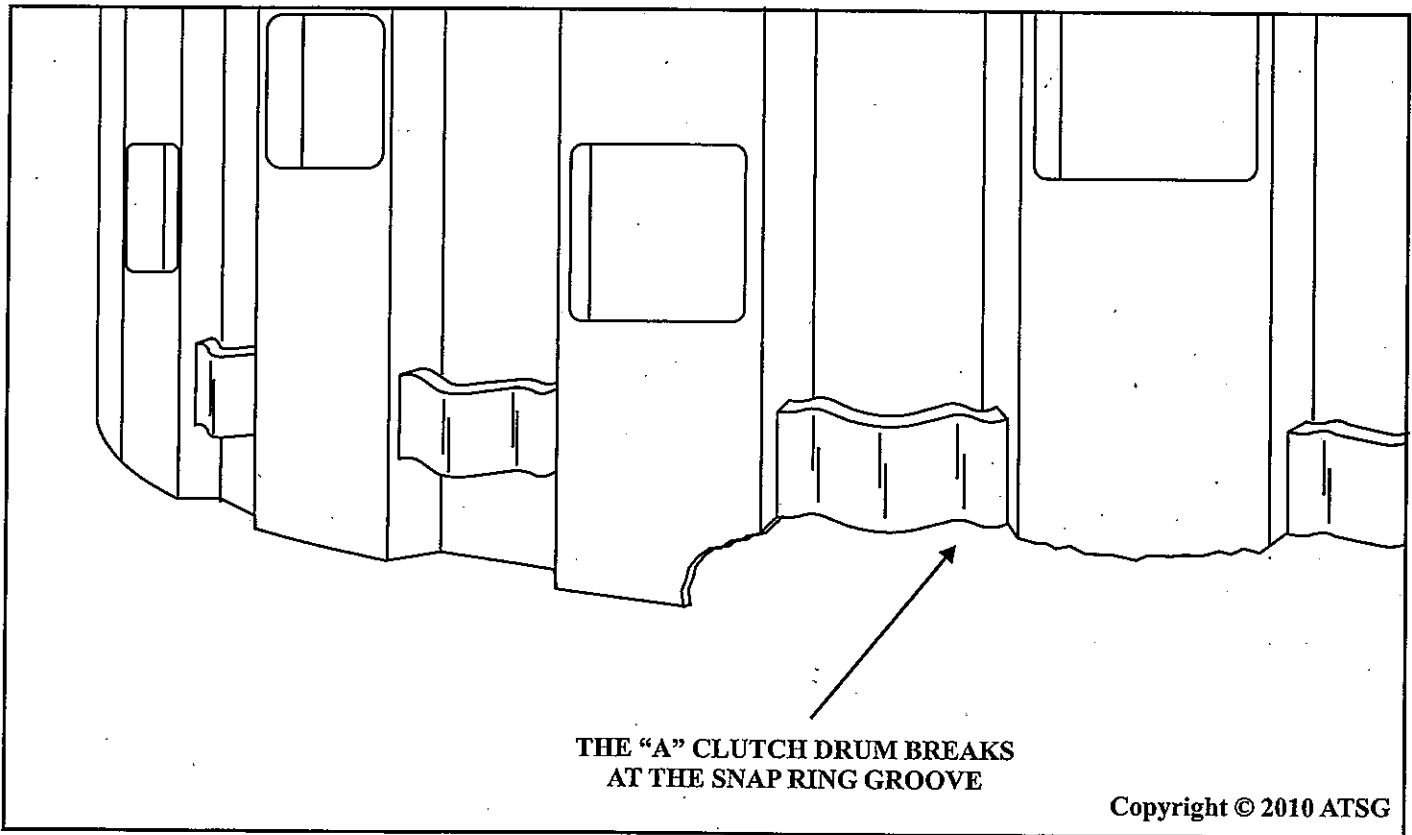
Figure 1  
Automatic Transmission Service Group

Upon disassembly of the transmission the "A" Clutch drum is found to be broken at the clutch pack retaining snap ring (Refer to Figure 1) and the snap ring has come out of the drum. The technician replaced the drum with the updated part only to have it come back with the same complaint and the same broken drum.

Using the part numbers found under Service Information, replace the pressure regulator valve and the lower front valve body.

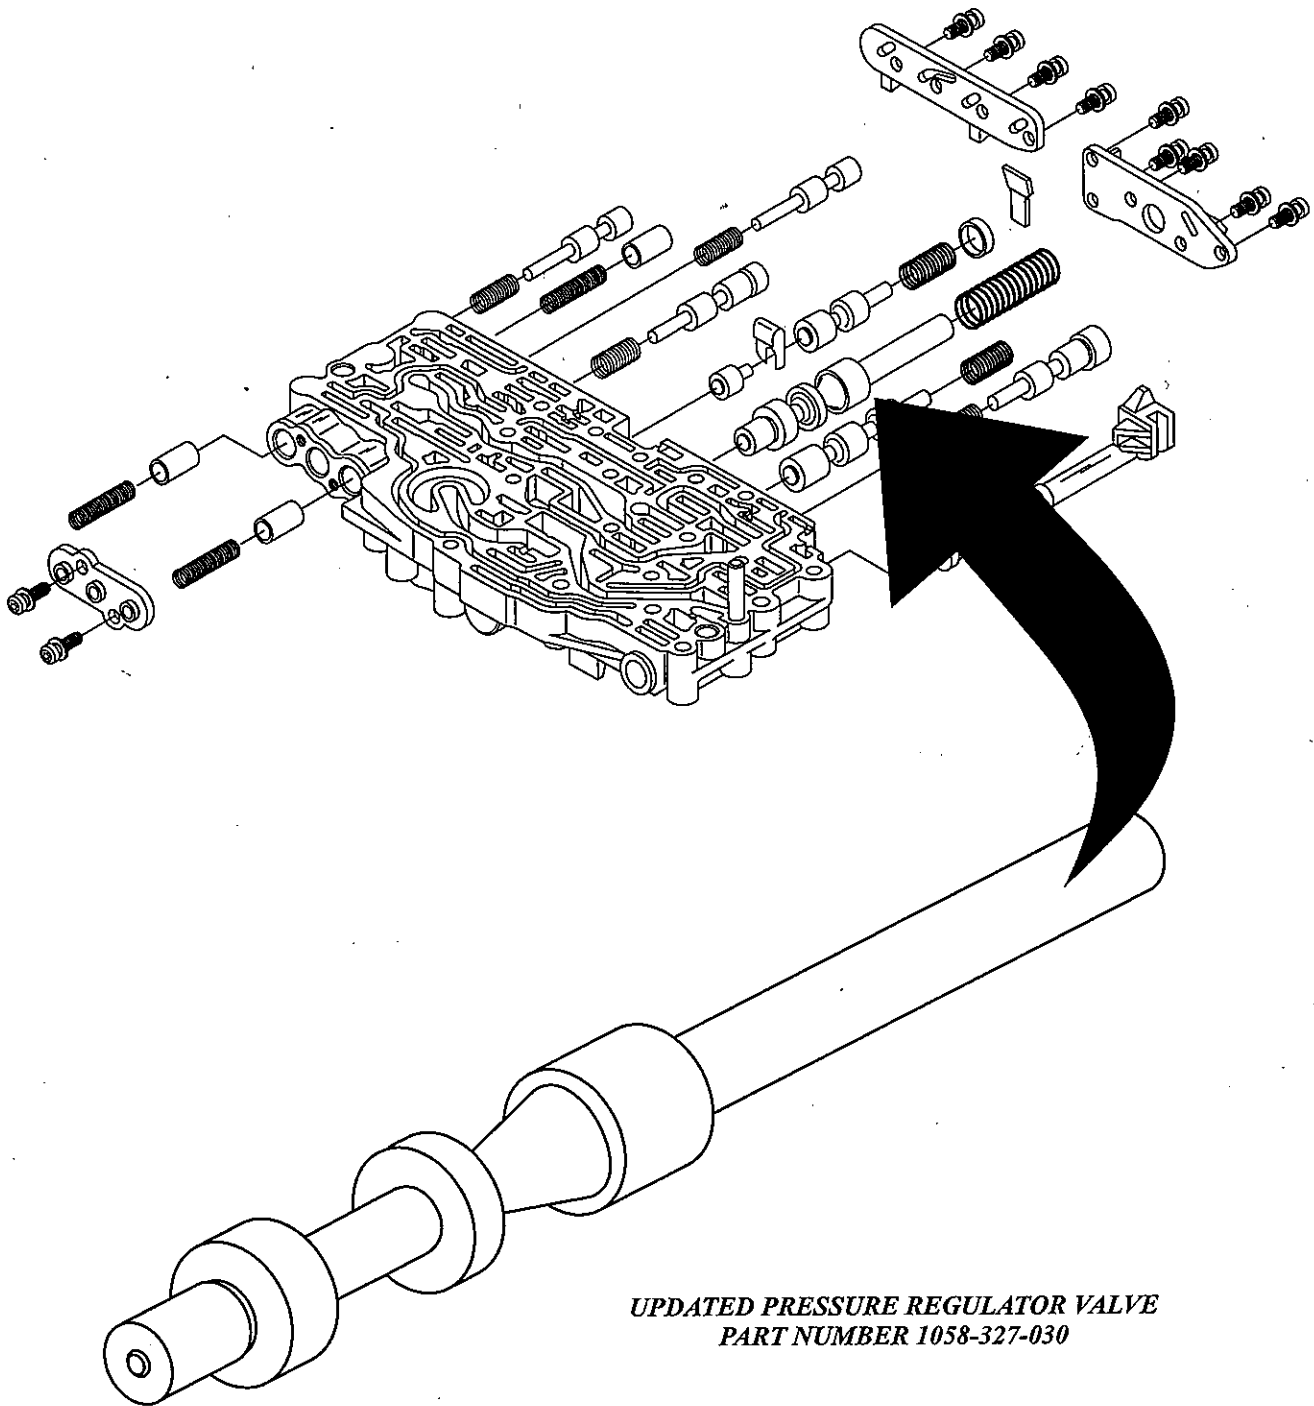
Figure 2

The drum is breaking in the snap ring area due to *un-commanded* pressure spikes. There is an updated pressure regulator valve (See Figure 2) which could help the situation as long as the valve bore is not worn. The pressure spikes can still occur and are caused by wear in the pressure regulator valve bore in the lower front valve body, Refer to Figure 3.

*UPDATED PRESSURE REGULATOR VALVE  
PART NUMBER 1058-327-030*
