## BMW/JAGUAR ZF5HP24 "A" CLUTCH DRUM FAILURE

**COMPLAINT:** A vehicle with a ZF5HP24 comes in with a complaint of little or no movement forward, reverse is good.

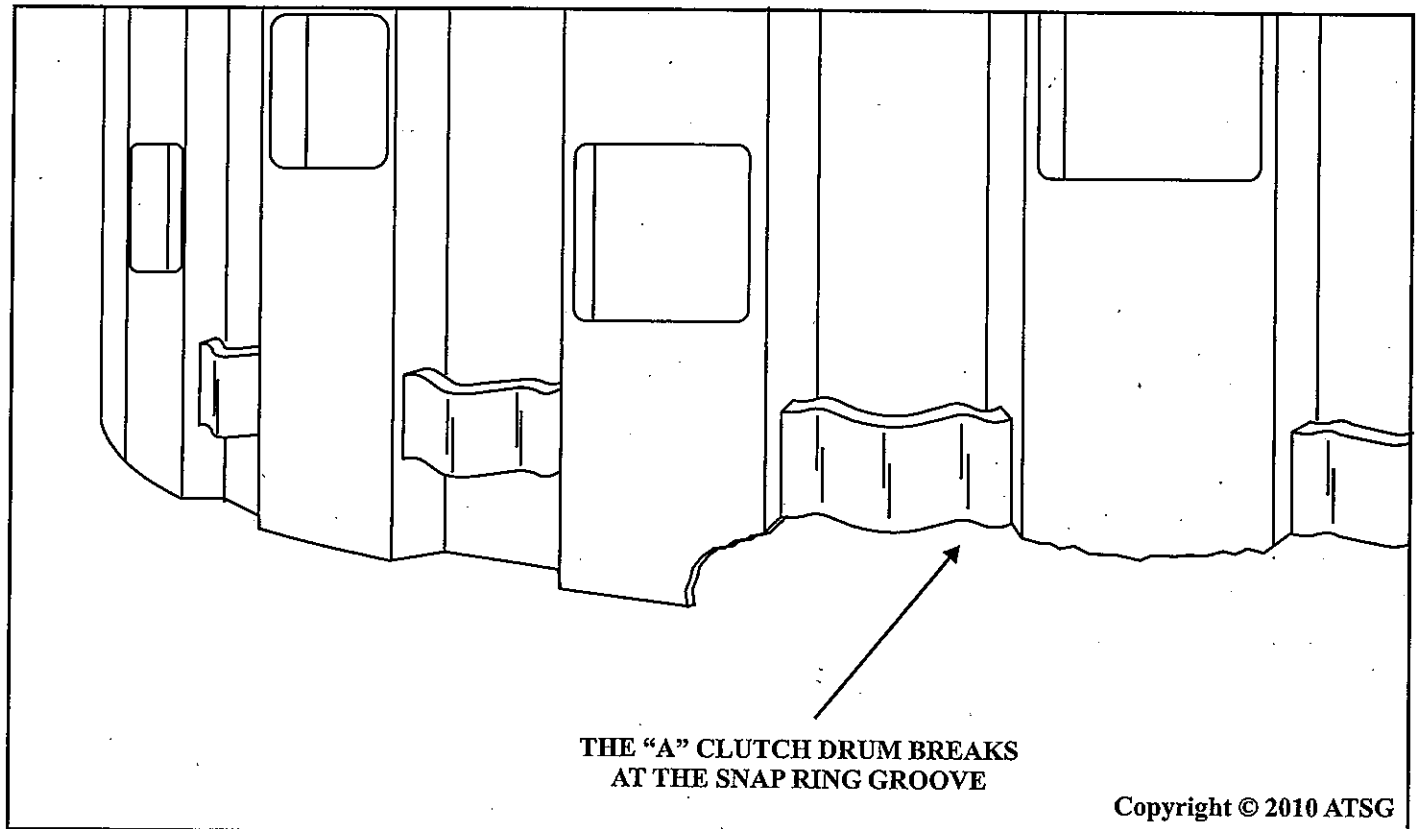
Figure 1  
Automatic Transmission Service Group

Upon disassembly of the transmission the "A" Clutch drum is found to be broken at the clutch pack retaining snap ring (Refer to Figure 1) and the snap ring has come out of the drum. The technician replaced the drum with the updated part only to have it come back with the same complaint and the same broken drum.

**CAUSE:** The drum is breaking in the snap ring area due to *un-commanded* pressure spikes. There is an updated pressure regulator valve (See Figure 2) which could help the situation as long as the valve bore is not worn. The pressure spikes can still occur and are caused by wear in the pressure regulator valve bore in the lower front valve body, Refer to Figure 3.

**CORRECTION:** Using the part numbers found under Service Information, replace the pressure regulator valve and the lower front valve body.
