Repairing an XJS instrument cluster

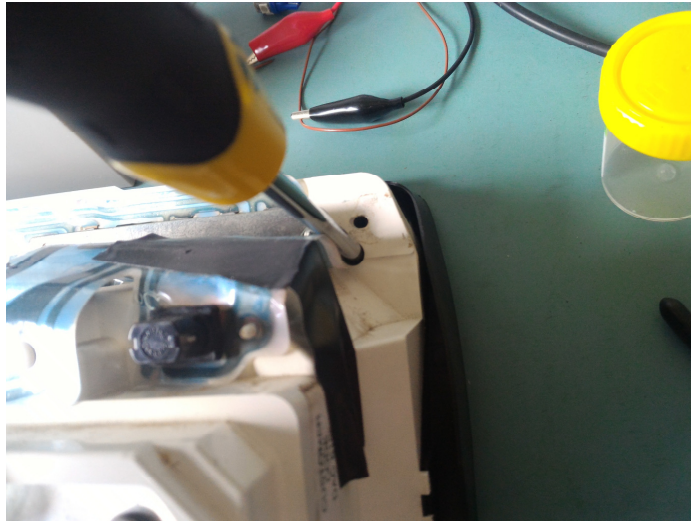
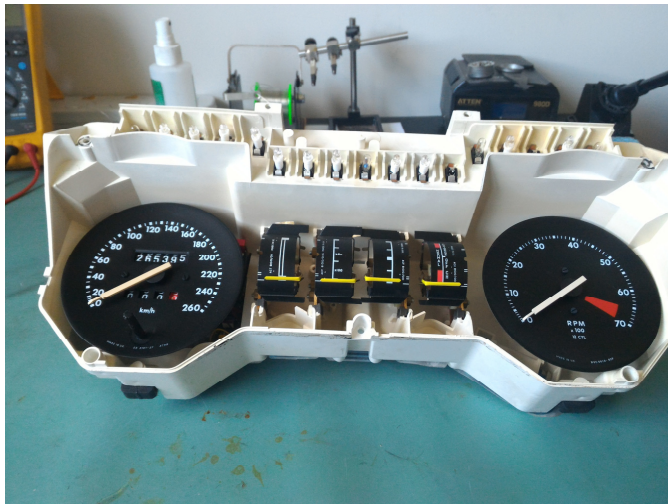
For most work you will not need to split cluster but just incase there are 7 screws that hold the front on 2 at the top 3 at the bottom and one each side shown in the first photo below.

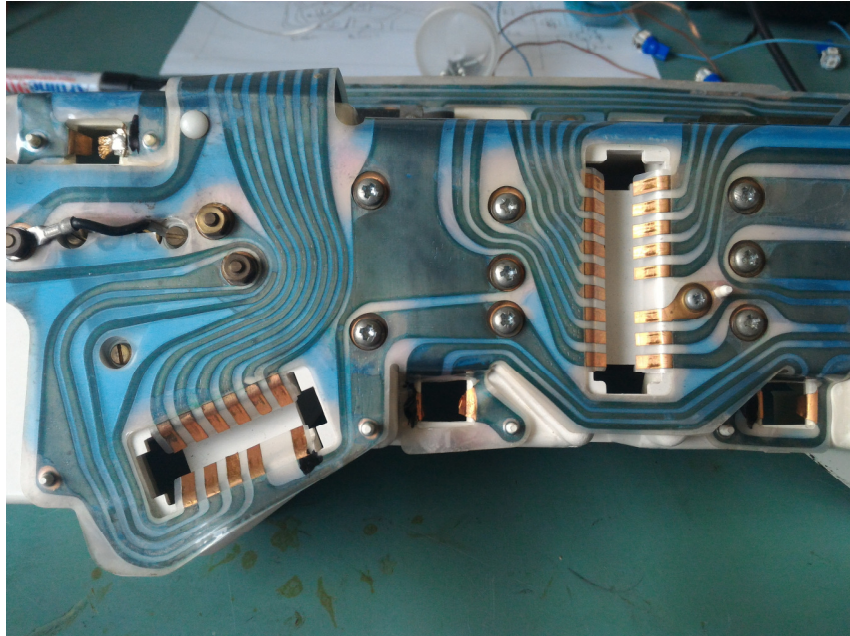
Most problems with intermittent or poor functioning gauges will be caused by the 2 main connectors. It is not uncommon for the traces to detach from the backing causing poor connection. Another common problem is corrosion probably caused by a leaking windscreen at some time in the cars life.

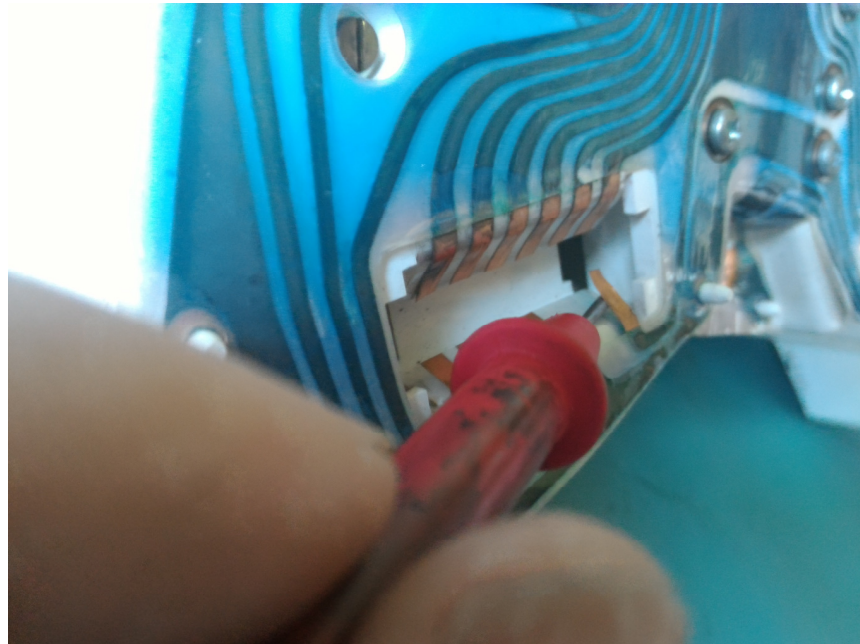
Detached trace

These detached traces can be glued back on to the plastic with superglue. When gluing use the superglue sparingly, push and hold the trace down with a jewelers screwdriver.

Try not to get the glue on the top of the trace, if you do don't despair. When the glue is dry use fine (at least 600) wet & dry paper and lightly sand the copper trace until the glue is gone.

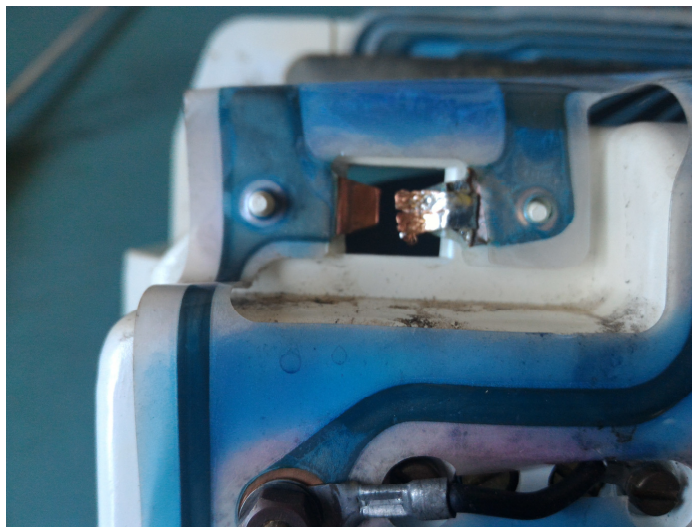
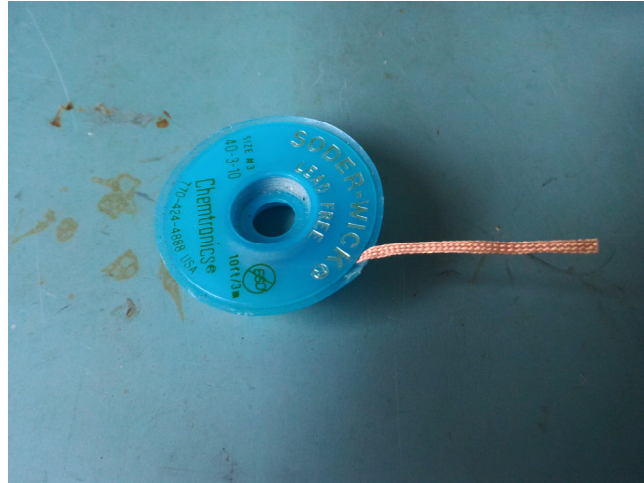
A problem I came across was a broken trace on the top RH (looking from the front) Globe. I repaired this using a bit of solder wick. This is a repair I did 5 years ago and it's still going strong. You could also solder a couple of bits of wire, as long as it touches the globe carrier it should work. Any damaged traces can be repaired with wire as long as it is insulated.

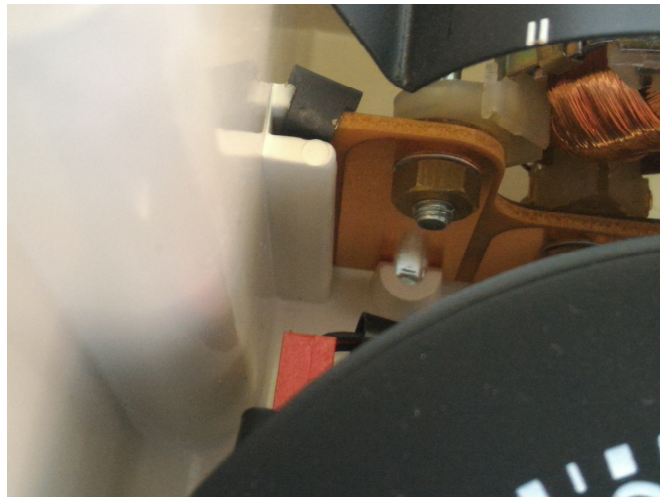
All of the gauges are held in by screws which touch the trace and copper PCB of the gauge. The photo below is the oil pressure gauge with the screw removed you can see the light and a couple of marks where the screw touches the gauge PCB, not a good design IMHO.

Remove all of the screws (you can do this one at a time) and clean the trace with a pencil eraser if they are very dirty, then run over them with Isopropyl Alcohol on a cotton bud. If they look clean then you can skip the eraser and just clean with IPA and cotton bud.

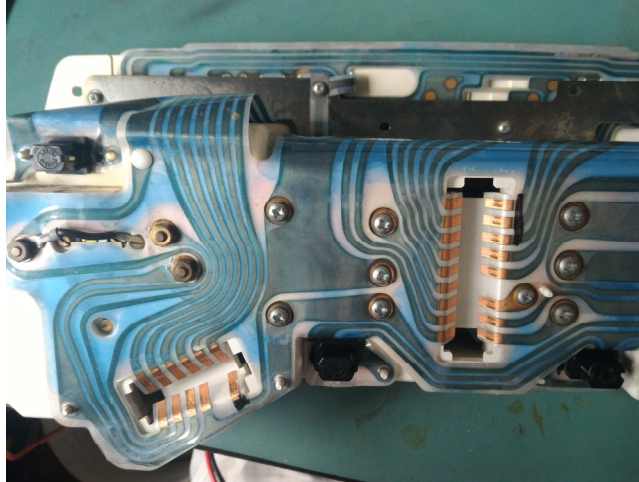
In the photo below I have marked all of the grounds on the connectors with a black marker, you can also see the steel plate that holds the T5 warning globes in, this steel plate is also a ground. My instrument cluster has no additional grounds all I did was repair the connectors and traces 5 years ago and the instrument cluster has worked fine since.

If you do want to run an additional ground to the chassis I would suggest running it from the steel plate. Drill a hole in it and add a separate wire, I would not attach it to the existing terminals.
