An annoying XJS oil leak fixed

My 1990, XJ-S has had an annoying oil leak from when I bought it two years ago and it has been getting slightly worse over time. The car is fitted with the 3.6 litre straight 6, AJ6 engine.

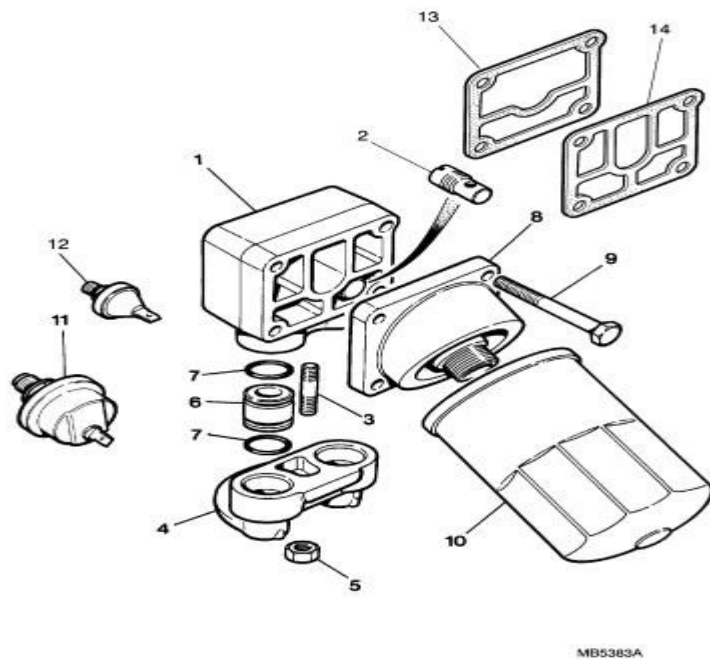
Figure 1: Detail of oil filter assembly

Thank goodness for the various XJ forums. It seems that this is a common XJ-40 problem because of the construction of the oil filter housing. This whole assembly is illustrated in Figure 1 below.

There are two gaskets between the oil filter housing and the cylinder block (items 13 & 14 in Figure 1) but careful examination showed they were not leaking. On cars with an oil cooler there are two hoses that originate from the base of the connecting block (item 1 of Figure 1); one is the feed to the cooler and the other is the return. When an oil cooler was not fitted, as with my car, then the hoses are replaced with a short aluminium "U" bend assembly (item 4 of Figure 1) that link the oil cooler outlet / inlets to keep the oil circulating through the engine. The oil tightness of the arrangement depends on two short metal collars with a rubber "O" ring seal at the top and bottom of each (items 6 and 7 of Figure 1).

With time, the “O” rings harden and no longer provide an effective seal allowing oil to escape the unit. The aluminium “U” bend assembly is held to the base of the oil filter connecting block by a single 13 mm nut (item 5 of Figure 1). I managed to remove this nut from above by reaching under the oil filter and working by feel – even managed this with the oil filter in place. You will need a deeply cranked ring spanner or long reach socket with a ¼” drive as a standard ½” socket assembly will not get in-between the two bowls of the “U” bend assembly.

The “O” rings on my car were so brittle that they just broke into pieces as I tried to lever them off the metal collars. New ones were supplied overnight by Britcar Parts at a £1 each (Part No. CAC 5118) and, with plenty of oil, easily slipped into place. Reassembly is a reverse of the strip down.

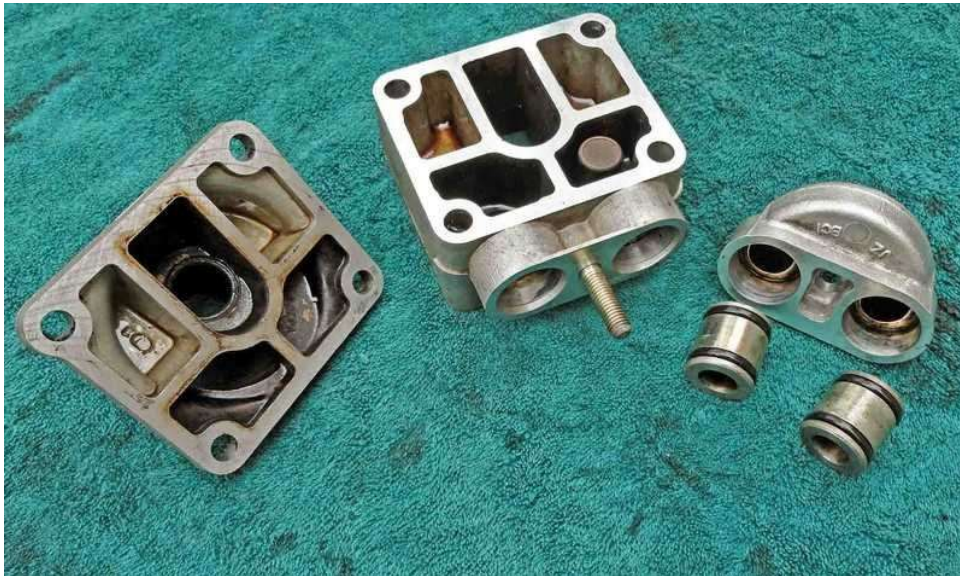
Figure 2: Oil filter to block assembly (thanks to Lawrence for the pic.)

Figure 2 shows the whole oil filter to block assembly and the oil cooler “bypass” items (4, 6 & 7 of Figure 1 are on the far right).

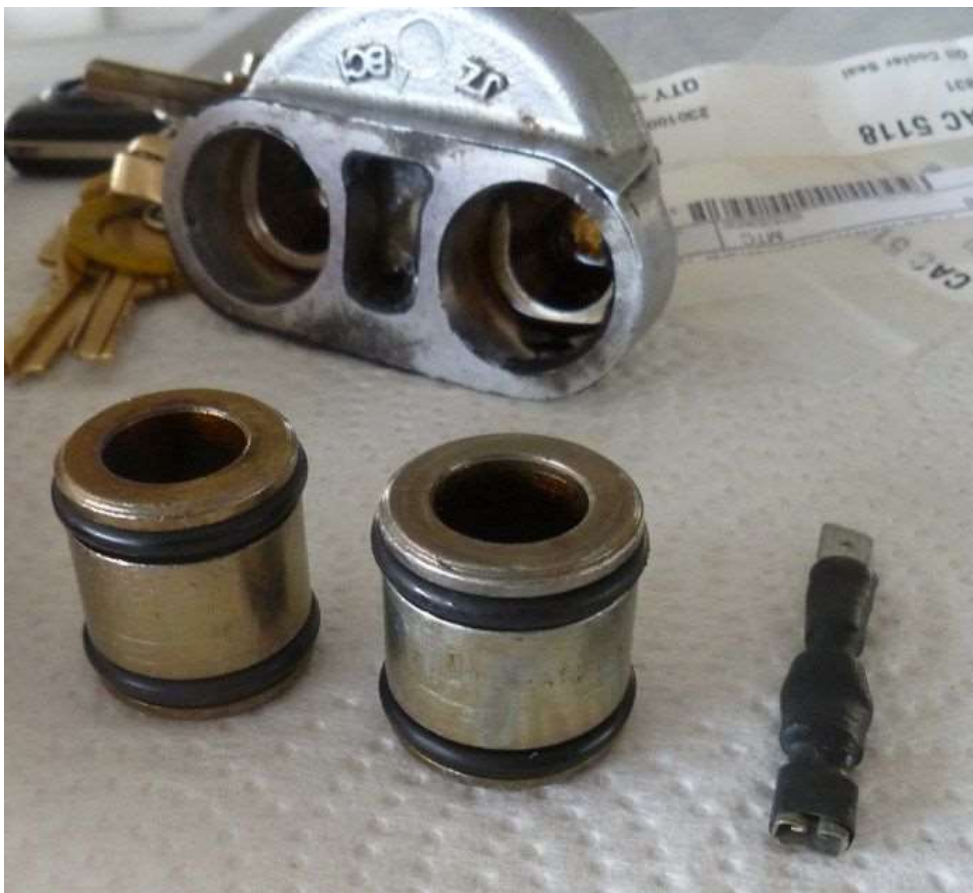
Figure 3: Detail of metal sealing collars and “O” rings (thanks to Lawrence for the pic.)

The detail of the two short metal collars are shown in Figure 3.
