TECHNICAL BULLETIN

JTB00283v2

XK Folding Top and Glass Separation

XK Range (X150)

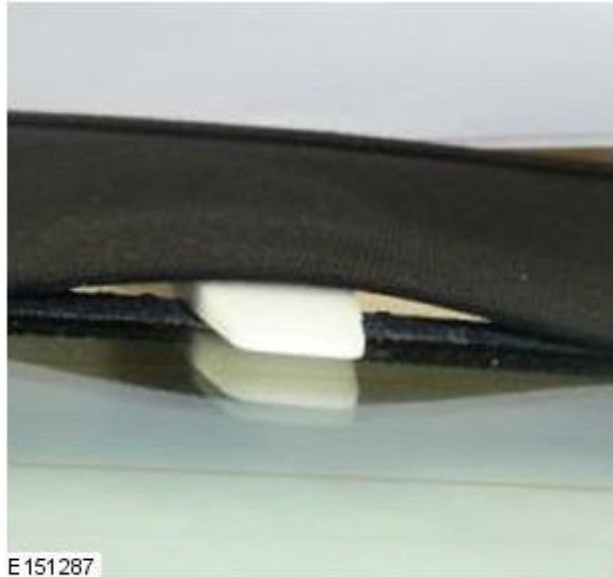
E 151287

NOTE: Plastic peg shown inserted for clarity of separation.

Graphic E151287 shows separation of the backlight bonding.

1. **NOTE:** 350mm is the maximum length of any one delaminating area that can be repaired. Up to maximum of 3 repairs around the glass are permitted.
