MODEL
2007 XK

NUMBER
XK100-001

TECHNICAL BULLETIN

New PDI Instructions to Activate Passive System

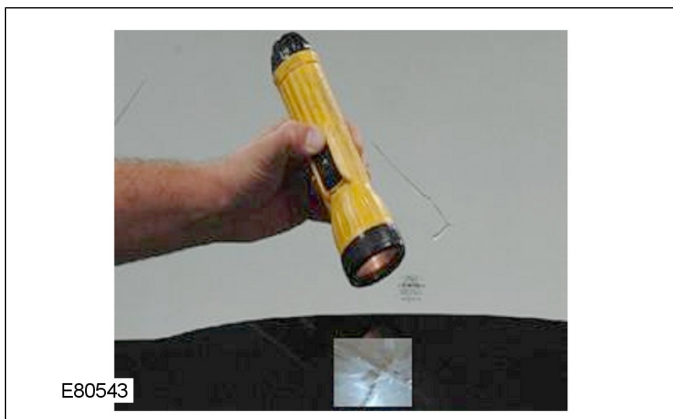
7. Flashlight test.

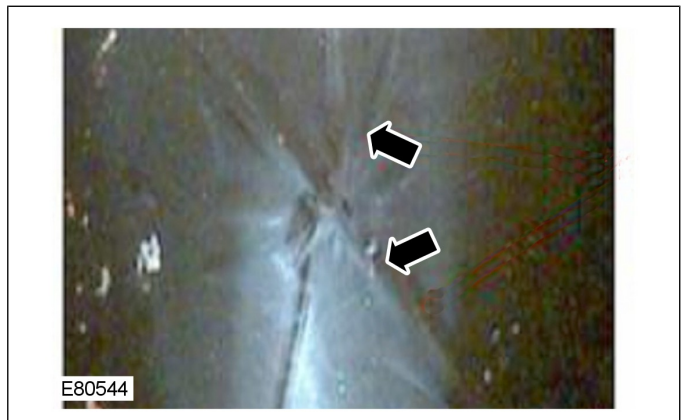
8. View from outside using flashlight (radial cracks).
Several radial cracks emanate from origin point.

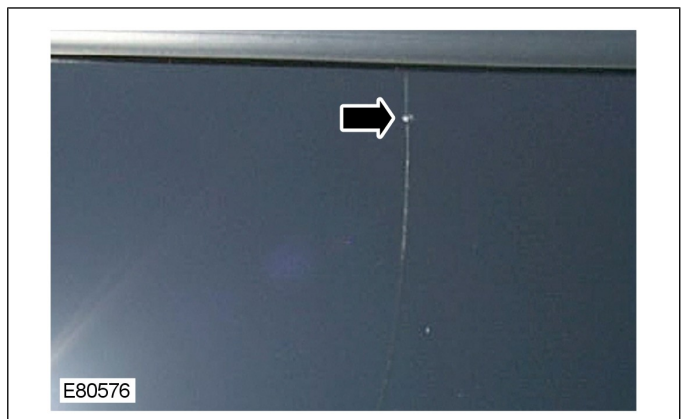
9. Low impact resulting in single crack.

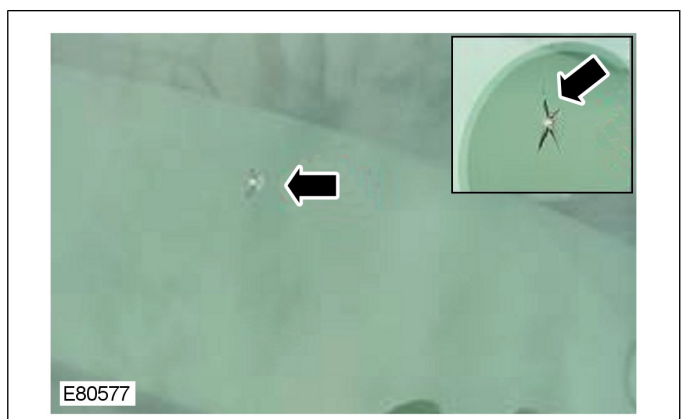
10. Moderate impact resulting in several cracks.

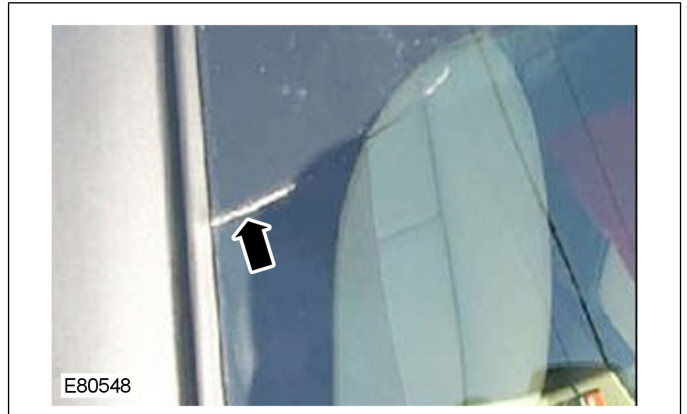
NOTE: The three examples below all show evidence linking to stress cracking. This must be confirmed using the ballpoint pen test previously described (in step 6) before any claim is made. Claims subsequently found to be caused by small stone damage will be rejected.

14. Crack along A-pillar.

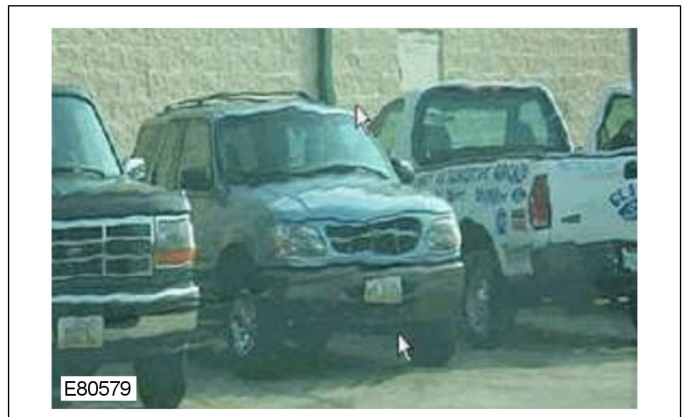
NOTE: Warrantable items include imperfections in glass manufacturing and factory assembly such as: distortion, delamination, spalling, bubbles, visual flaws between windshield layers and stress cracks.

15. Distorted glass.

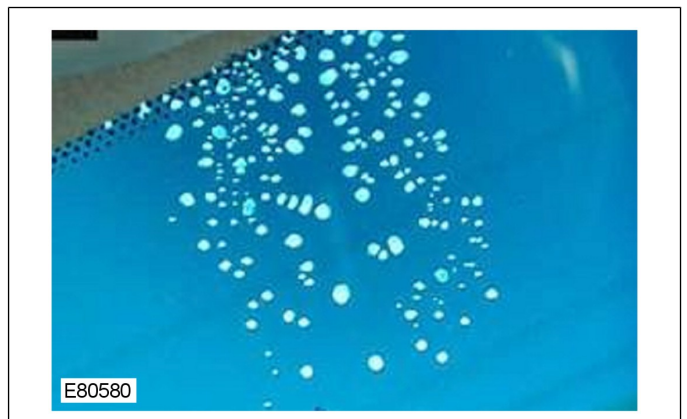
16. Bubbles (Delamination).
