MODEL
2007 XK

TECHNICAL BULLETIN

New PDI Instructions to Activate Passive System

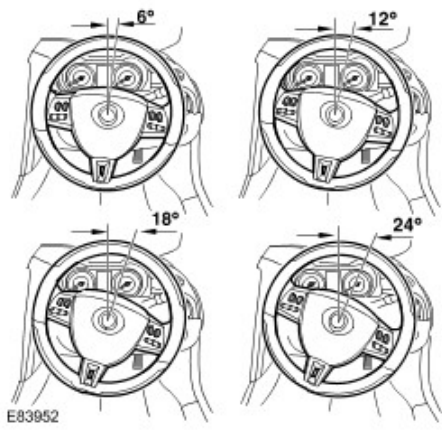
E83952

Raise an electronic product quality report (EPQR) providing photographic evidence of the alignment mark error where possible and details of the extent of steering wheel misalignment corrected, quoting the degree matching the closest to the misalignment shown in E83952.

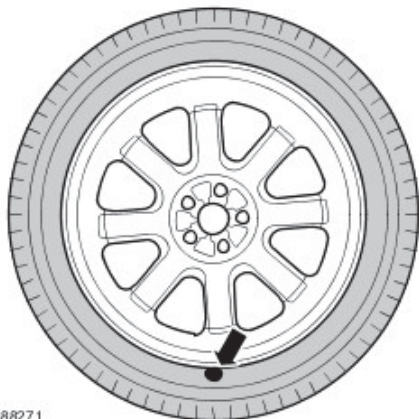
E88271

From the above VINs a 'red' paint dot for XF vehicles, and a 'yellow' paint dot for all other models (10-13mm in diameter) is being applied to the tire inboard sidewall to identify the high spot for radial force variation. Engineering evaluation tests have established that when installing a wheel to the hub the position of this yellow spot can influence the vehicles level of refinement. The optimum condition is to bias the wheel on the hub spigot towards the tires red/yellow dot position. To achieve this optimum condition the following process should be adhered to when installing a wheel to the vehicle. Follow the Service Instruction outlined below.

- To ensure that the optimum position of the wheel to the hub is achieved, the red (XF) and yellow (all other models) spot (see E88271) must be placed in the lowest position (6 o'clock), the wheel nuts should be installed hand-tight only, and then the vehicle lowered to the ground prior to final tightening of the wheel nuts to the specified torque value.

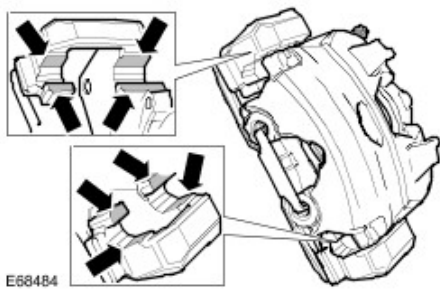
E68484

Cause: Front brake caliper to brake pad anchor interface.

1. Remove front brake pads (see Global Technical Reference GTR Workshop Manual, section: 206-03).
2. Clean and apply grease to the front brake caliper (see E68484).

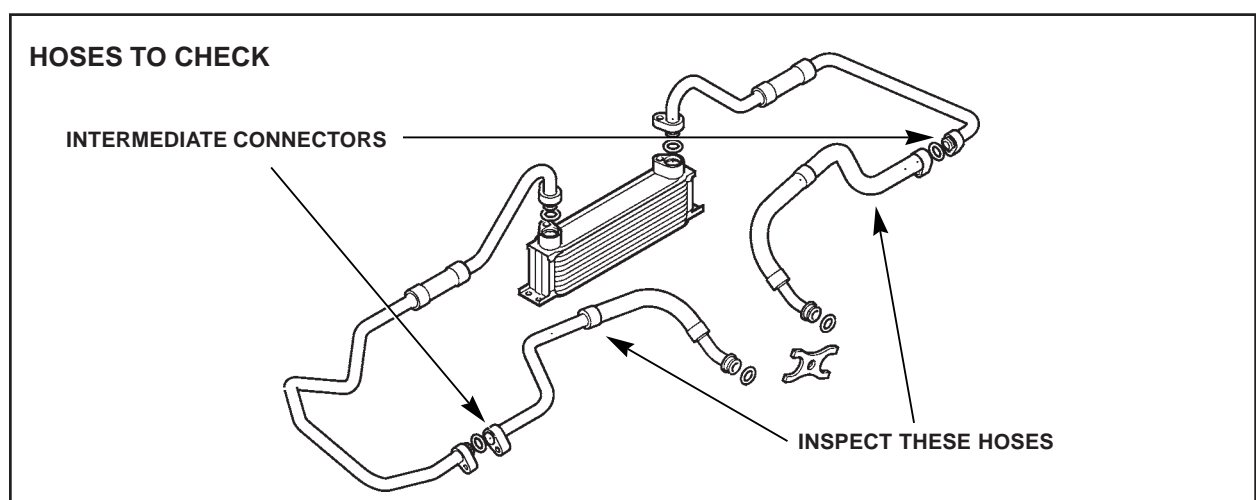
Inspect, at the first available opportunity, all 2004-05 MY XK range vehicle within the above VIN range. Check the feed hose/pipe leading from the engine to the intermediate connector and the oil cooler return pipe/hose from the intermediate connector back to the engine for a date code of **43 03**.

If the date code is illegible, not present, or reads **43 03** on either the engine to intermediate connector oil cooler feed pipe/hose or the oil cooler return pipe/hose, both pipe/hoses must be replaced.

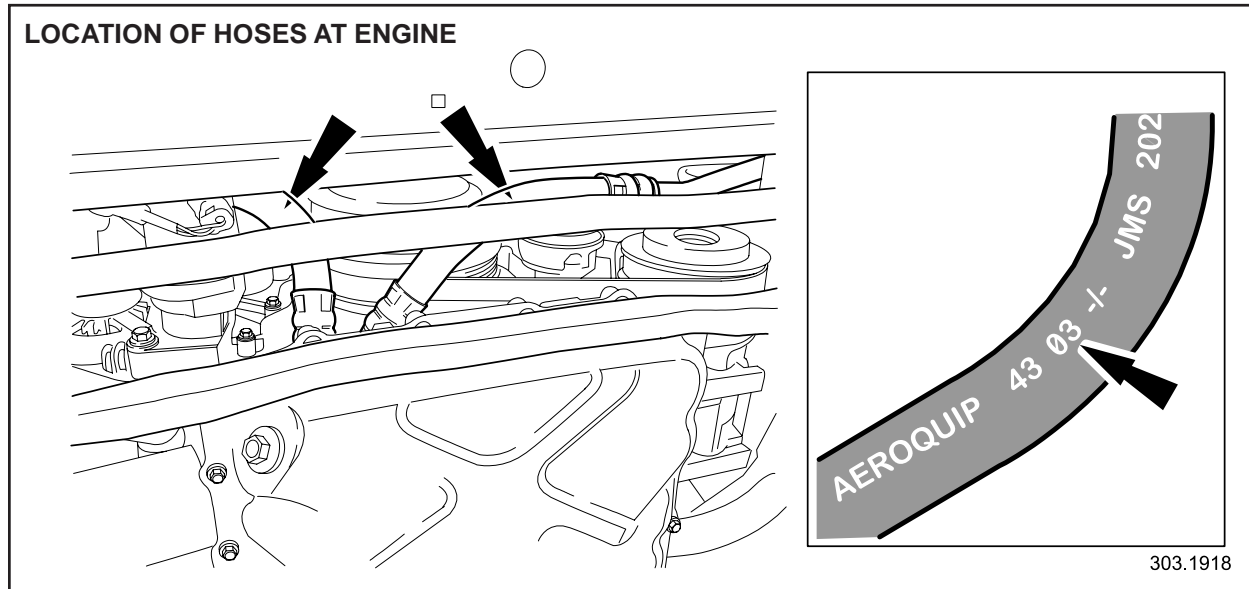
ILLUSTRATION 1

3. Check the date code (Illustration 1) on the oil cooler feed pipe/hose running from the engine to the intermediate connector and on the oil cooler return pipe/hose from the intermediate connector back to the engine. Use a small mirror if required.

4. If the date code displayed is **43 03** or the code cannot be determined, continue to step 5 of this workshop procedure. If the date code displayed is **not 43 03**, no further action is required. Lower the vehicle.
5. Remove the undertray.
6. Place a suitable drain tray under the vehicle.
7. Remove the oil cooler pipe/hose joint retaining plate securing bolt on the front of the engine (Illustration 2).

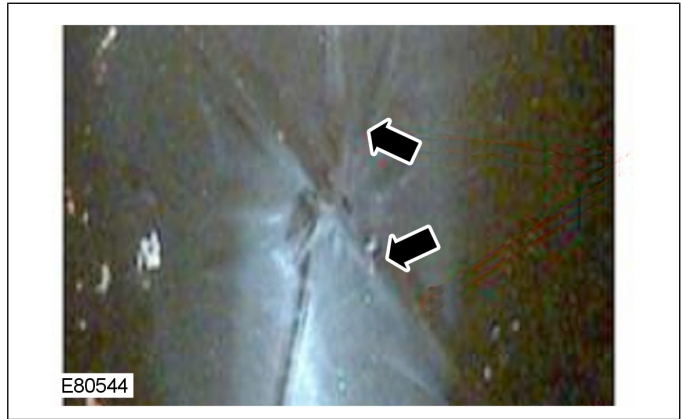
8. View from outside using flashlight (radial cracks).
Several radial cracks emanate from origin point.

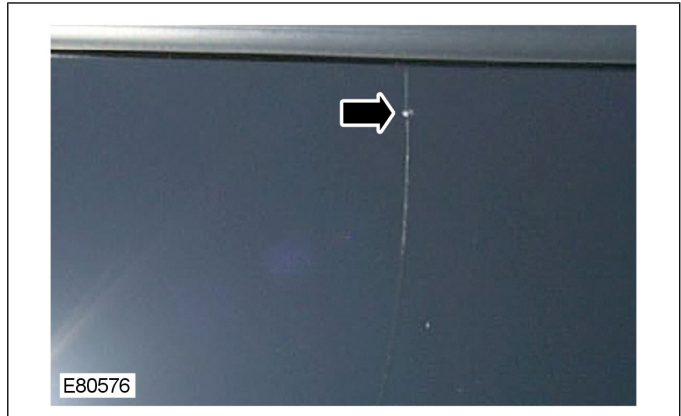
9. Low impact resulting in single crack.

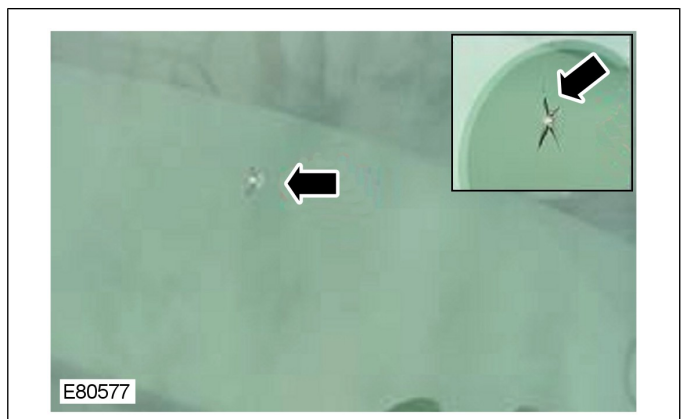
10. Moderate impact resulting in several cracks.

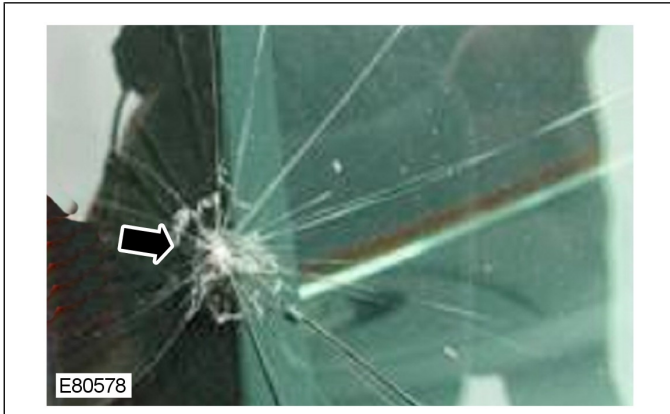
11. High impact resulting in many cracks.

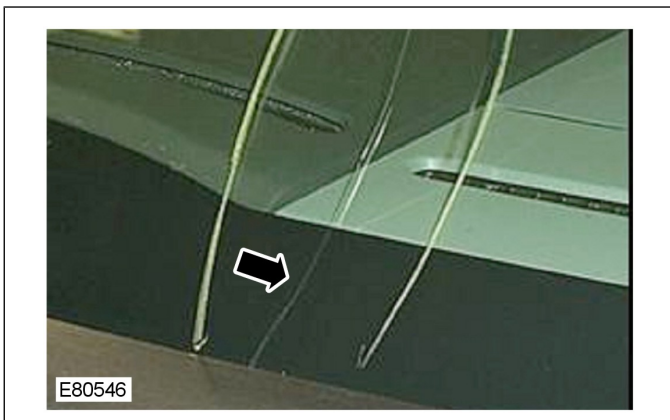
NOTE: The three examples below all show evidence linking to stress cracking. This must be confirmed using the ballpoint pen test previously described (in step 6) before any claim is made. Claims subsequently found to be caused by small stone damage will be rejected.

12. Crack along cowl.

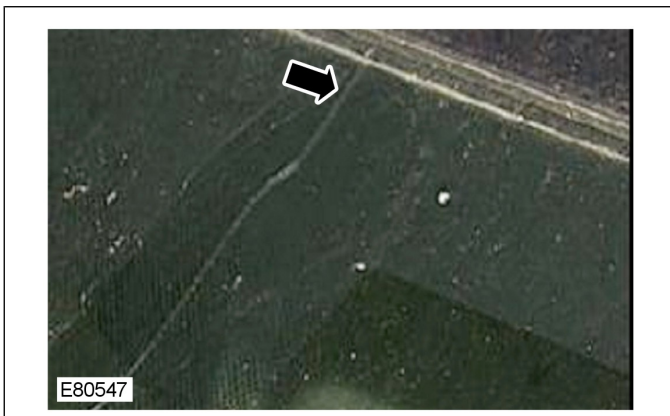
13. Crack along roof line.

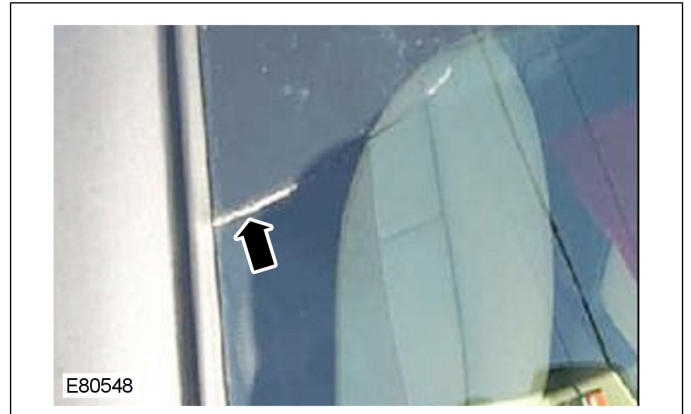
14. Crack along A-pillar.

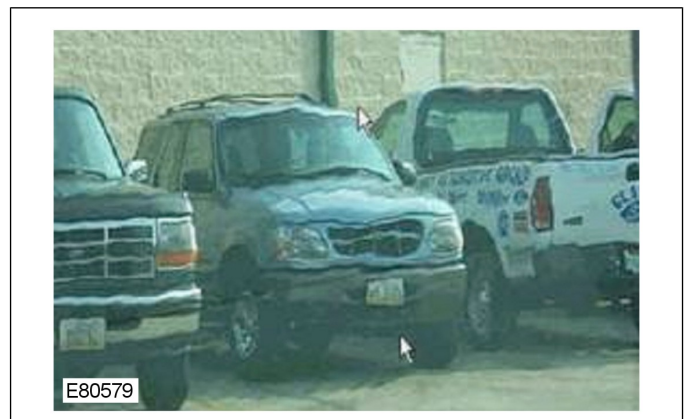
NOTE: Warrantable items include imperfections in glass manufacturing and factory assembly such as: distortion, delamination, spalling, bubbles, visual flaws between windshield layers and stress cracks.

15. Distorted glass.

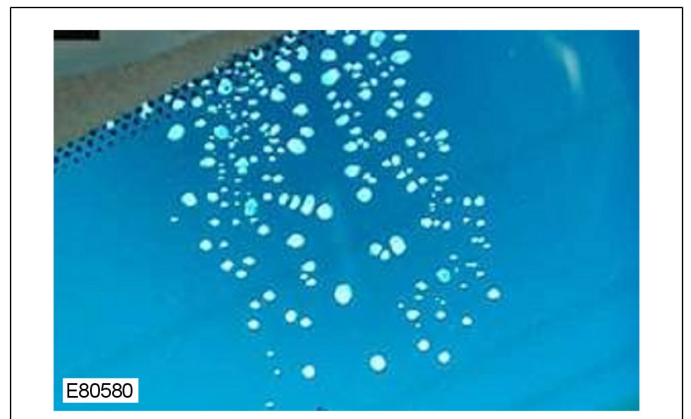
16. Bubbles (Delamination).

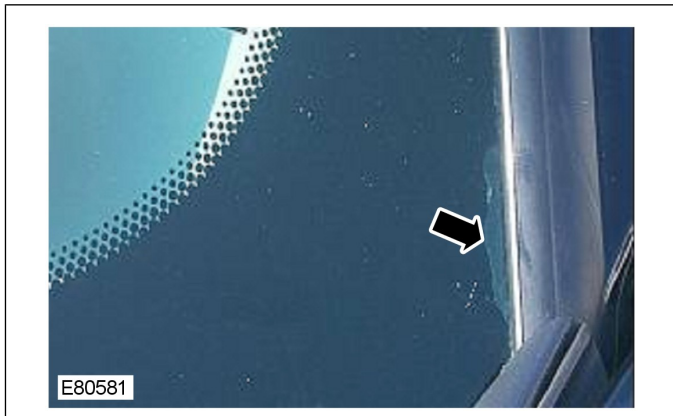
17. Edge delamination (Spalling).
