SERVICE ACTION

Service Action
Number: K100

Subject: Battery Monitoring System (BMS) and Software Enhancement Programme	Publication No.:	100-K100v2
	Model:	XK
	Model Year:	2010-2012
	VIN Range:	B32753 – B44940
	Date of Issue:	11 th June 2012
	Expiration Date:	31 st March 2014

RE: Battery Monitoring System (BMS) and Software Enhancement Programme

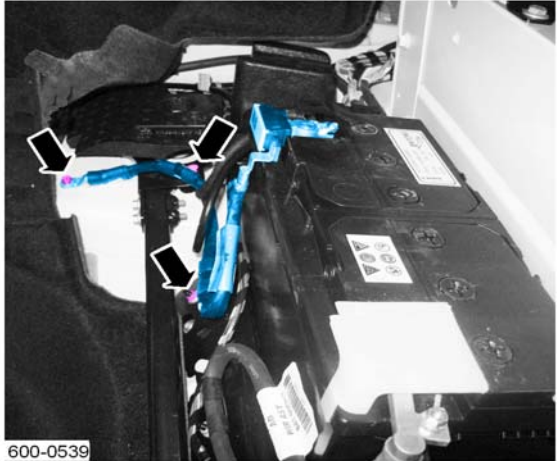
<p>18</p>	<p>Remove the battery ground cable and BMS assembly (see Fig. 1).</p> <ul style="list-style-type: none"> Remove the 2 nuts.

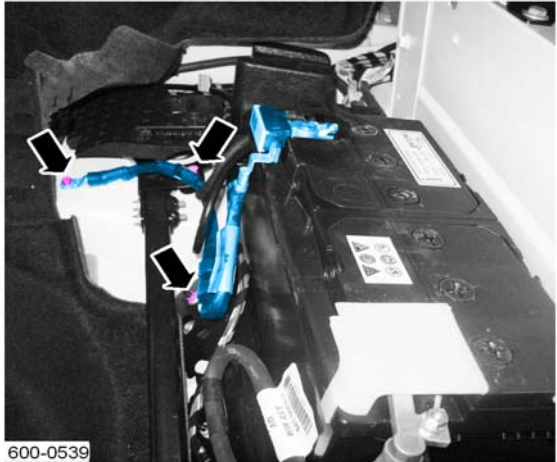
<p>Fig. 1</p>
<p>19</p>	<p>Install the battery ground cable and BMS assembly (see Fig. 2).</p> <ul style="list-style-type: none"> Tighten the 2 nuts to 25 Nm.
