TECHNICAL SERVICE BULLETIN reissue No.JTB00176/2006 10 September 2006

Subject/Concern:	Headlamp Internal Condensation
Model:	
The New XK	VIN Range: B00001 Onwards
XF	VIN Range: R00001 Onwards

Markets: All
Section: 417-01 - Exterior Lighting

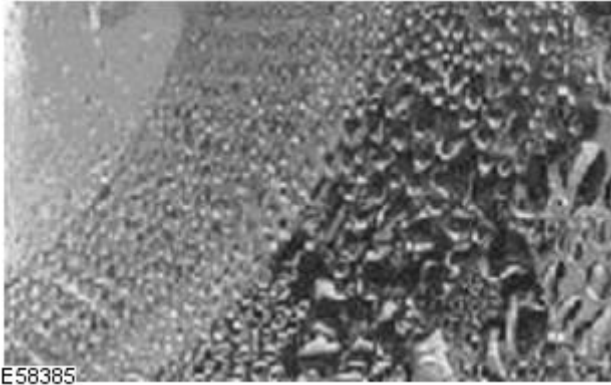
E58385

2. Large apparent visible droplets of water on the interior side of the clear glass lens.

1. Turn the headlamp dip and main beam functions 'ON', and run the engine for 30 minutes. If water droplets still remain on the inside of the headlamp glass, the lamp should be renewed. If there is evidence of standing water within the headlamp unit, the unit will also need to be renewed. For additional information, refer to
